APPENDIX D
REPORT OF DESIGN PANEL

The Design Panel was assigned the task of reviewing the design of the systems involved in the Apollo 13 accident, including their qualification history. The service history of the specific components flown on Apollo 13 was also to be examined from a design point of view to ascertain whether any abnormal usage experienced might have had a detrimental effect on the functional integrity of the components. The Panel was also charged with review of other spacecraft systems of similar design or function to ascertain whether they contained potential hazards. Finally, the Panel was to analyze, as required by the Board, proposed failure mechanisms to the extent necessary to support the theory of failure.

Early in the proceedings of the Board, it became evident that the failure was centered in the cryogenic oxygen subsystem of the electrical power system of the spacecraft, and, more specifically, in the no. 2 cryogenic oxygen tank. For this reason, detailed examinations of the Panel were limited to this subsystem. Interfacing systems were examined only to the extent required to understand the function of the oxygen system and/or to relate data from flight

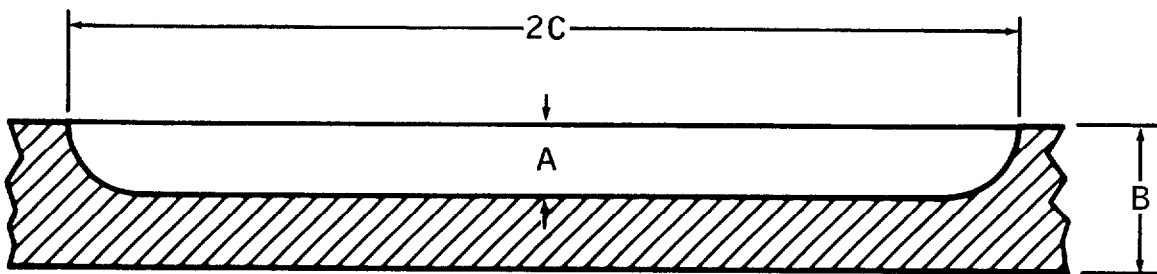
Figure D3-9.- Ligament model for ductile fracture of pressure vessel.

Area of lack of fusion produces
an effective crack of depth A
& length $2C$ in tank wall of
thickness B . $2C \gg A$

equatorial weld. It is postulated that the ligament will fail when its stress reaches the tensile strength of the material. Calculations show that the ligament stress σ_l is related to the average wall stress

where F_{tu} is the ultimate tensile strength. Failure will occur by tearing of the ligament accompanied by rapid decompression of the tank. It should be appreciated that this is a rather crude model of ductile fracture, and will probably overestimate the failure stresses in a spherical vessel. However, it should be useful in assessing the effectiveness of the proof tests in light of subsequent service, because of the very large margins between proof and operating pressures.

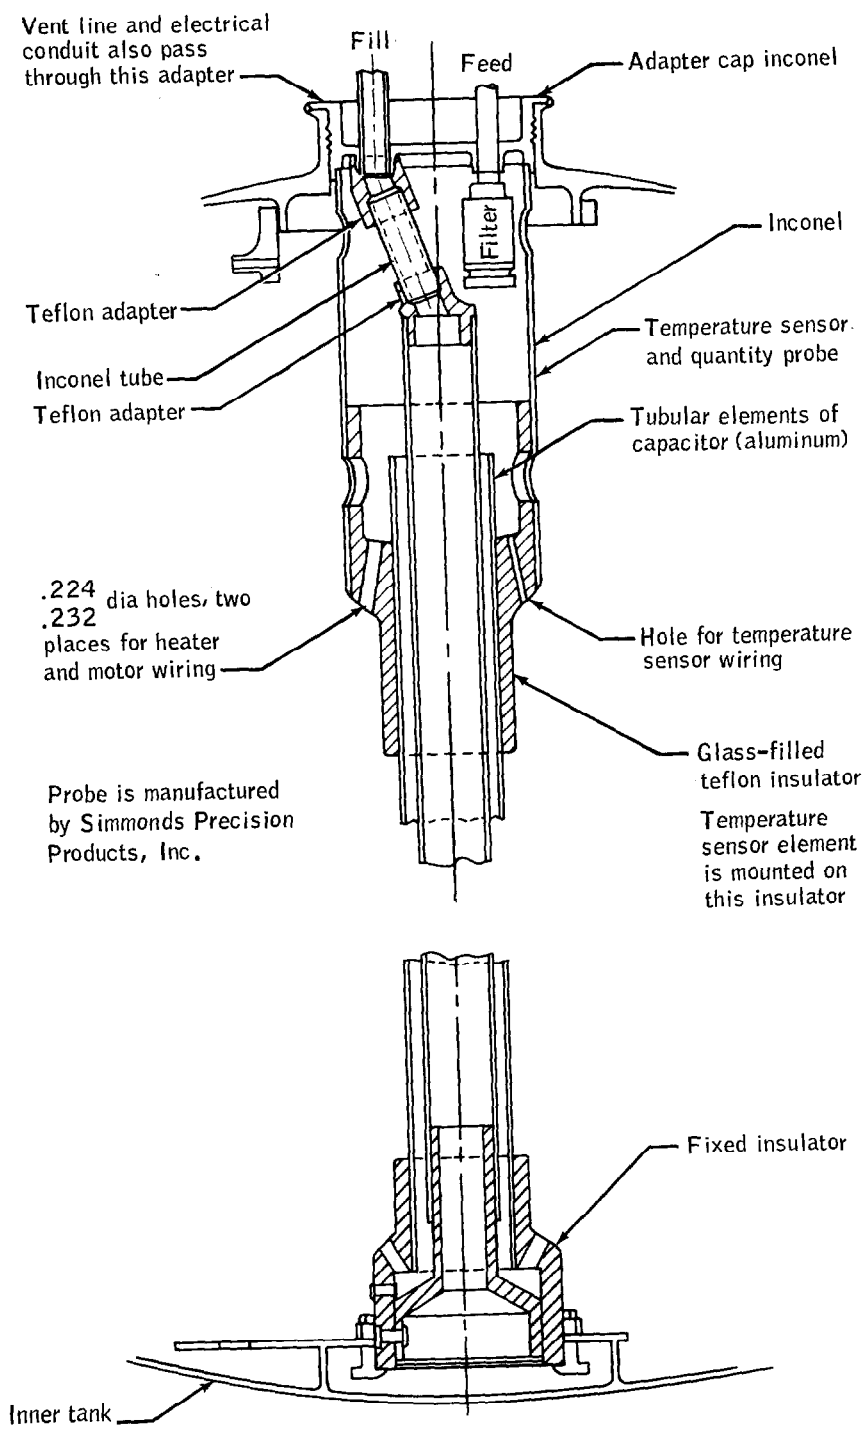
Figure D3-12.- Quantity gage.

The quantity gage capacitor (fig. D3-12) consists of two concentric aluminum tubes which are adequately mounted and supported. The inner tube of the capacitor constitutes the extension of the fill line. The outer tube is perforated to insure access of the oxygen to the space between the capacitor plates. The relative position of the two plates is maintained by insulating Teflon separators. Shorting of the capacitor at the plates within the tank requires bridging of the gap between the tubes by a conductive material. Shorting could also be induced by the contact of bare lead wires resulting from insulation damage. The power input to the quantity gage is regulated and limited by the high impedance source of the signal conditioner. The spark that could be

generated is at the 7- to 10-millijoule level. The evidence provided by the data can be construed to indicate that the effects of the probe failure during flight were limited to data loss.

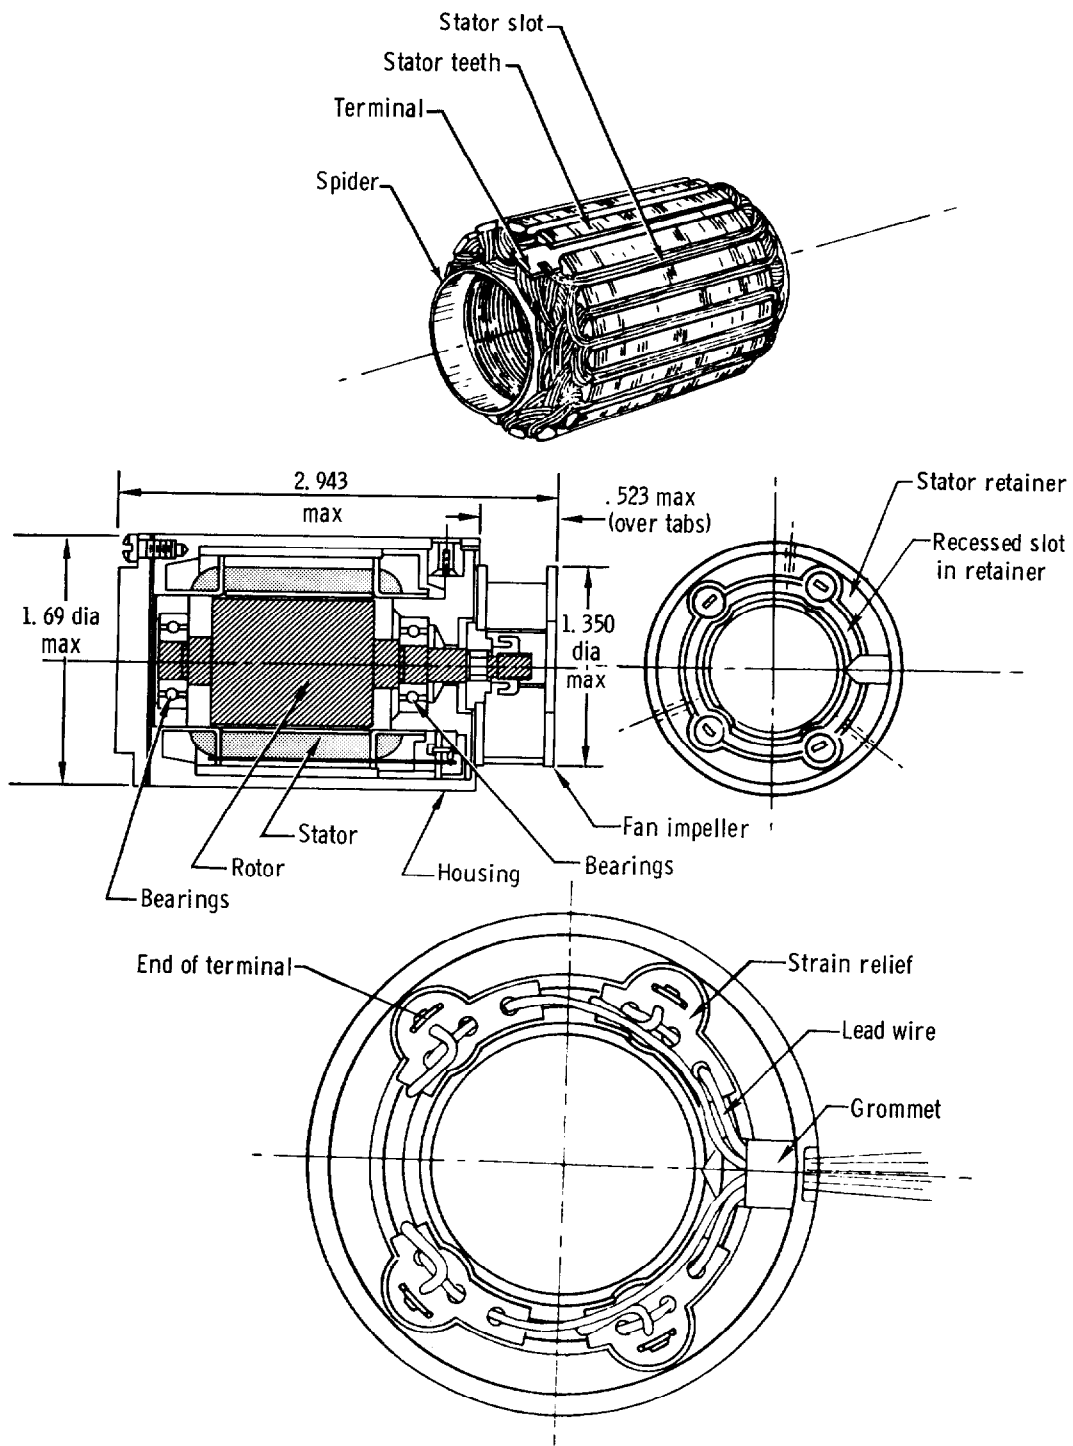
Figure D3-15.- Oxygen fan motor.

The stator windings are fabricated with number 36 American Wire Gage (AWG) wire, using a Teflon-coated ceramic insulation. The ceramic insulation is brittle and subject to breakage if proper tension is not used in fabricating windings or if sharp bends are made at the winding

end turns. Acceptance testing of the wire is conducted on the first 100 feet of each reel. The wire is considered acceptable if no more than 10 breaks in insulation are exhibited in the sample when pulled through mercury at 25 feet per minute. The rejection rate for stator winding faults for motors processed early in the production run was substantial. Improved yield was achieved only by rigid adherence to the winding tension process control used in fabricating the windings, proper assembly techniques, and frequent in-process dielectric testing. Phase-to-phase short circuits or shorted turns within a single phase are more likely than phase-to-ground faults. A limited amount of insulation is provided between windings and ground. Phase-to-phase insulation is limited to the end turns. Considerable improvement was accomplished in the acceptance rate of motors built after the fabrication control techniques were developed (Appendix C). No problem was exhibited in the testing of the two motors finally installed for flight in oxygen tank S/N XTA0008.

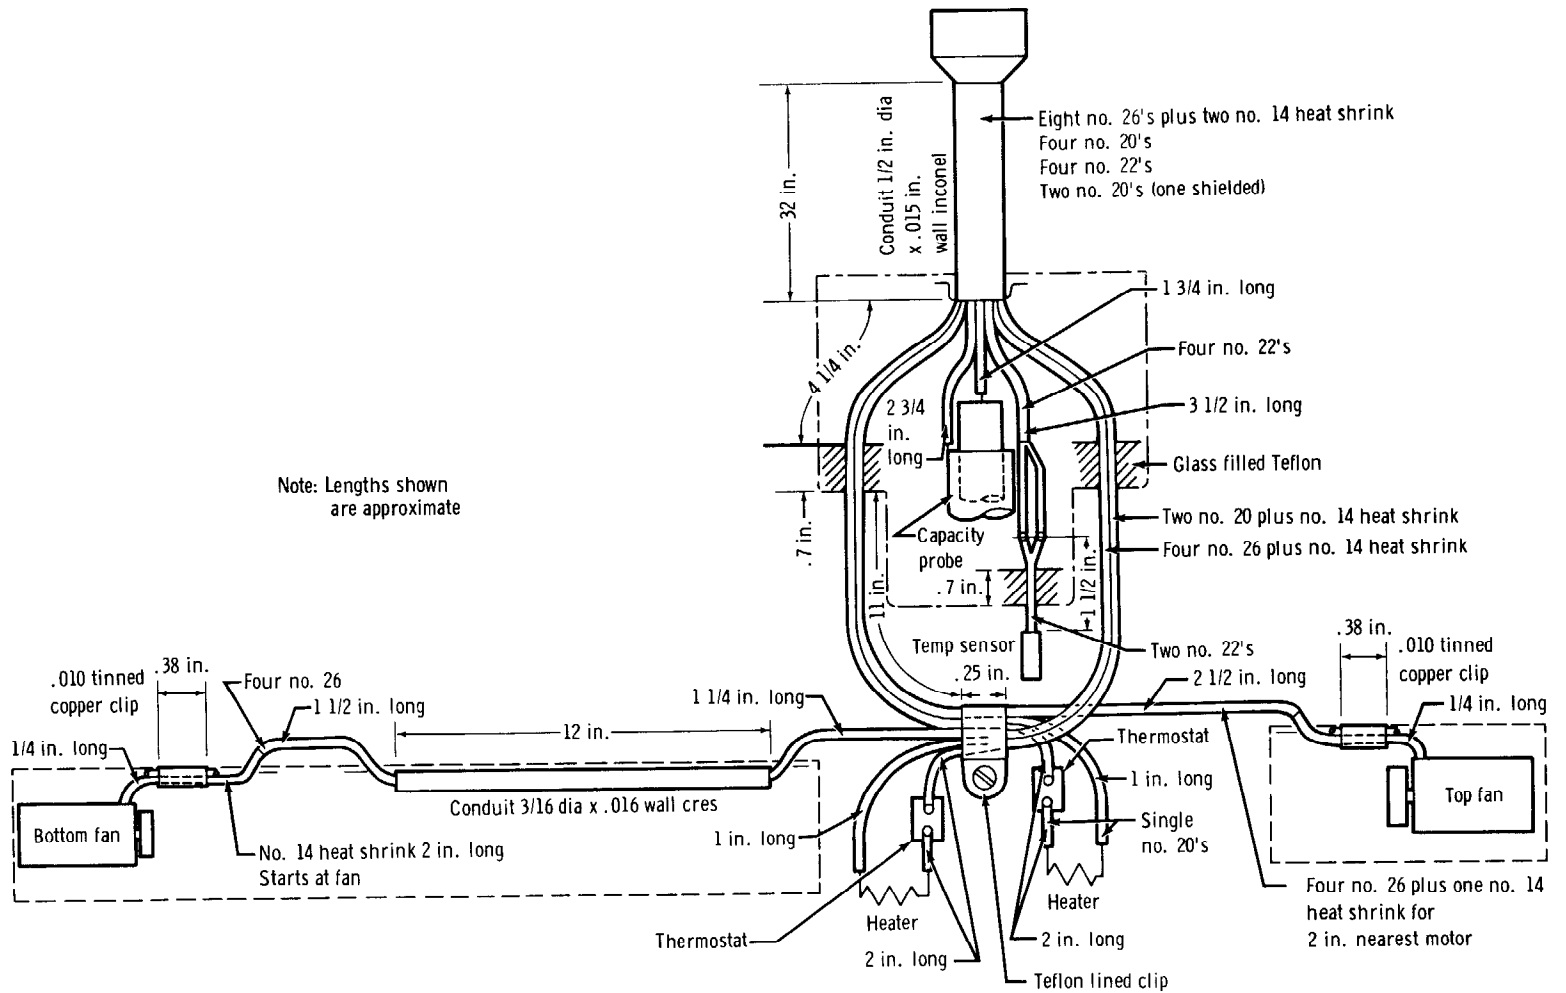
Figure D3-16.- Oxygen tank wiring distribution.

The mechanical design of the tank with respect to provisions for wiring is considered deficient. Damage to the wiring may be either insulation damage or conductor damage, portions of which cannot be inspected or adequately tested during or after assembly.

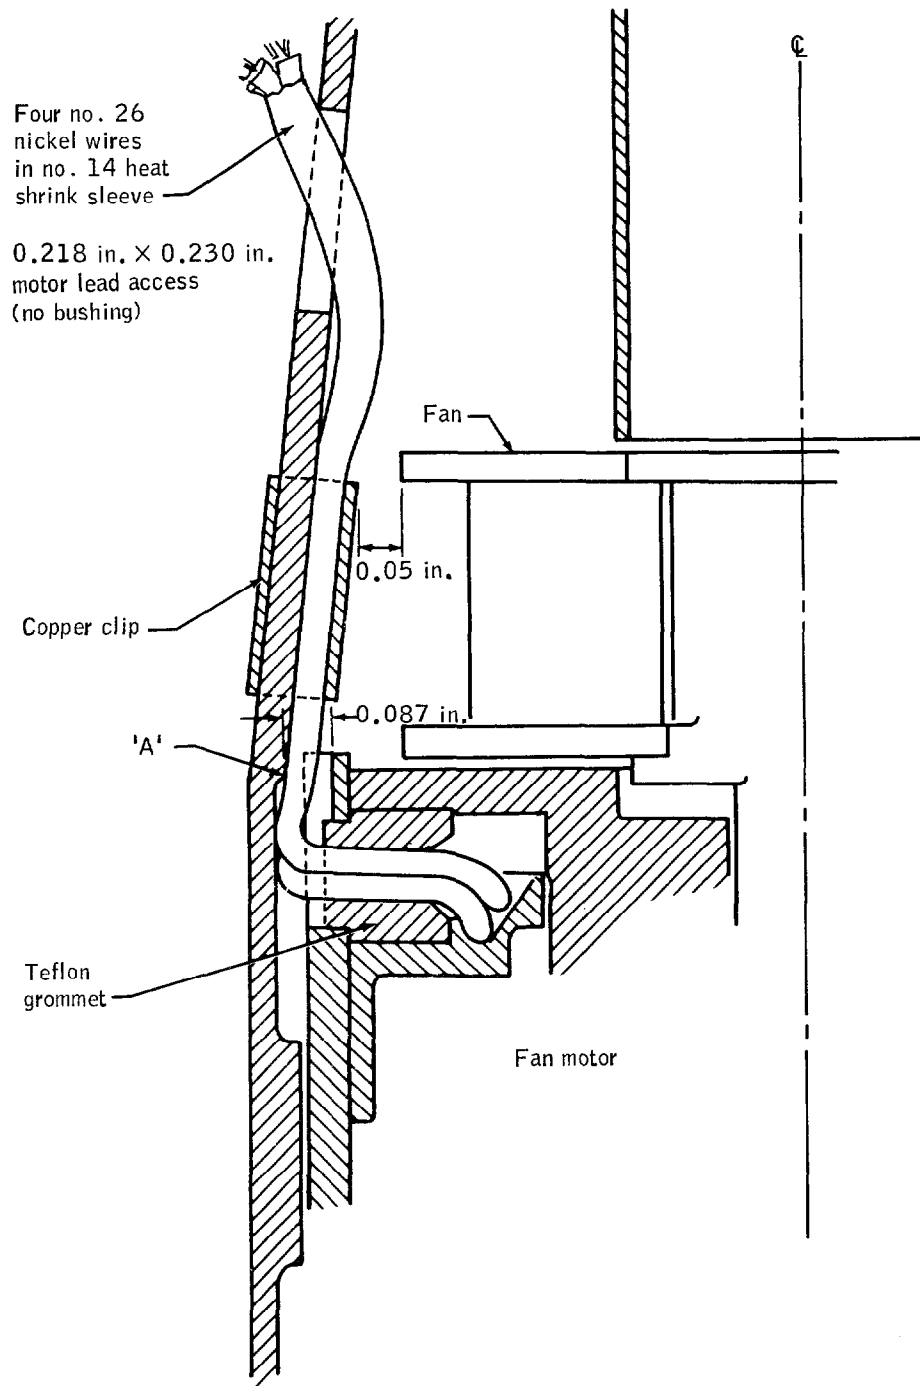
Figure D3-17.- Typical wire routing for fan motor (four times full size).

During assembly of the tank, three bundles of six wires each are sequentially pulled through the conduit. The first bundle, consisting of the two quantity gage wires and the four temperature sensor wires, is pulled through the conduit along with the pull wires for the other bundles. The second and third bundles each consist of one set of motor leads encased in 0.012-inch shrink-fit tubing and one set of heater leads. The pull wires have a break-strength of 65 pounds. Since the third bundle of wire must be forceably pulled through the conduit, damage to wires in this bundle or the others may result which may not be detectable without physical inspection. Physical inspection cannot be accomplished with this design.

The calculated break strength of a number 26 AWG nickel wire is 11 pounds and elongation of 28 percent can be experienced before break. If the number 26 AWG wires do not share the load associated with pulling the bundle through the conduit, damage to the wire(s) will result before the pull wire breaks. Stretching of the wire results in local neck-down of both the conductor and insulation. In subsequent operation of the circuit, the locally smaller gage conductor can produce local hot spots and progressive deterioration of the insulation.

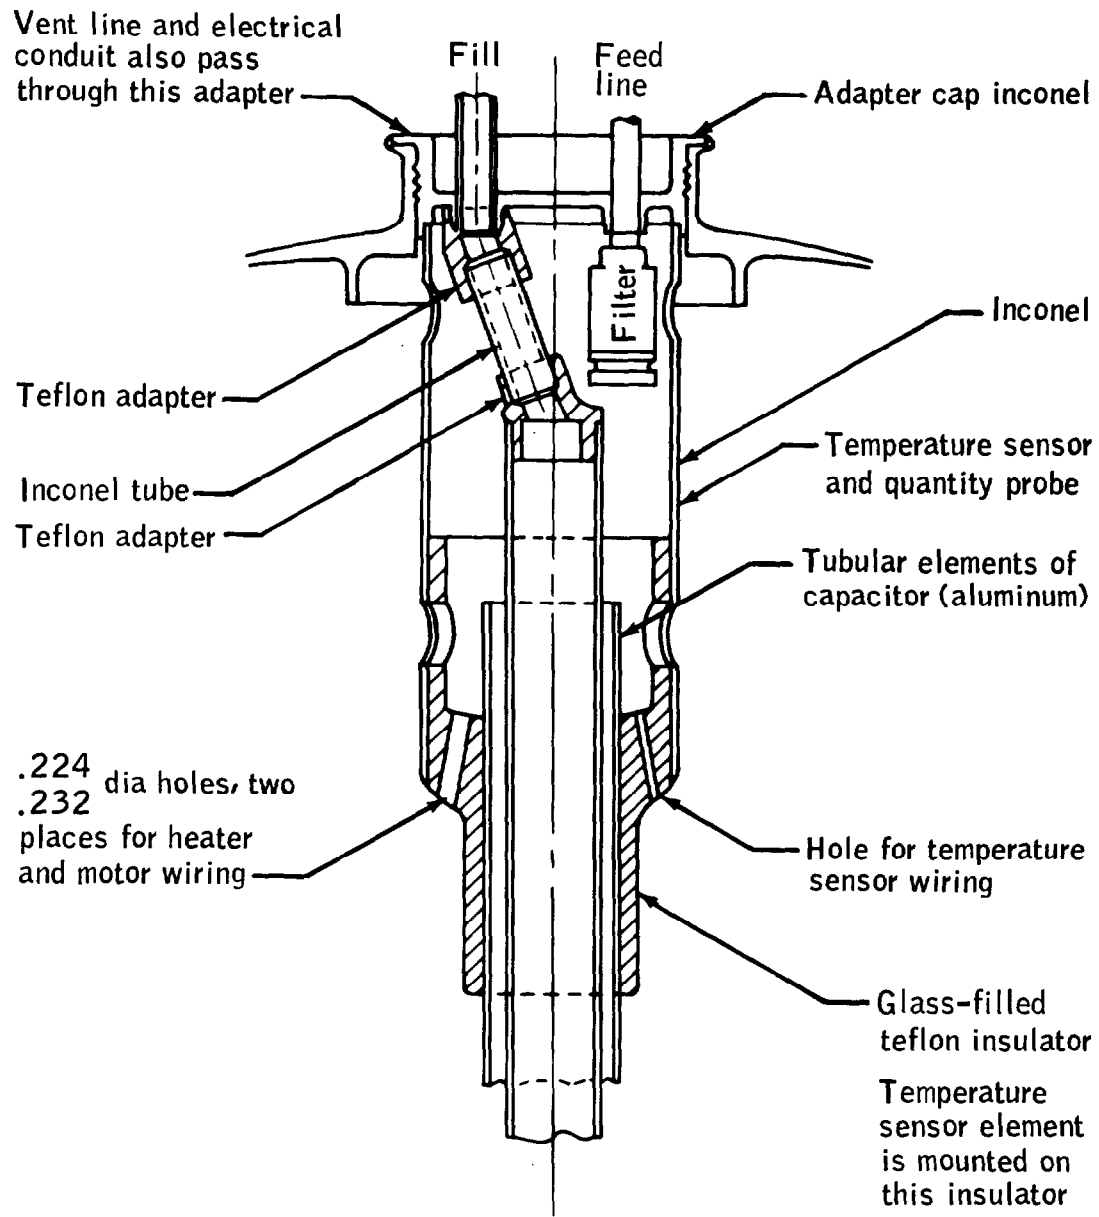
Figure D3-18.- Arrangement of head end of tank.

The head ends of the tank and the temperature sensor and quantity probe are shown in figure D3-18. One of the more significant features of the design is the arrangement of the connections in the fill line which routes the cryogenic fluid to the bottom of the tank, via the inner element of the quantity gage capacitor, and which permit the fluid to flow from the bottom of the tank during ground detanking. The manufacturing drawings of the elements of this connection, two Teflon adapters and an Inconel tube, allow a tolerance stack which is excessive. One combined worst case results in a connection which cannot reach from the fill tube connection in the tank head to the center element of the quantity gage capacitor. The other results in a connection length which prevents assembly of the probe to the adapter in the head of the tank. These are shown in figure D3-19. The tolerances on concentricity between the inner element of the capacitor and the outer shell of the probe are not known and are omitted from this figure. Inclusion would show an even worse situation than shown.

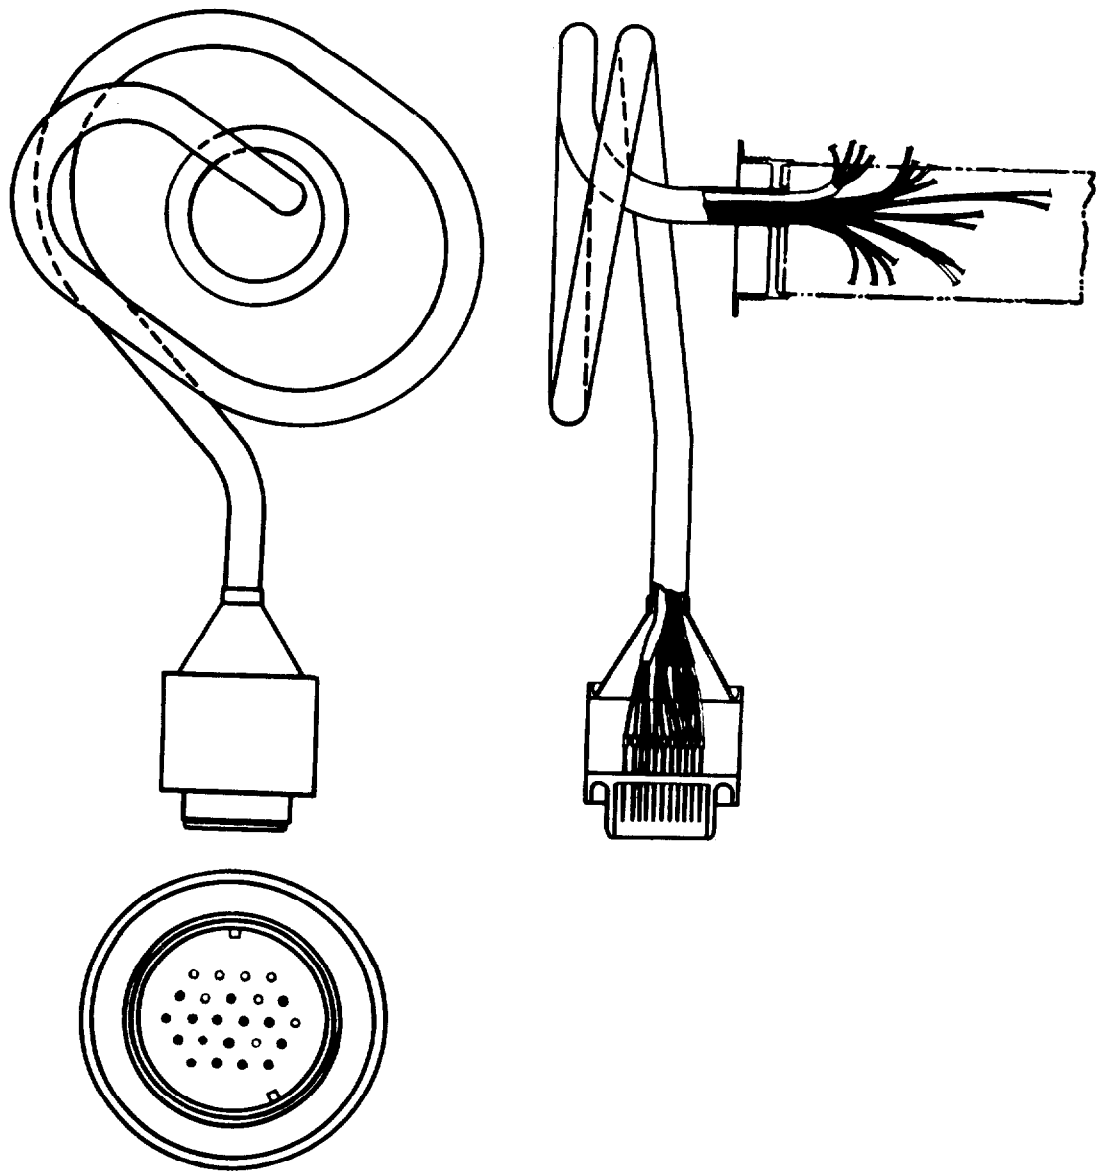
Figure D3-23.- Arrangement of electrical conduit.

A total of 18 wires pass through the electrical conduit, eight AWG no. 26's, four AWG no. 22's, and six AWG no. 20's. The conduit is shown in figure D3-23. At the start of the investigation some members of the Panel felt that the unorthodox detanking procedure used at KSC could have resulted in unacceptably high temperatures in this electrical conduit due to resistive heating of the heater wires. This possibility is discussed in a later section.

The design of this portion of the tank results in a configuration in which it is not possible to perform visual inspection of wiring after assembly. In consequence, the possibility of damage, in many cases undetectable by normal quality assurance procedures, is significant.

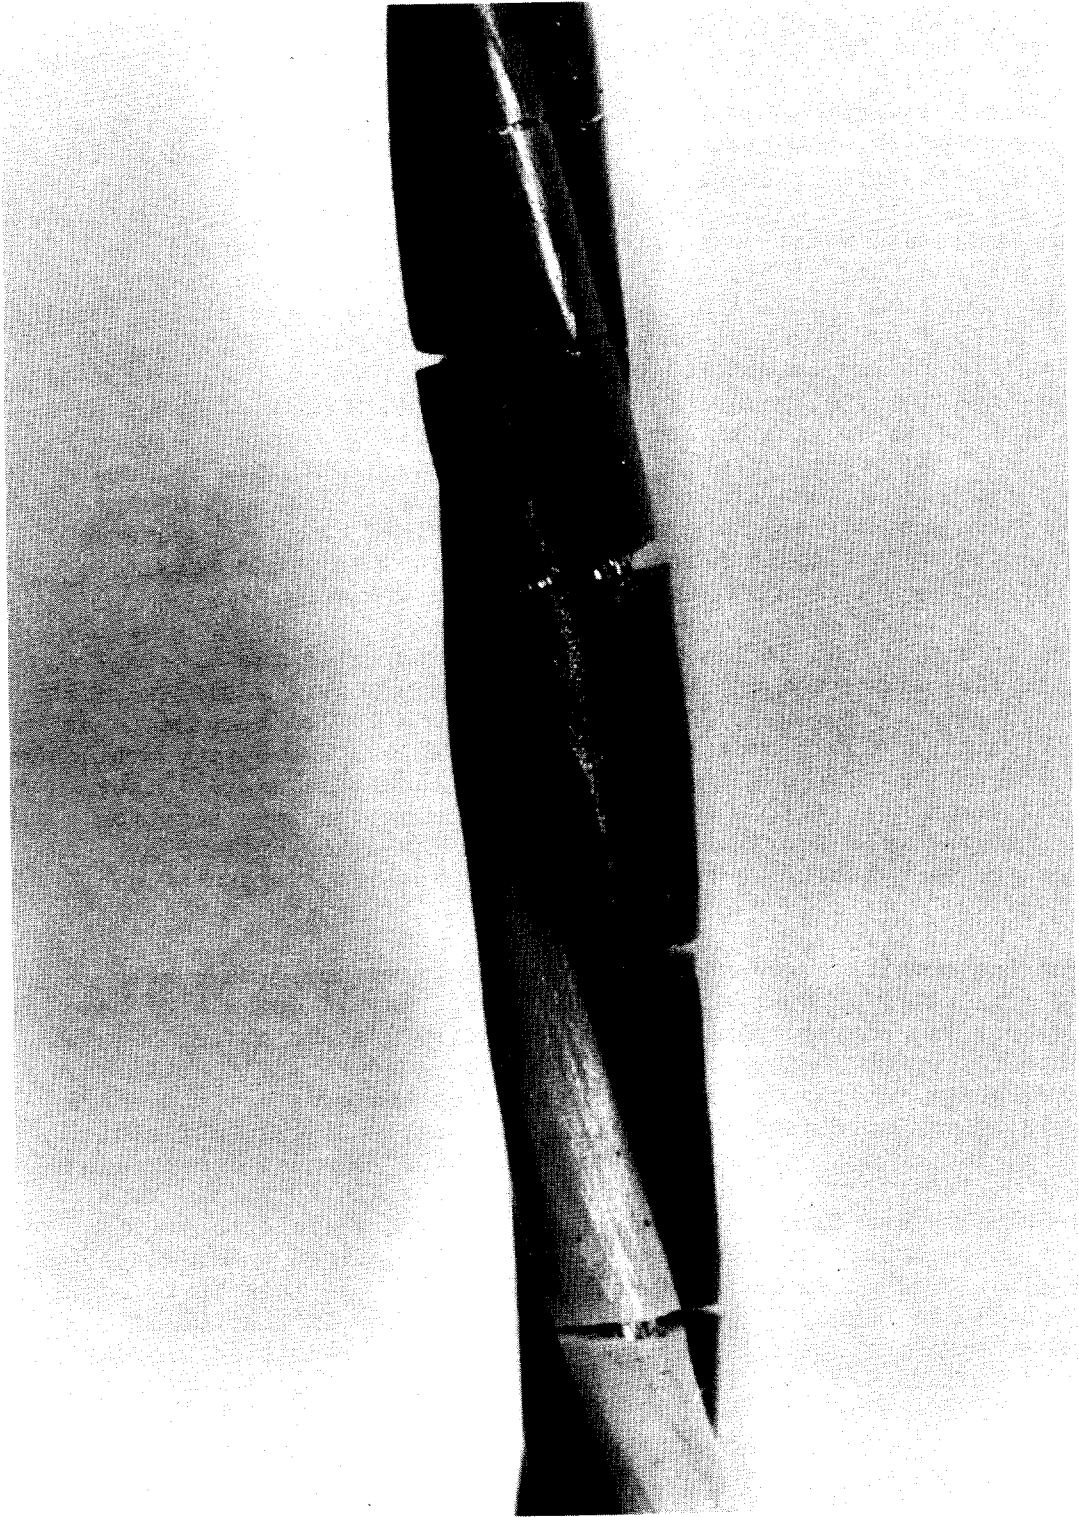
Figure D3-24.- Photograph of wire damage.

As described in the preceding sections, the design of the oxygen tank as a pressure vessel is very adequate. It is constructed of a tough material well chosen for the application. There is no evidence of substandard manufacture of the particular tank involved, nor has any evidence been found of subsequent damage that would result in degradation of the structural integrity of the pressure vessel (as distinguished from the internal components of the tank).
