# **REPORT OF APOLLO 13 REVIEW BOARD**

**APPENDIX F - SPECIAL TESTS AND ANALYSES**

**APPENDIX F**  
**SPECIAL TESTS AND ANALYSES**

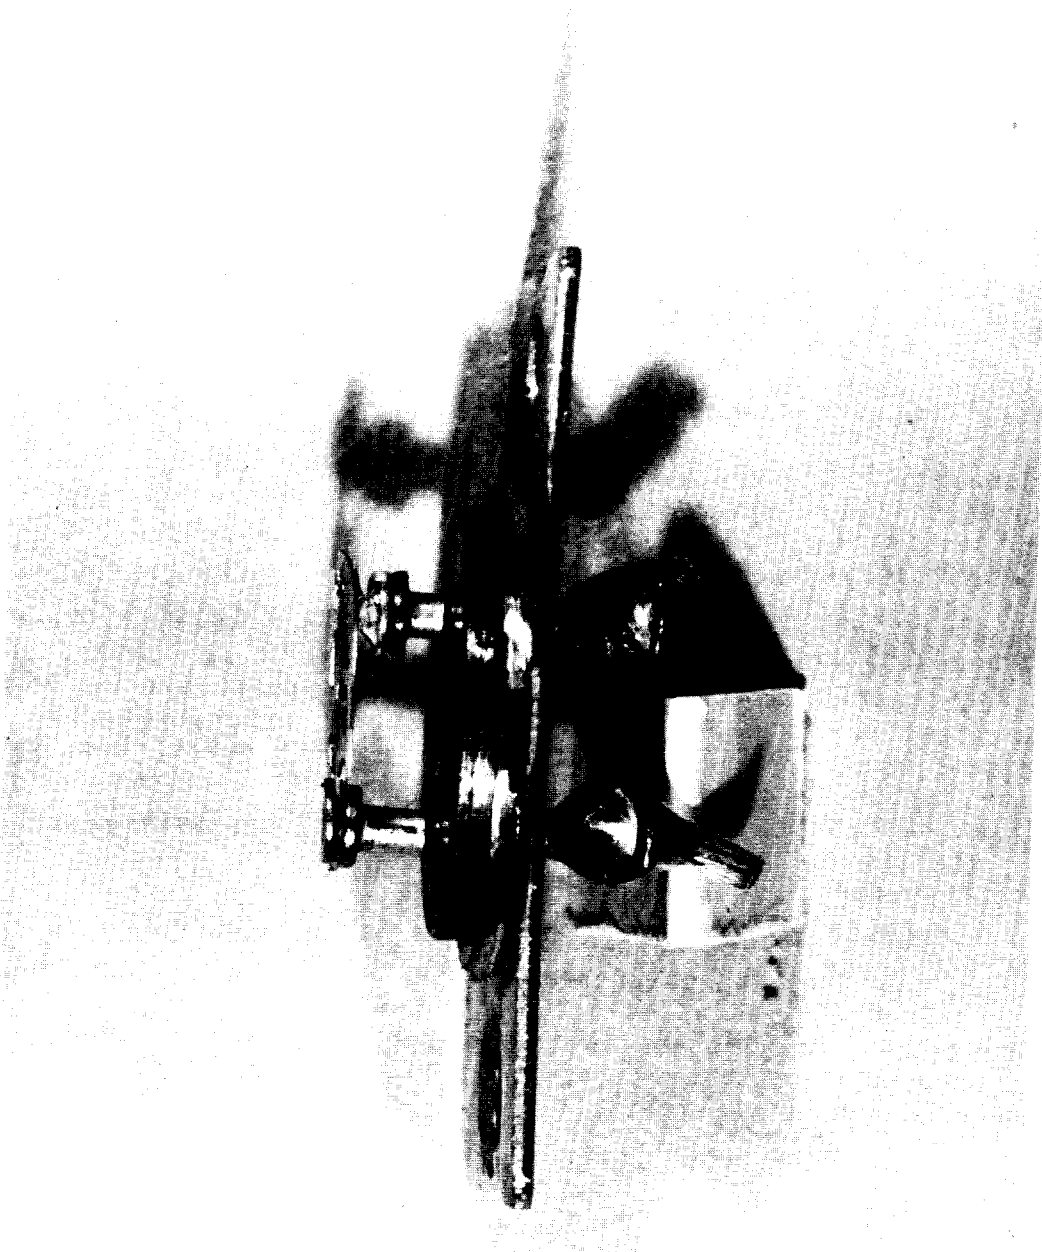
Batteries were used as a power source to test the switches. They were initially supplied with 31 V dc at currents up to 3.5 amperes. No contact degradation was observed under these conditions. When the voltage was raised to 65 V dc, some increase in contact resistance (up to about 3 ohms from a few milliohms) was noted at 1.25 amperes, although the switch continued to operate. The current was then increased to 1.5 amperes at 65 V dc; and when the switch attempted to open, it fused closed. The body of the switch was removed and the condition of the contact can be seen in figure F3.1-1.

Thermostatic switches similar to those in oxygen tank no. 2 will fuse closed when they attempt to open with a 65 V dc potential and currents in excess of 1.5 ampere.

Figure F3.1.1.1.- Fused thermal switch control.

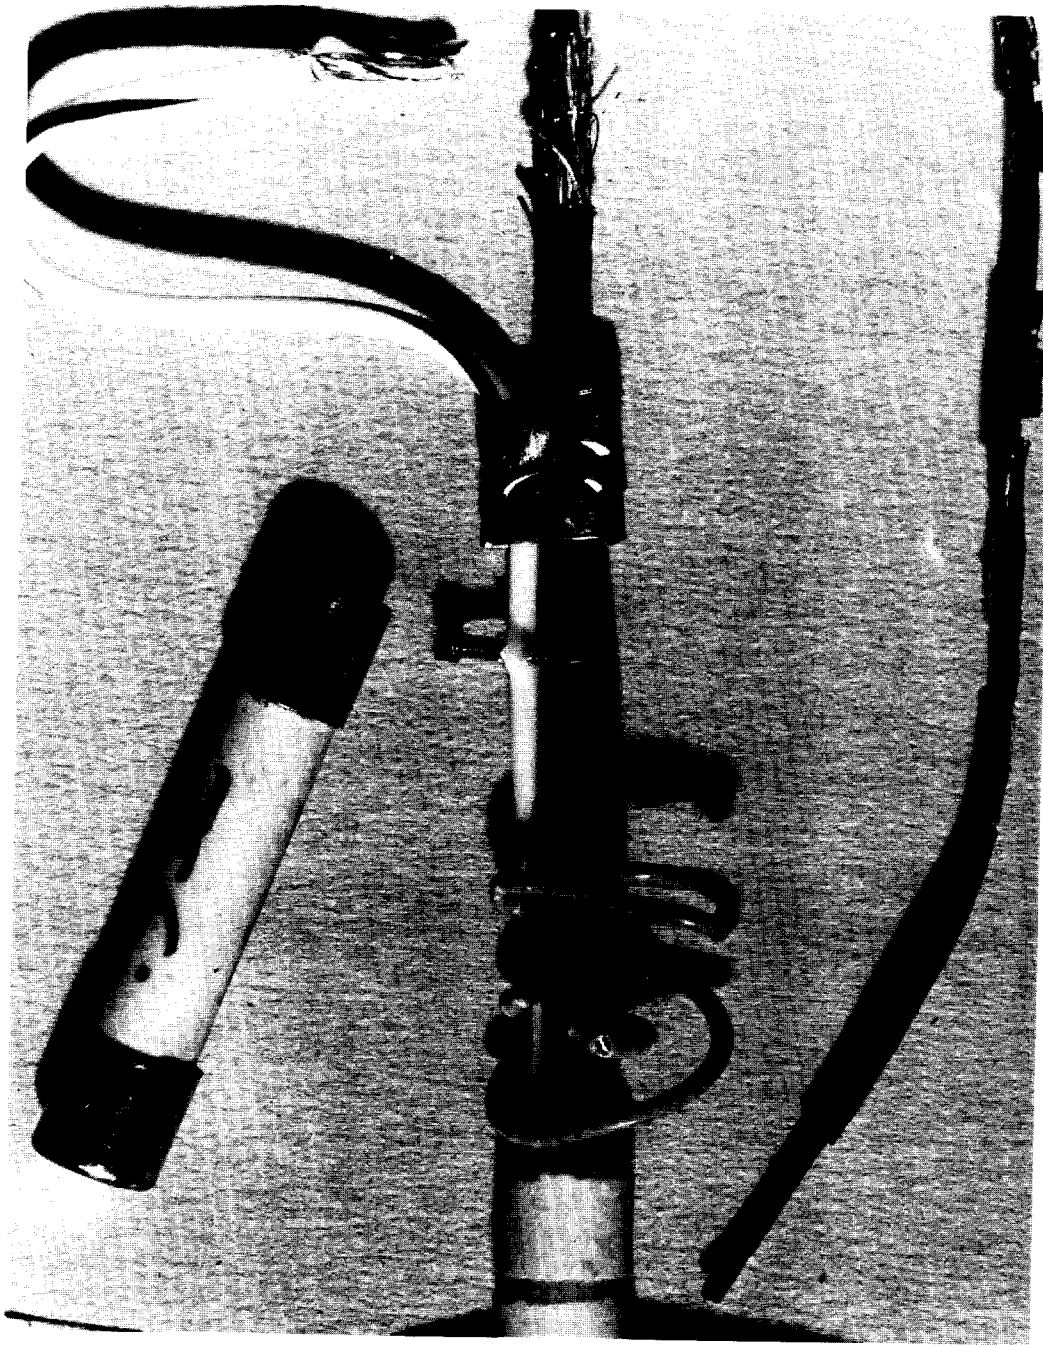
Sample sections of Teflon-insulated conductors obtained from Beech Aircraft Corporation through MSC were baked in oxygen for 5 hours at 572° F, held overnight at room temperature in oxygen, and baked further for 2 hours at 842° F. The Teflon lost its pliability, cracked, and flaked off as shown in figure F3.4-1.

Figure F3.4-1.- Heat degraded wire and test harness replica.

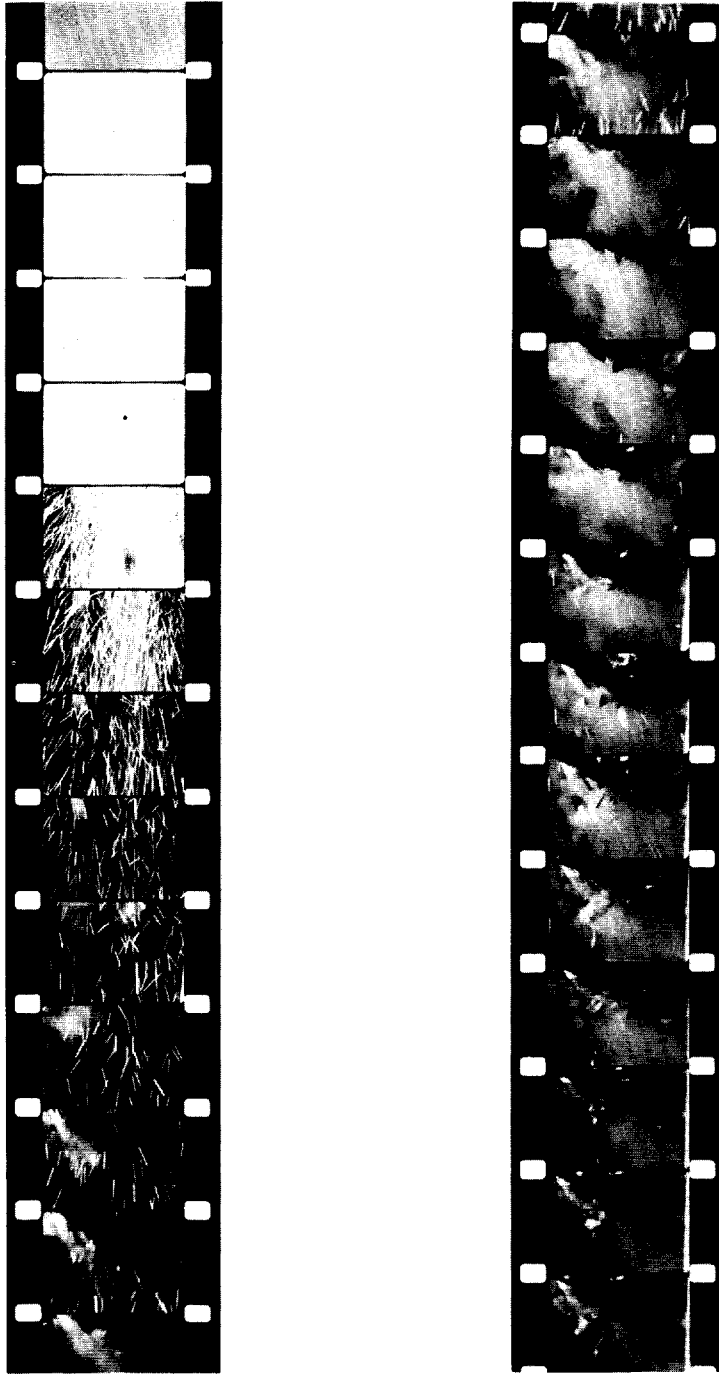
Figure F3.5-12 shows the conduit and chamber interface burnthrough scenes taken from the external movie coverage. The time for this sequence (24 frames) is 1 second. The small amount of external burning resulted

Figure F3.5-12.- External views of chamber-conduit interface at time of failure.

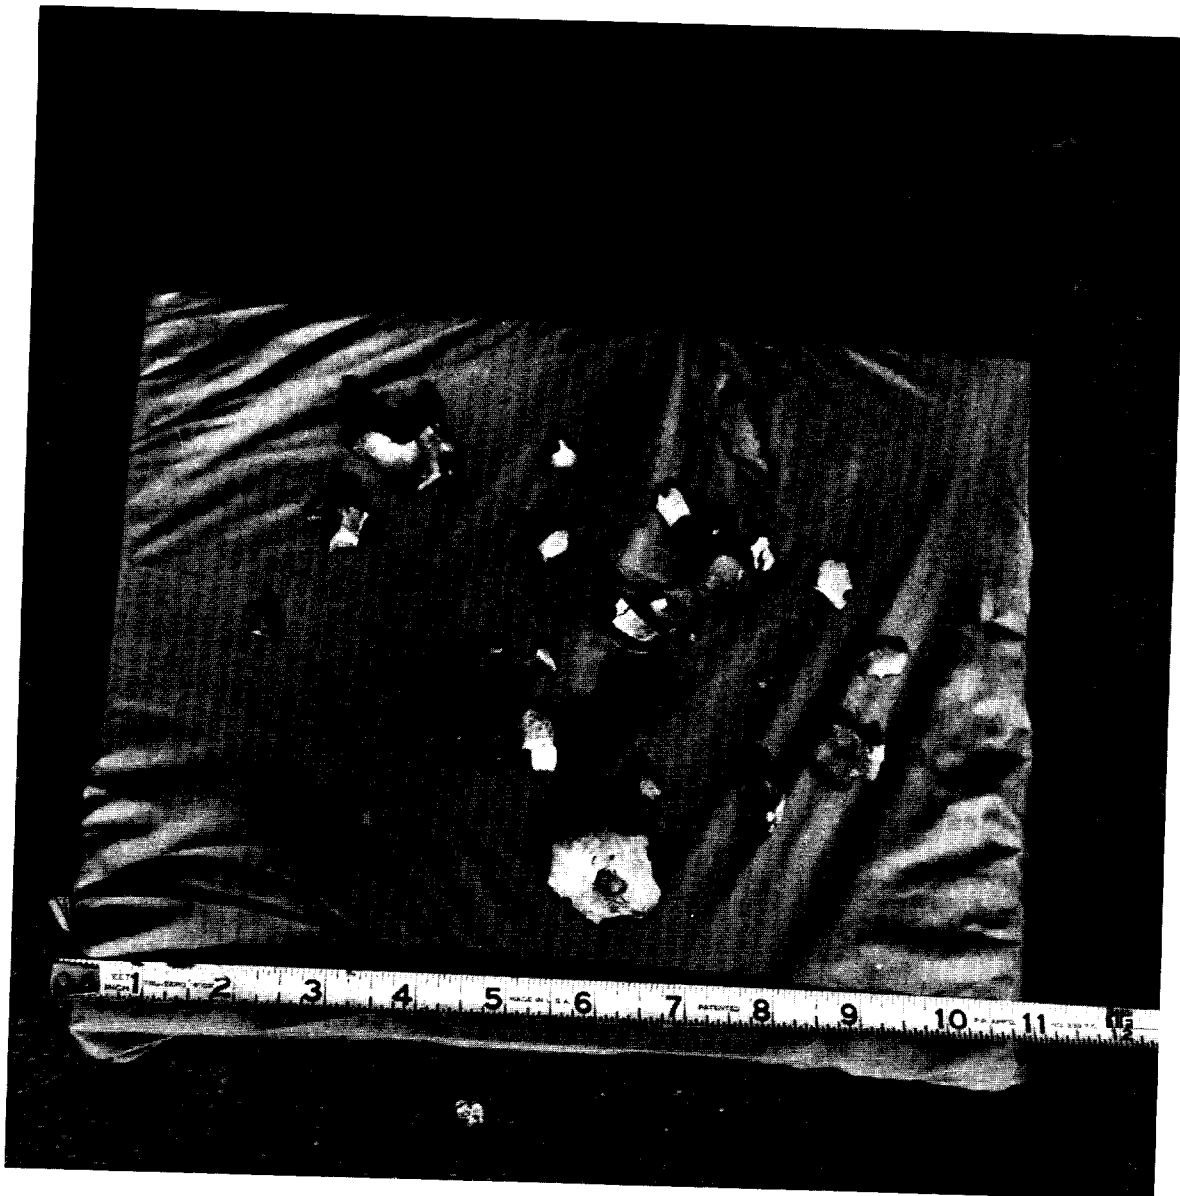
After the test, the section of conduit was found approximately 8 feet from the chamber. Several pieces of the Teflon insulator, two pieces of the conduit swedgelock nut, and one piece of conduit tubing were gathered from a 20-foot radius around the test area (fig. F3.5-13). The only item remaining in the test chamber was a portion of the Inconel section of the capacitance probe (fig. F3.5-14). The stainless steel portion was completely gone and a portion of the Inconel was burned. No remains of the aluminum portion of the probe could be found. The conduit-chamber interface was torched out to a maximum diameter of 1-7/8 inches (see figs. F3.5-15 and F3.5-16).

Figure F3.5-13.- Parts of probe insulator and tubing collected from area around test chamber.

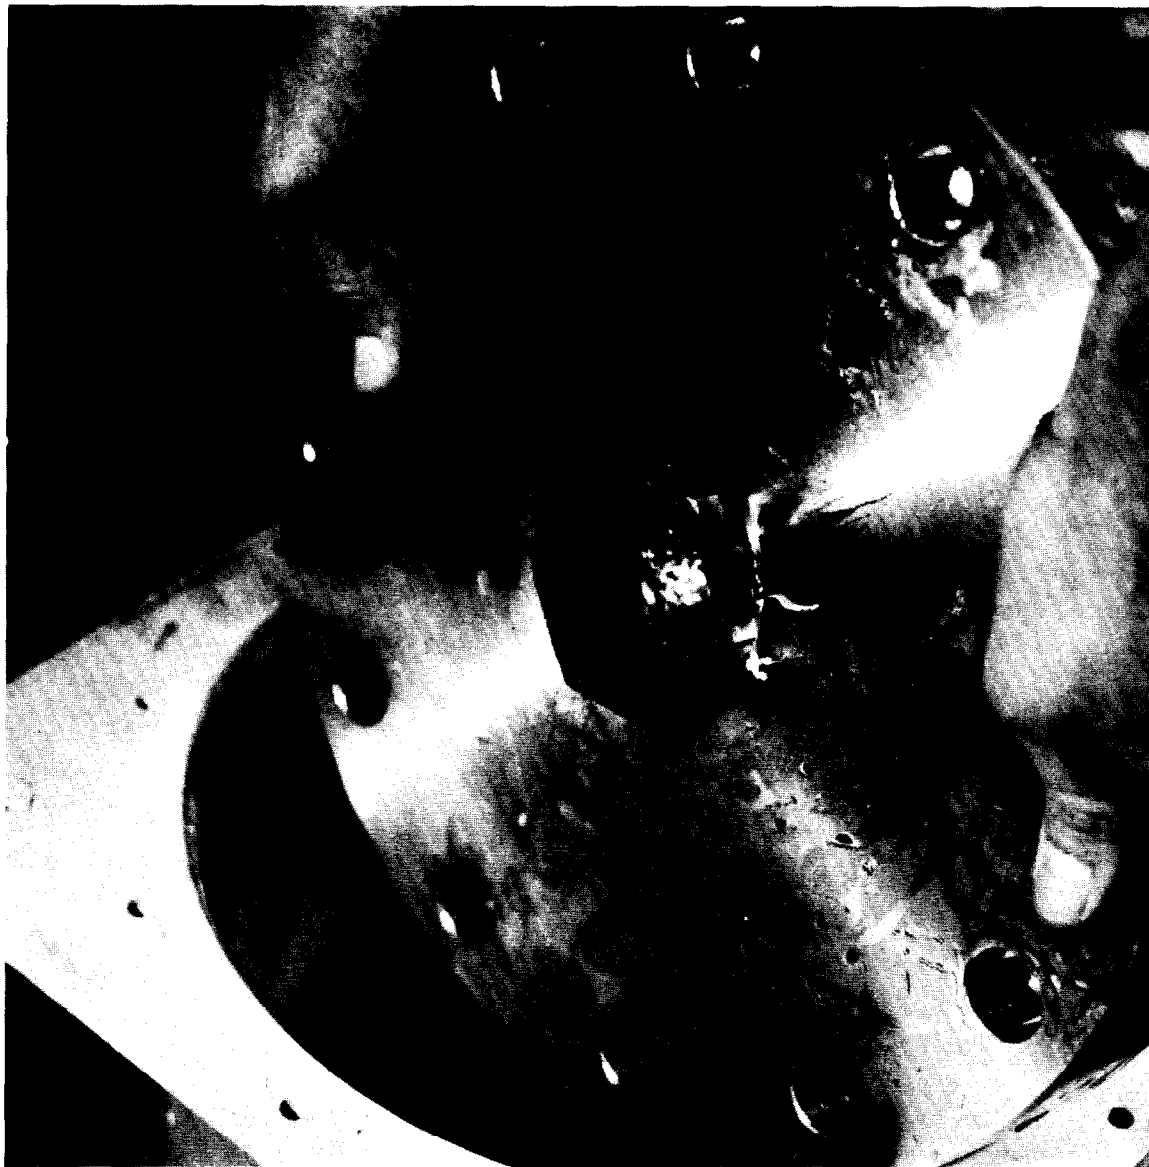
Figure F3.5-15.- External view of chamber flange on which conduit-quantity probe interface was mounted (after test).

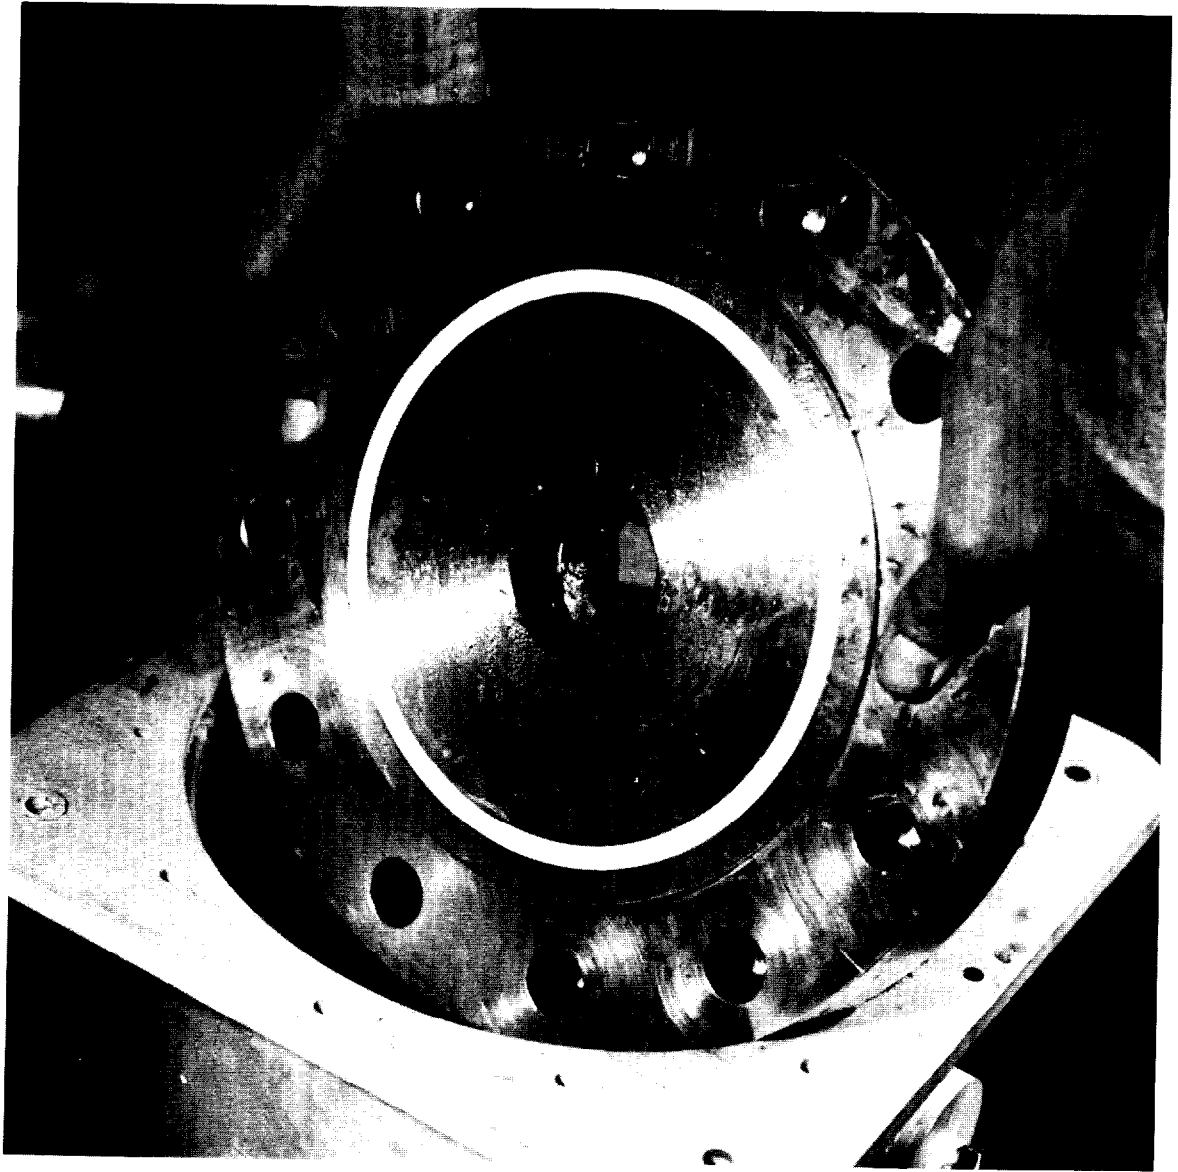
Figure F3.5-16.- View of chamber flange internal surface after test.

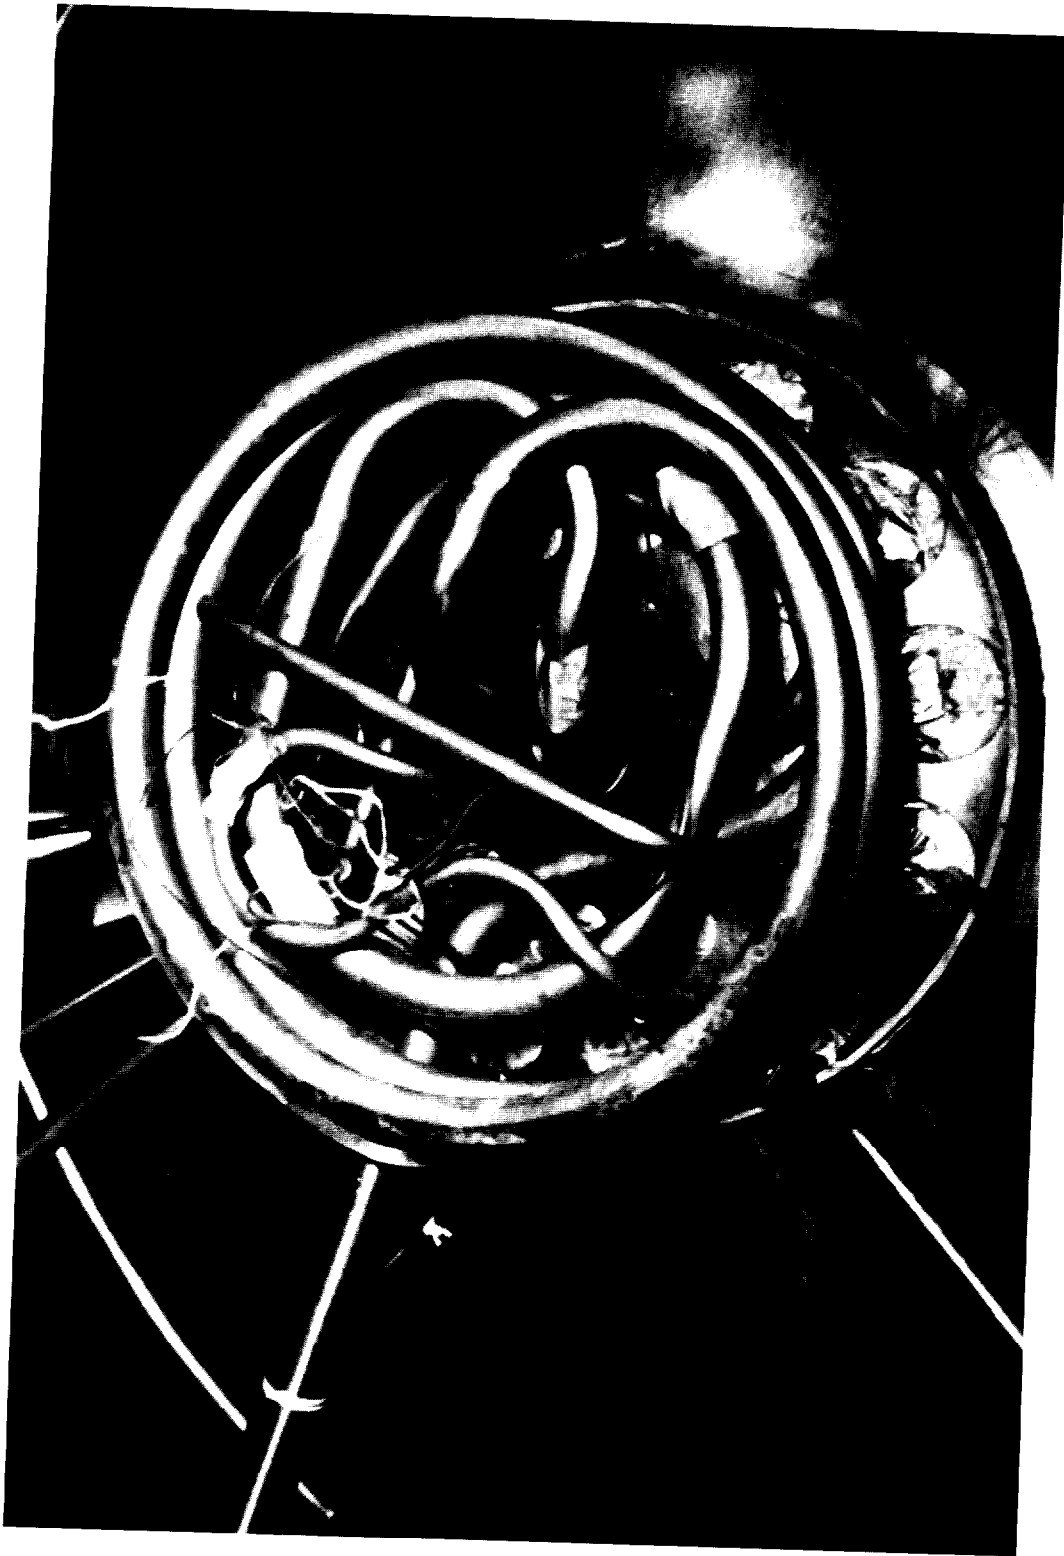
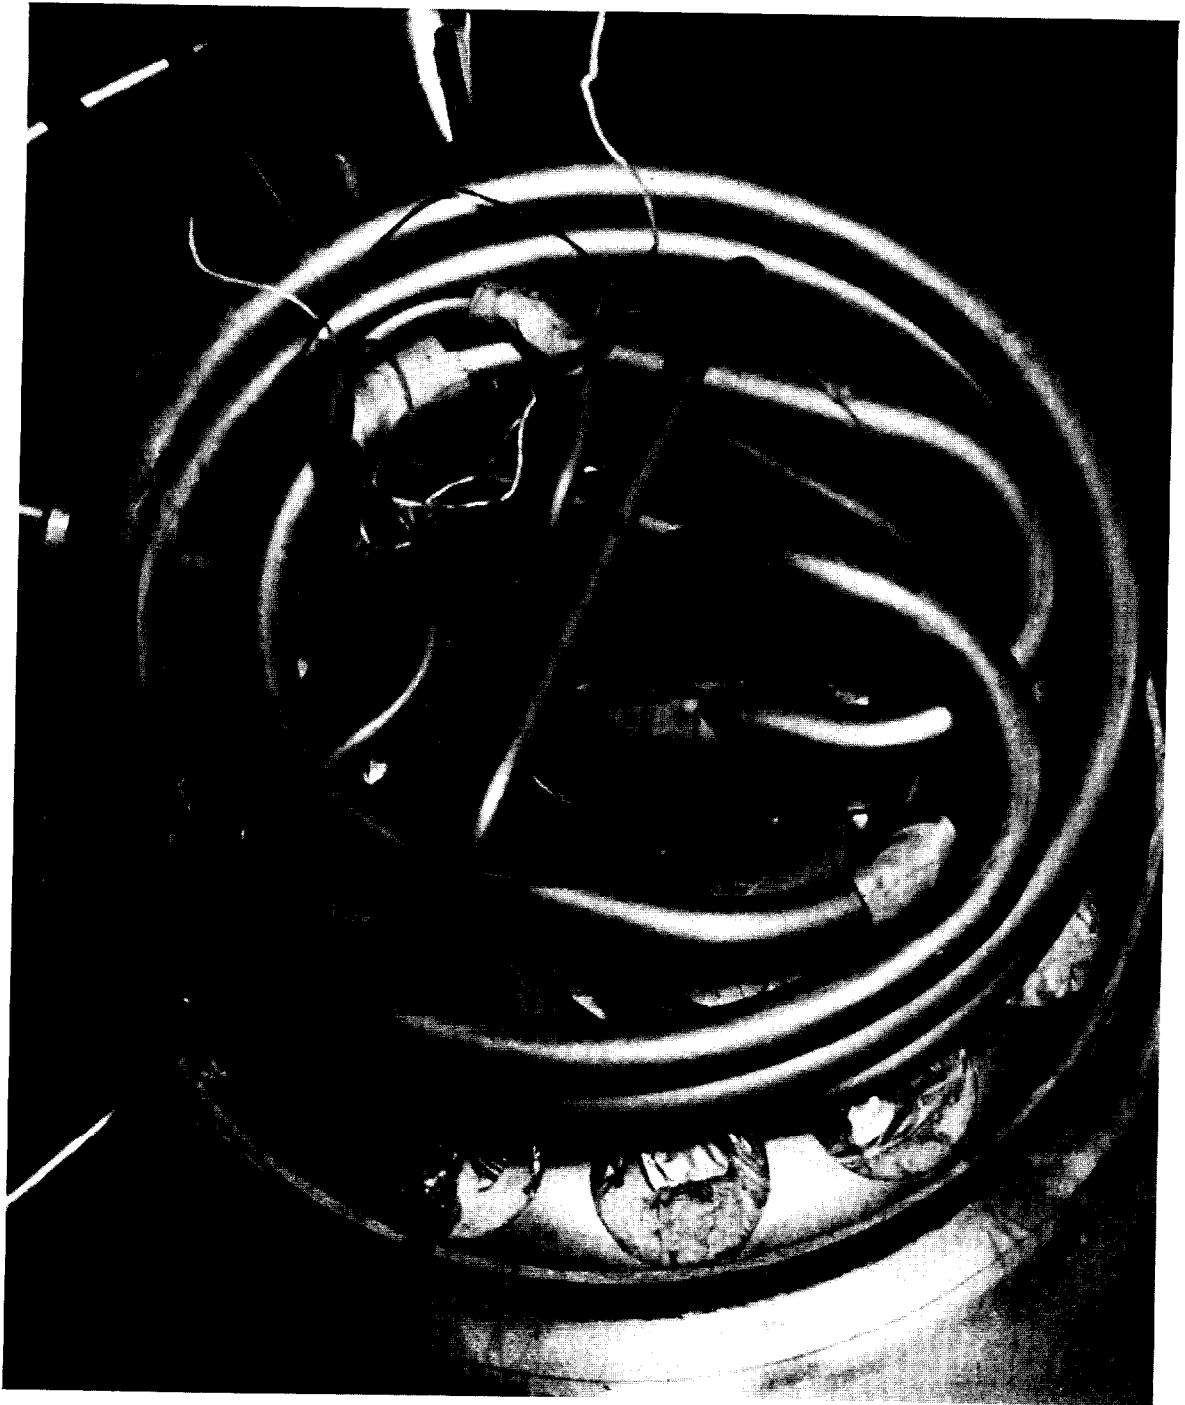
(a) Wide-angle view.  
Figure F3.7-3.- View of failed conduit.

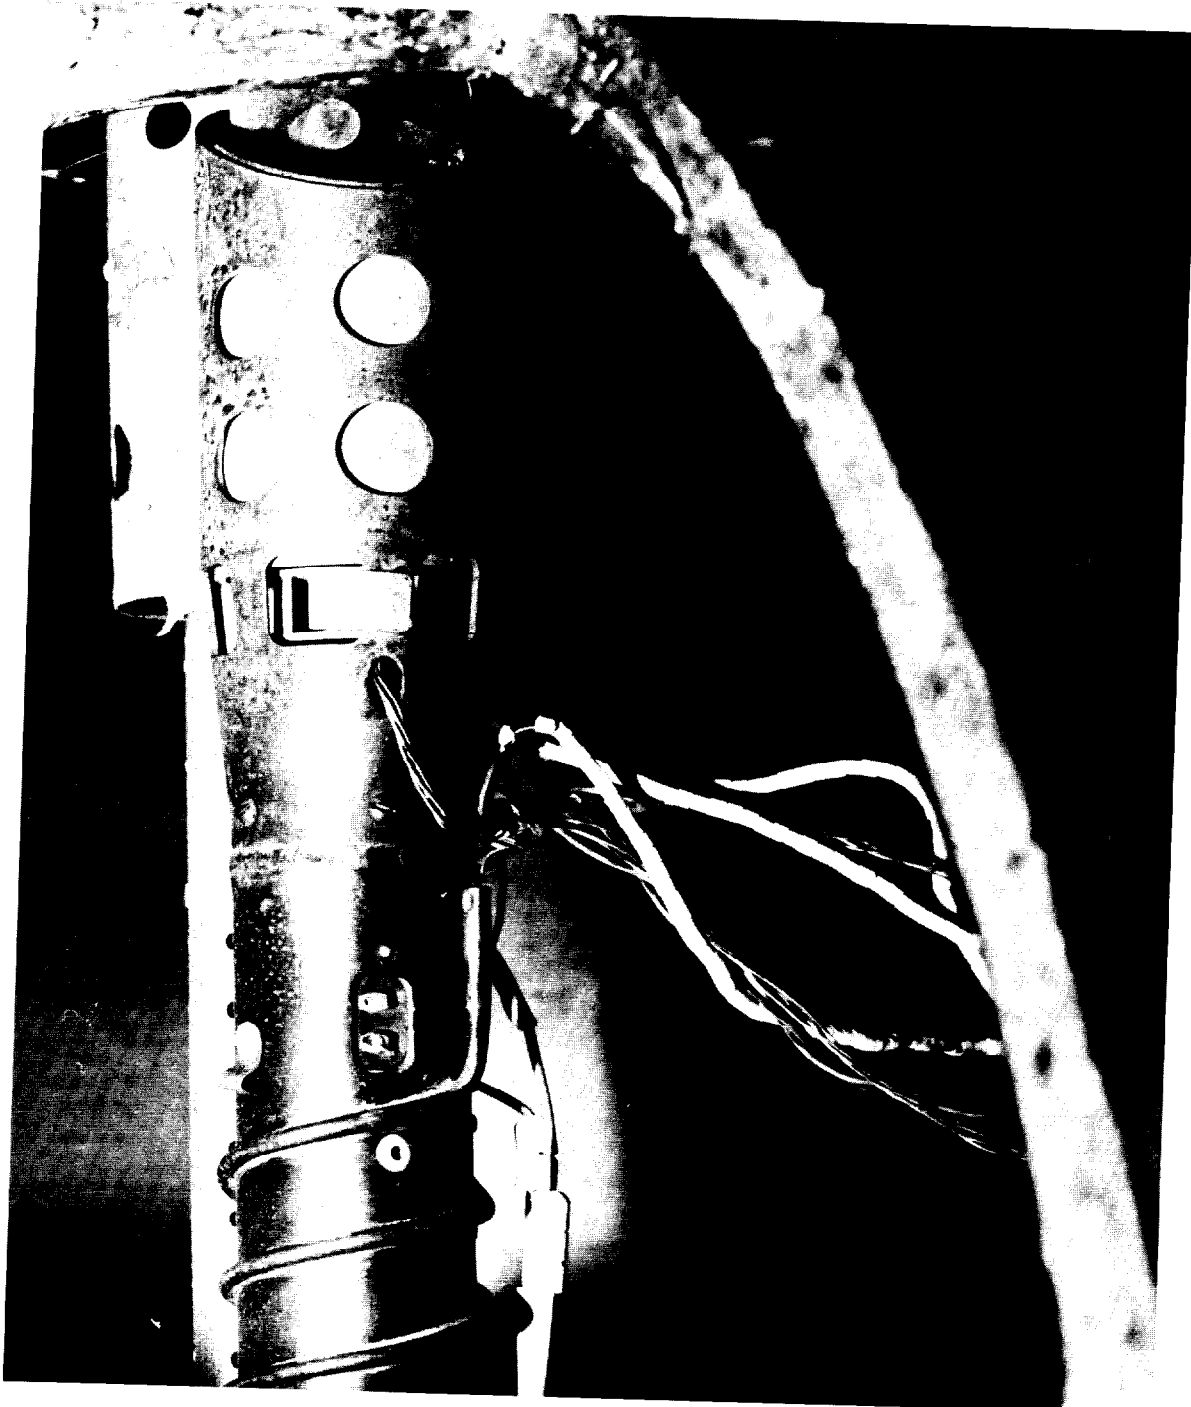
Figure F3.7-4.- Posttest internal view of tank components.

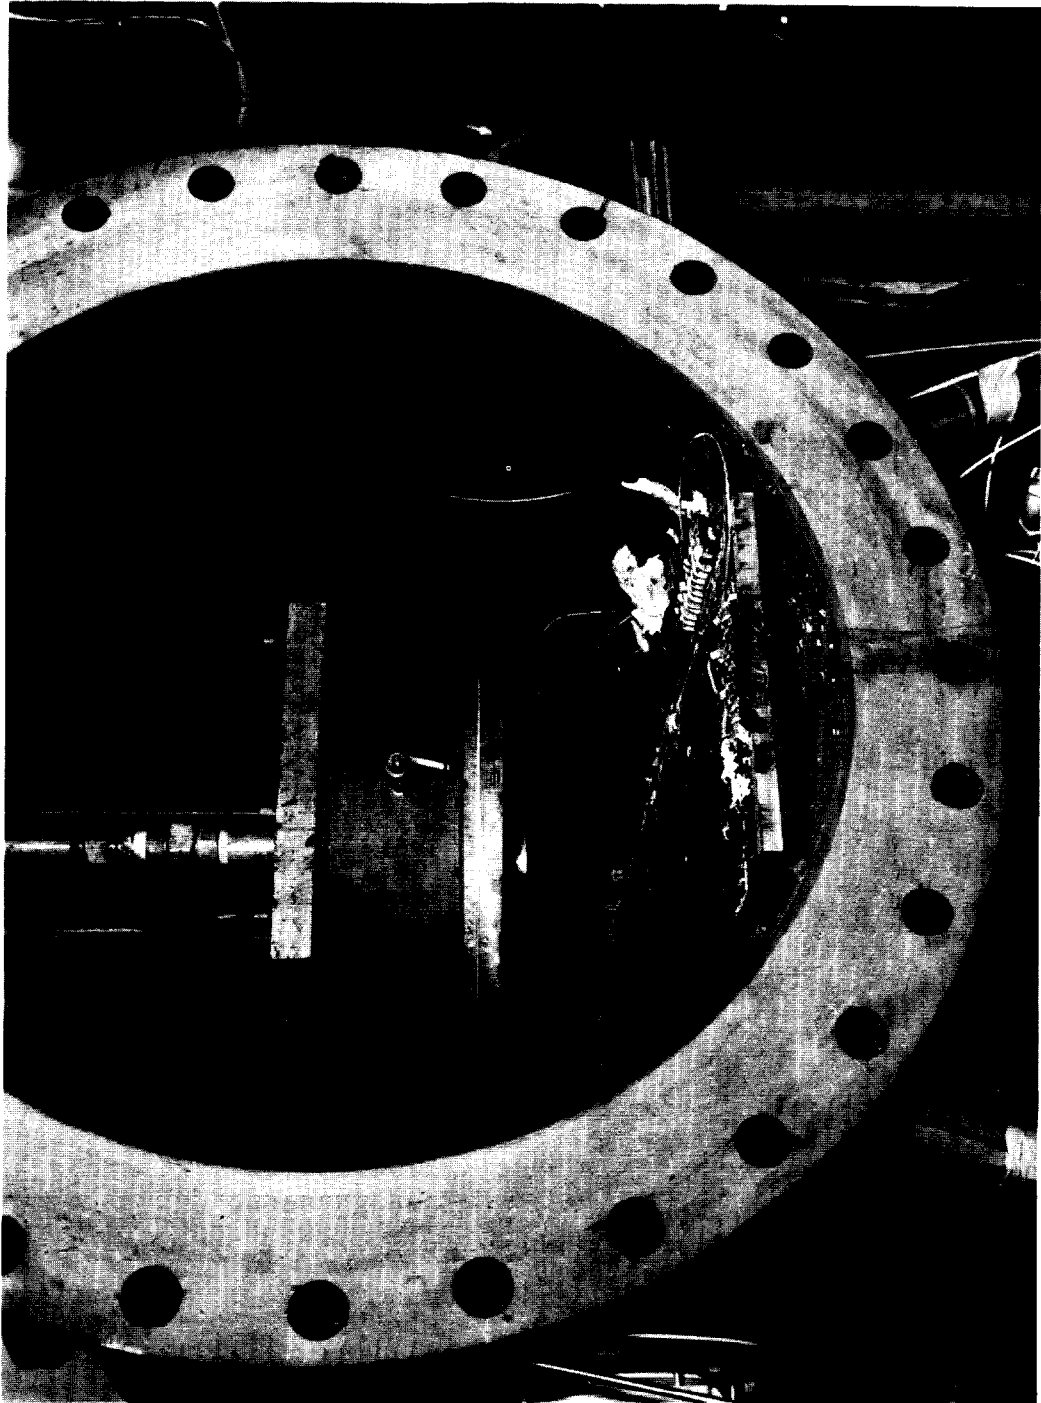
The Mylar insulation blanket burns completely when ignited locally and exposed simultaneously to oxygen from a 1000 psi/-190° F source. The pressure rise rate increases from 6 psi/sec without combustion to about 42 psi/sec with the combustion of Mylar. A substantial increase in the pressure rise rate in the oxygen tank shelf space due to Mylar combustion might therefore be expected. From tests conducted elsewhere, it is further concluded that an ignition source is required to achieve Mylar/oxygen combustion.

Figure F3.9-5.- View of chamber conditions after test.

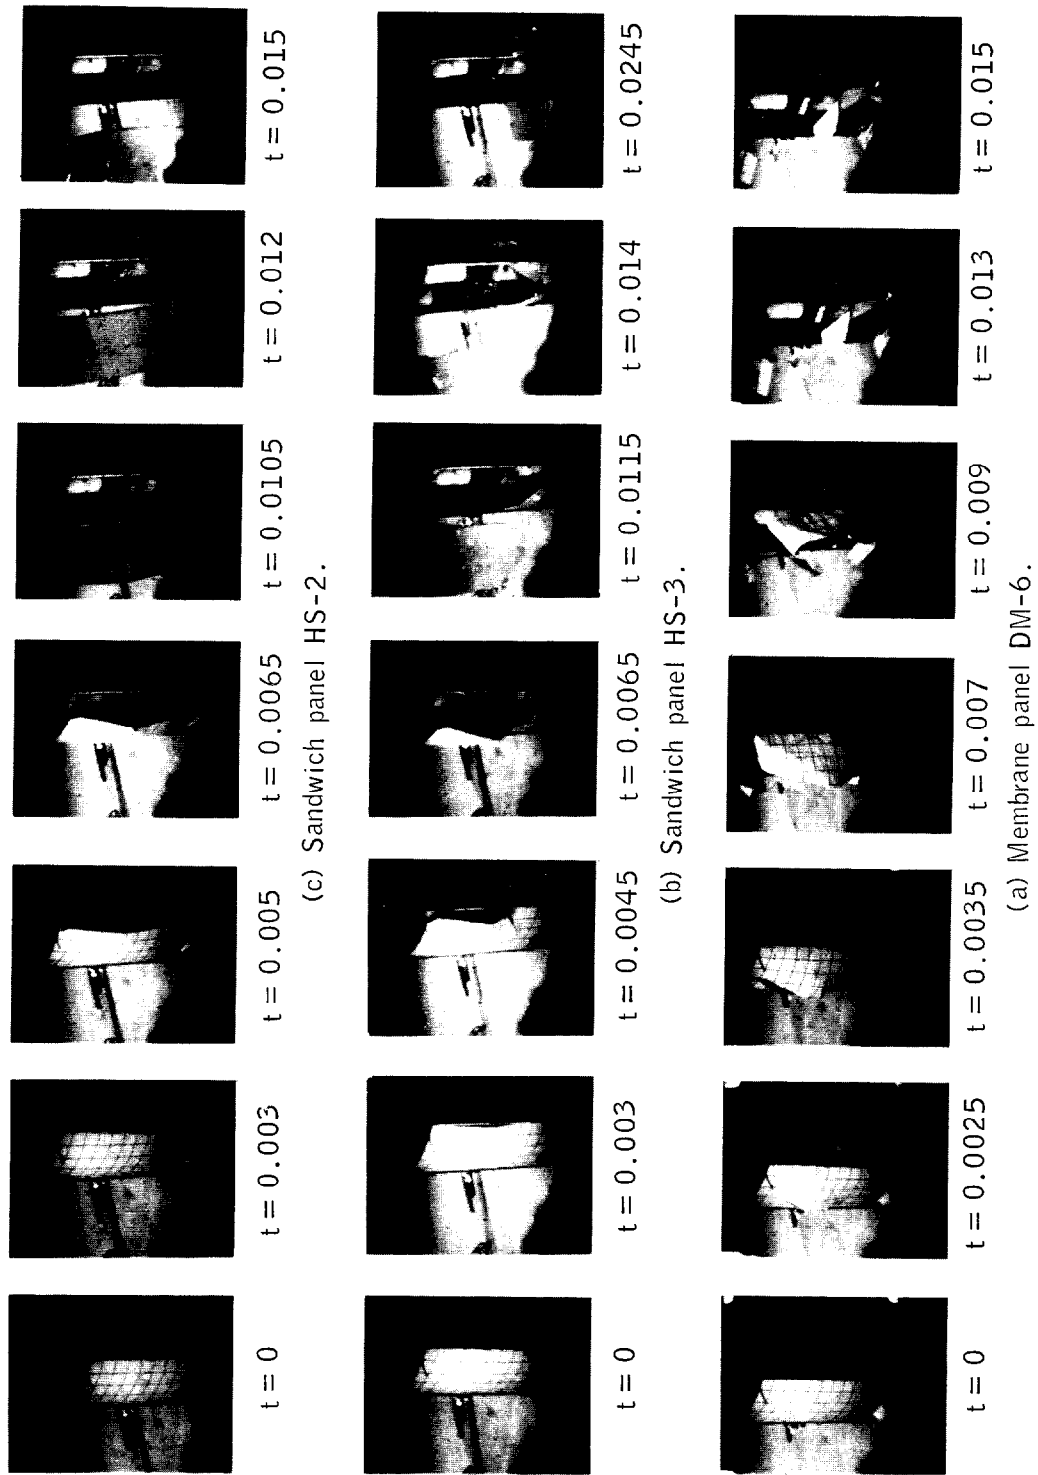
Demonstration of panel separation.- Panel separation has been demonstrated with both membrane and sandwich panels. Two sandwich panels separated completely from the test fixture during vacuum tests. Two membrane panels, although less representative of flight conditions, also separated completely in vacuum tests. However, similar tests with membrane panels in atmosphere left portions of panels attached to the test fixture as illustrated in figures F3.10-4(b) and (c). Complete separation in atmosphere could not be achieved due to mass and drag of the air.

Figure F3.10-5.- Sequential failure of two sandwich and one membrane panel (t = time from first observed failure).
