CHAPTER 4  
REVIEW AND ANALYSIS OF APOLLO 13 ACCIDENT

## PART 1. INTRODUCTION

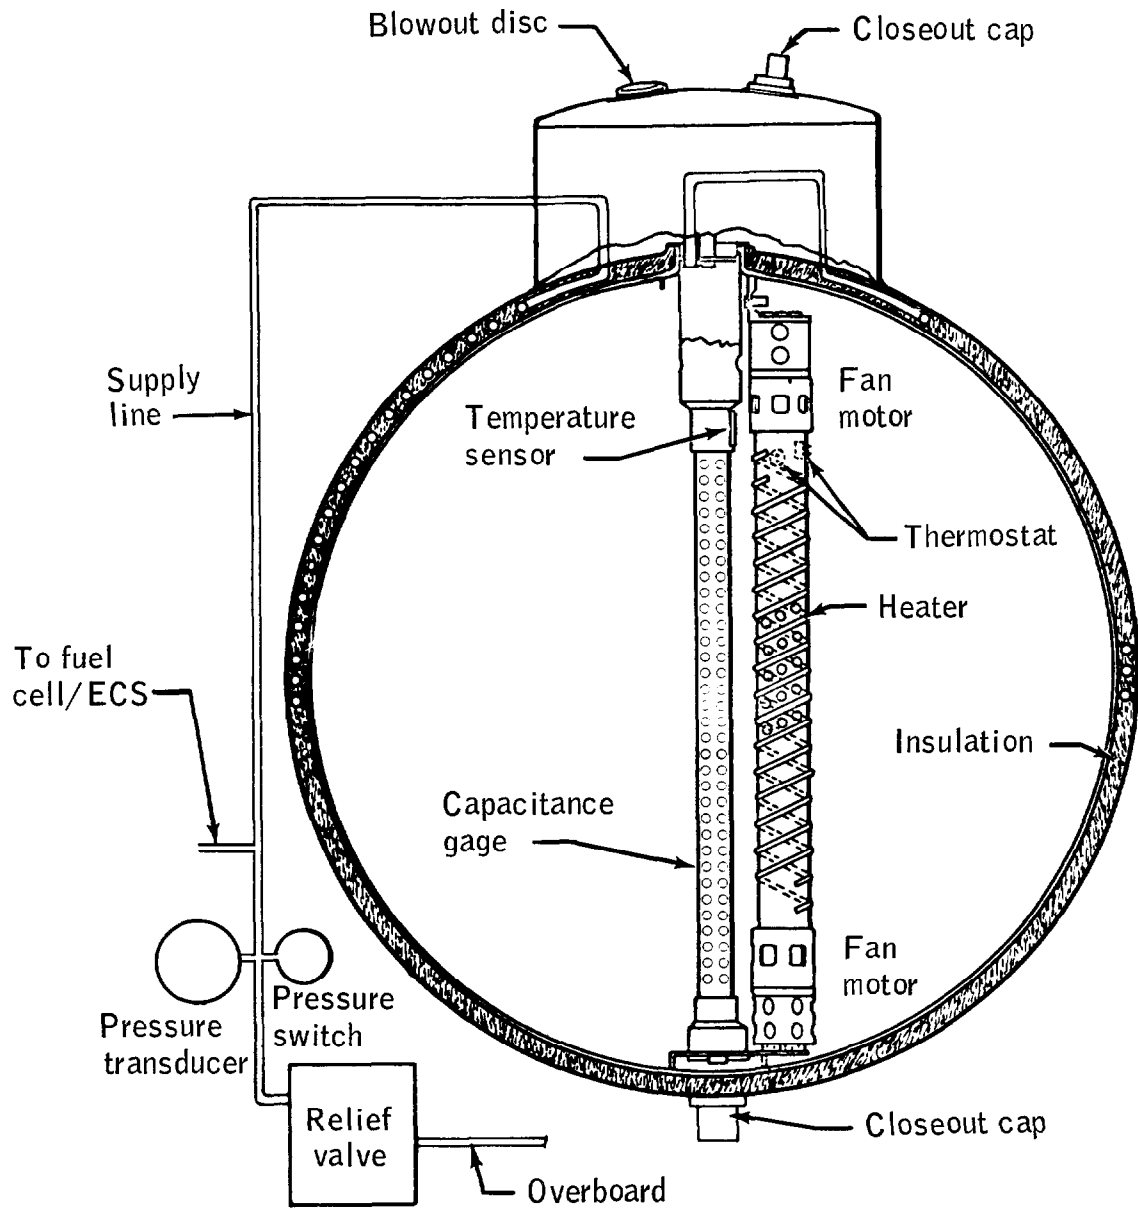
Figure 4-1.- Oxygen tank no. 2 internal components.

As the simplified drawing in figure 4-1 indicates, each oxygen tank has an outer shell and an inner shell, arranged to provide a vacuum space to reduce heat leak, and a dome enclosing paths into the tank for transmission of fluids and electrical power and signals. The space between the shells and the space in the dome are filled with insulating materials. Mounted in the tank are two tubular assemblies. One, called the heater tube, contains two thermostatically protected heater coils and two small fans driven by 1800 rpm motors to stir the tank contents. The other, called the quantity probe, consists of an upper section which supports a cylindrical capacitance gage used to measure electrically the quantity of fluid in the tank. The inner cylinder of this probe serves both as a fill and drain tube and as one plate of the capacitance gage. In addition, a temperature sensor is mounted on the outside of the quantity probe near the head. Wiring for the gage, the temperature sensor, the fan motors, and the heaters passes through the head of the quantity probe to a conduit in the dome. From there the wiring runs to a connector which ties it electrically to the appropriate external circuits in the CSM. The routing of wiring and lines from the tank through the dome is shown in figure 4-2.

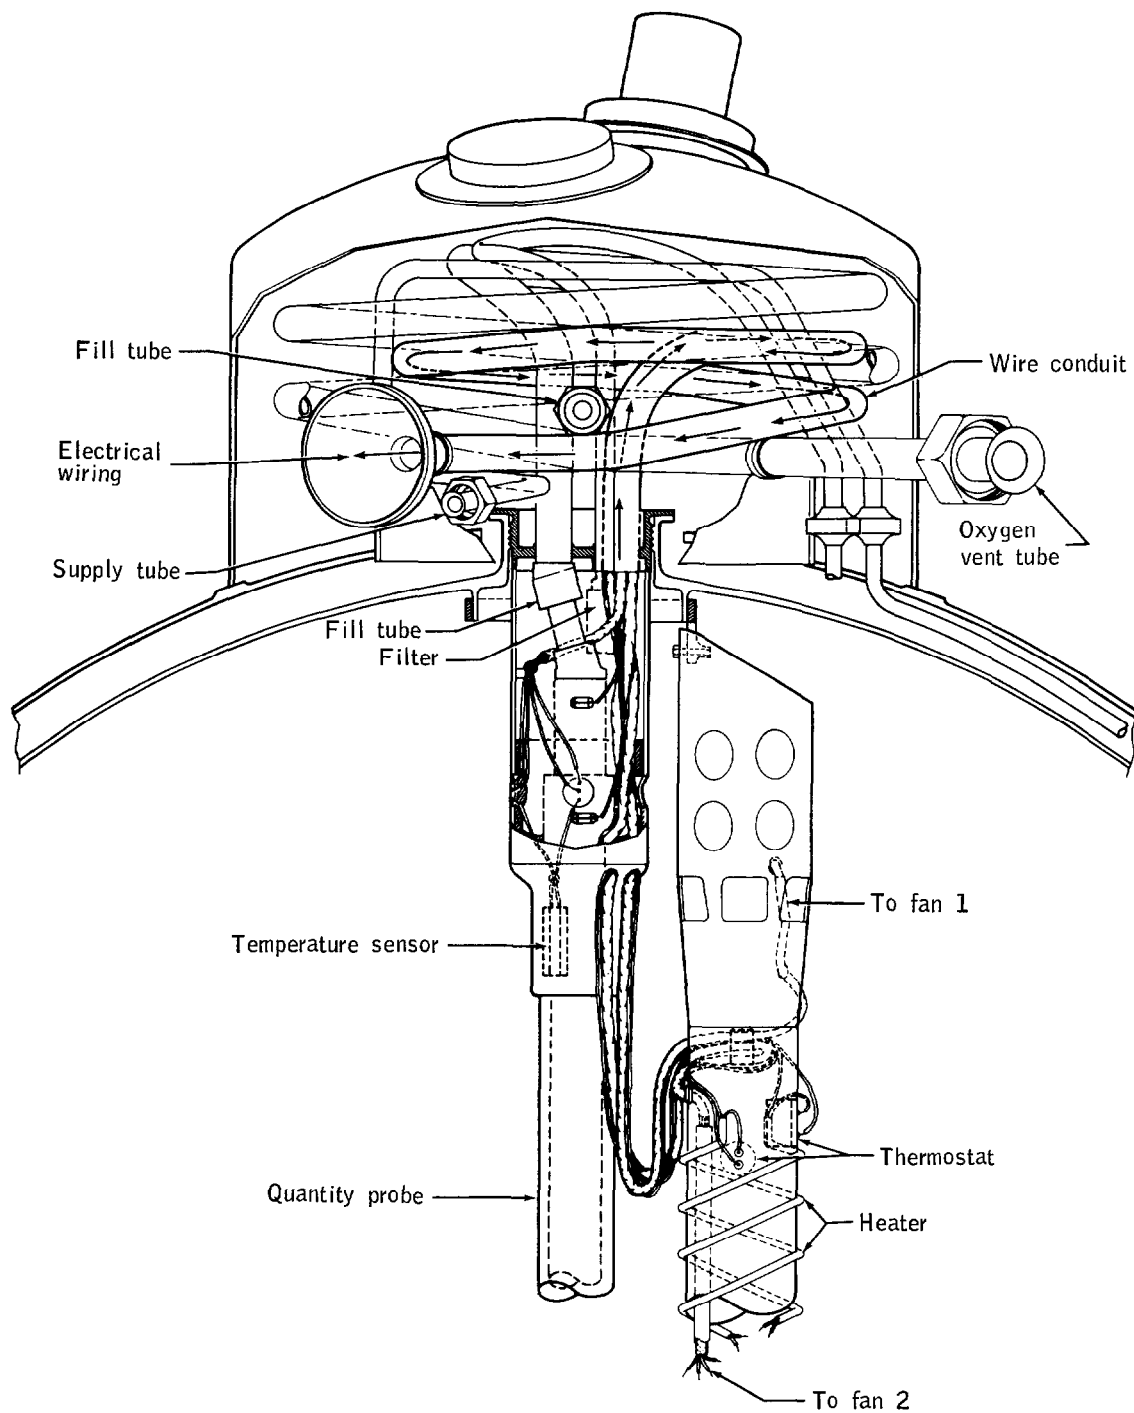
Figure 4-2.- Oxygen tank wiring and lines.

As shown in figure 4-2, the fill line from the exterior of the SM enters the oxygen tank and connects to the inner cylinder of the capacitance gage through a coupling of two Teflon adapters or sleeves and a short length of Inconel tubing. The dimensions and tolerances selected are such that if "worst case" variations in an actual system were to occur, the coupling might not reach from the fill line to the gage cylinder (fig. 4-3). Thus, the variations might be such that a very loose fit would result.

As noted earlier in this chapter, and shown in figure 4-2, each heater is protected with a thermostatic switch, mounted on the heater tube, which is intended to open the heater circuit when it senses a temperature of 80° F. In tests conducted at MSC since the accident, however, it was found that the switches failed to open when the heaters were powered from a 65 V dc supply similar to the power used at KSC during the detanking sequence. Subsequent investigations have shown that the thermostatic switches used, while rated as satisfactory for the 28 V dc spacecraft power supply, could not open properly at 65 V dc. Qualification and test procedures for the heater assemblies and switches do not at any time test the capability of the switches to open while under full current conditions. A review of the voltage recordings made during the detanking at KSC indicates that, in fact, the switches did not open when the temperature indication from within the tank rose past 80° F. Further tests have shown that the temperatures on the heater tube may have reached as much as 1000° F during the detanking. This temperature will cause serious damage to adjacent Teflon insulation, and such damage almost certainly occurred.

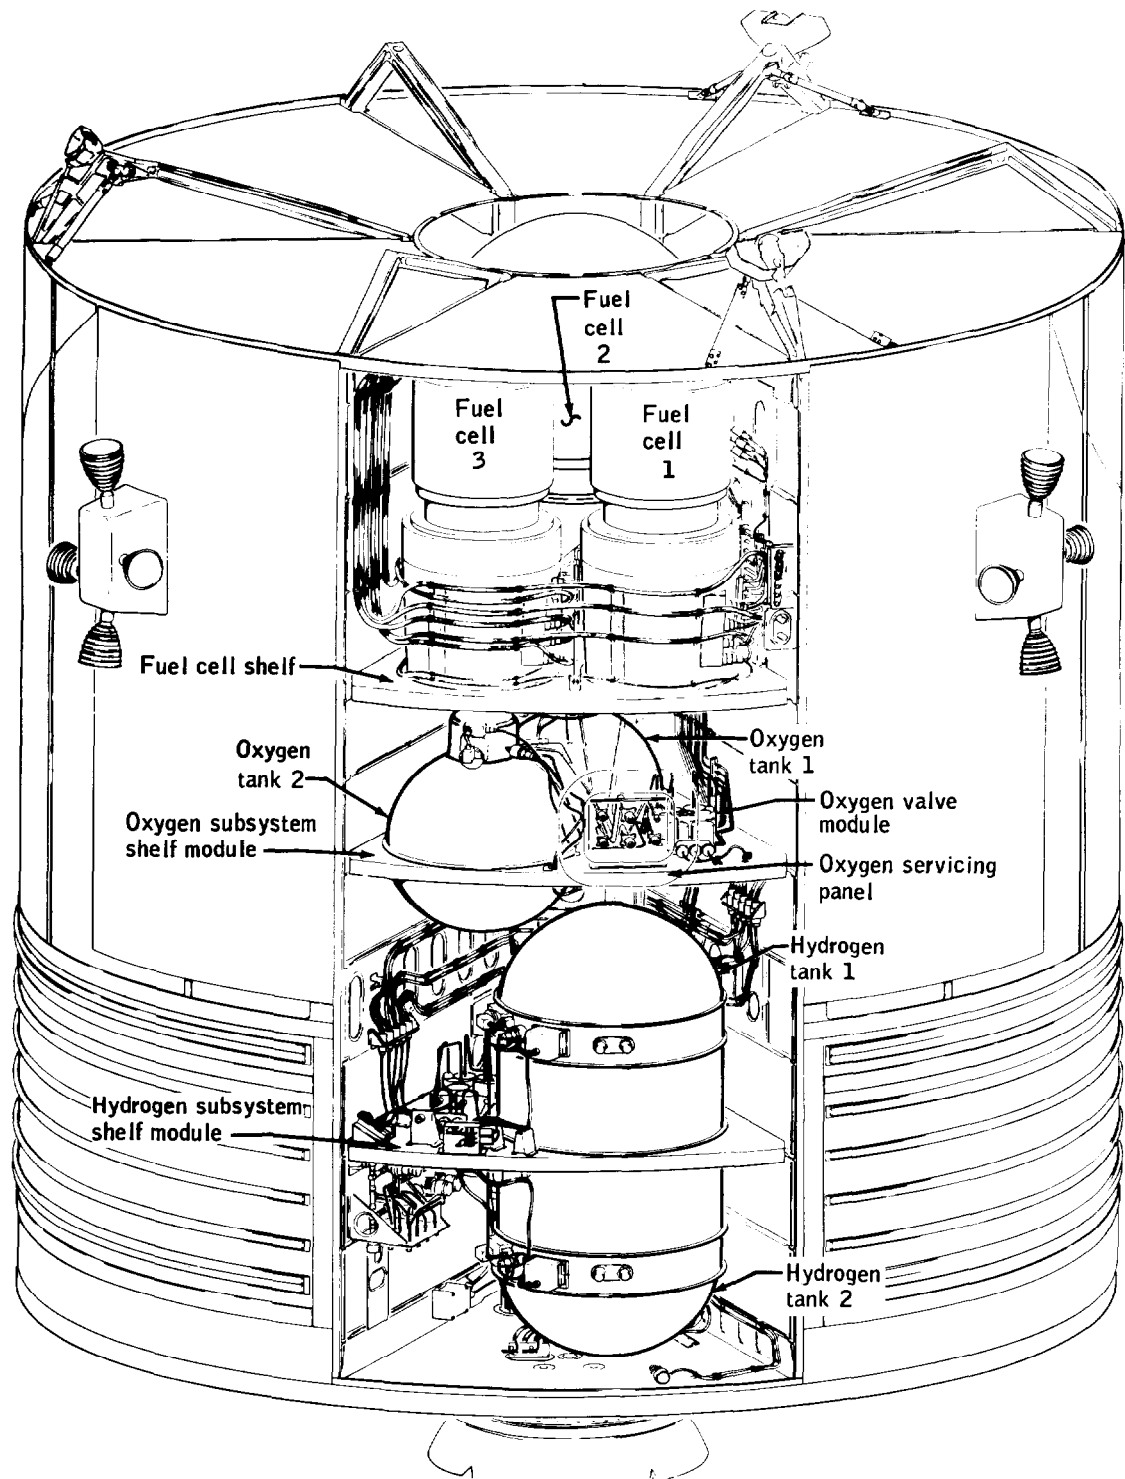
Figure 4-4.- Arrangement of fuel cells and cryogenic systems in bay 4.

Two oxygen tanks are mounted on a shelf in bay 4 of the SM, as shown in figure 4-4. Figures 4-5 through 4-8 are photographs of portions

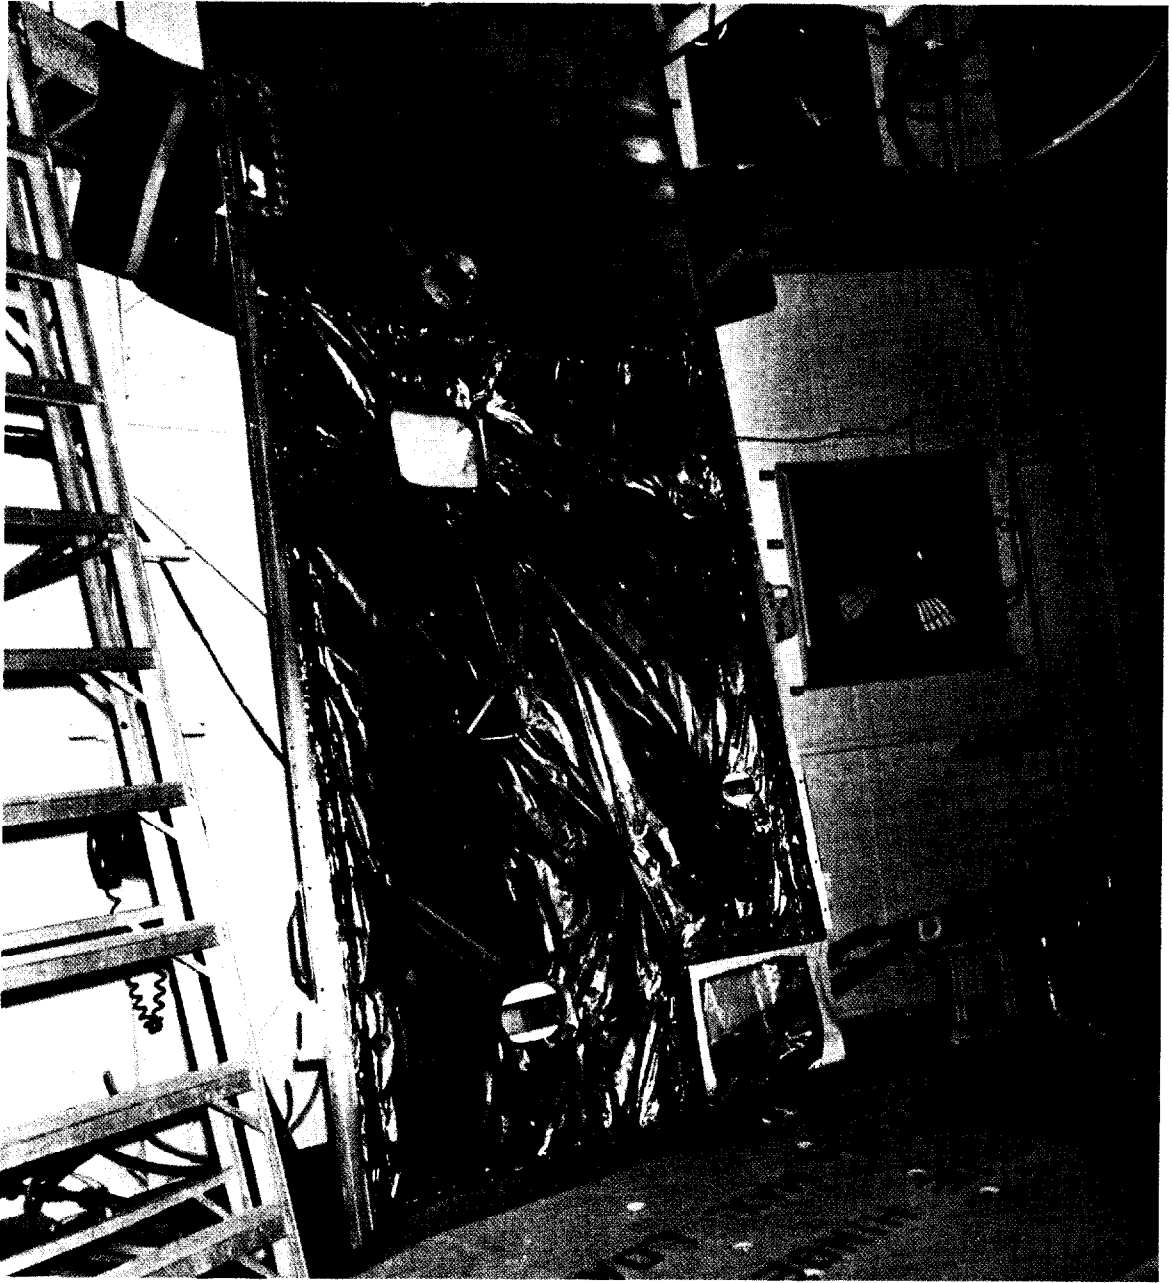
4-8.-  
Figure ~~4-8~~ Inside view of panel covering bay 4.

of the Apollo 13 service module (SM 109) at the North American Rockwell plant prior to shipment to KSC. Figure 4-5 shows the fuel cell shelf, with fuel cell 1 on the right, fuel cell 3 on the left, and fuel cell 2 behind cells 1 and 3. The top of oxygen tank no. 2 can be seen at the lower left. Figure 4-6 shows the oxygen tank shelf, with oxygen tank no. 2 at left center. Figure 4-7 shows the hydrogen tank shelf with hydrogen tank no. 1 on top and hydrogen tank no. 2 below. The bottom of the oxygen shelf shows some of the oxygen system instrumentation and wiring, largely covered by insulation. Figure 4-8 is a photograph of the bay 4 panel, which was missing from the service module after the accident.

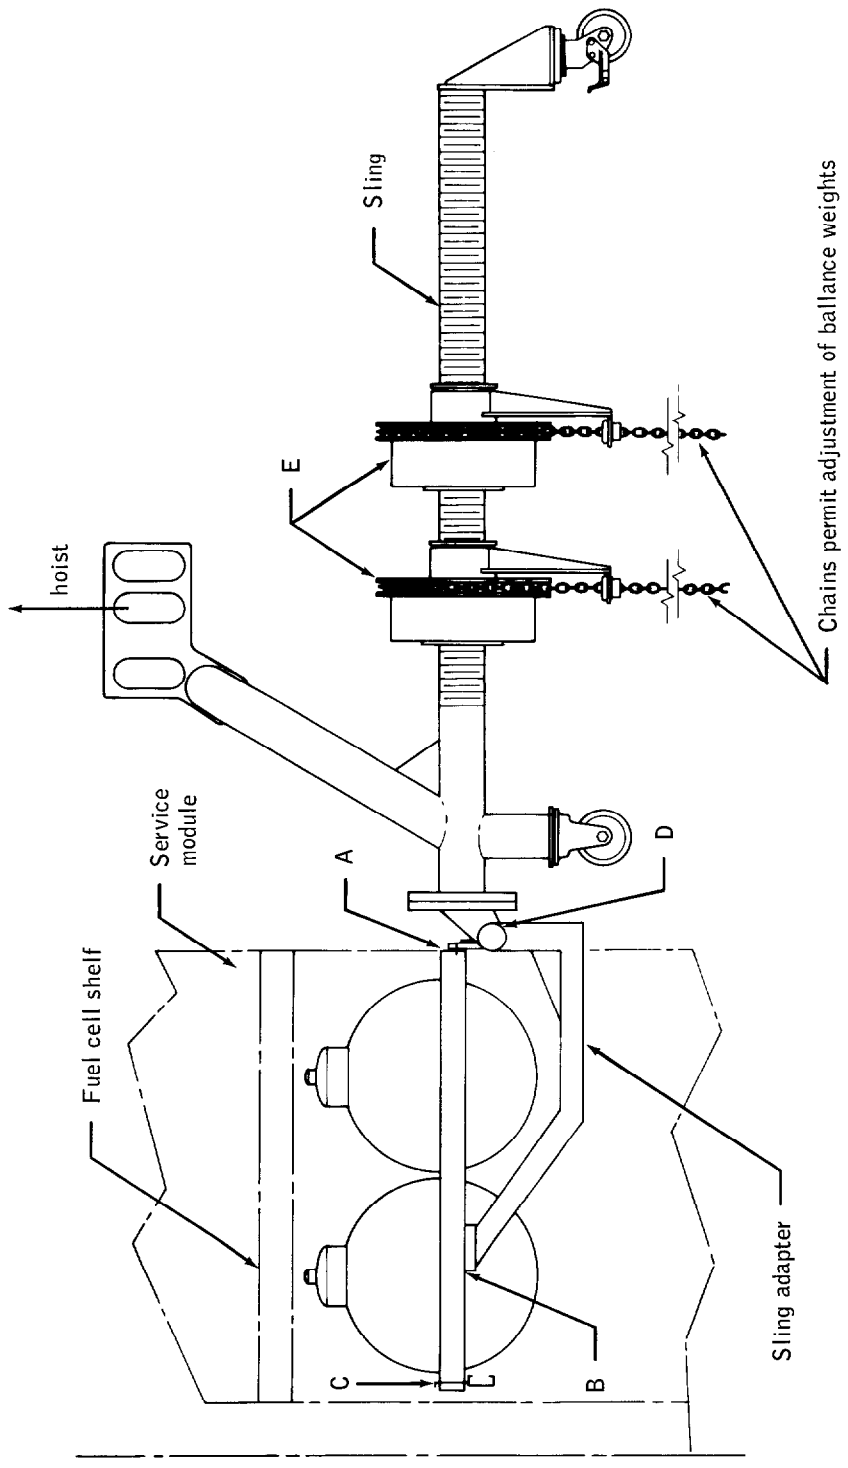
Figure 4-9.- Hoist and sling arrangement - oxygen shelf.

The oxygen shelf was removed in the manner shown in figure 4-9. After various lines and wires were disconnected and bolts which hold the shelf in the SM were removed, a fixture suspended from a crane was placed under the shelf and used to lift the shelf and extract it from bay 4. One shelf bolt was mistakenly left in place during the initial attempt to remove the shelf; and as a consequence, after the front of the shelf was raised about 2 inches, the fixture broke, allowing the shelf to drop back into place. Photographs of the underside of the fuel cell shelf in SM 106 indicate that the closeout cap on the dome of oxygen tank no. 2 may have struck the underside of that shelf during this incident. At the time, however, it was believed that the oxygen shelf had simply dropped back into place and an analysis was performed to calculate the forces resulting from a drop of 2 inches. It now seems likely that the shelf was first accelerated upward and then dropped.

The remaining bolt was then removed, the incident recorded, and the oxygen shelf was removed without further difficulty. Following removal, the oxygen shelf was retested to check shelf integrity, including proof-pressure tests, leak tests, and functional tests of pressure transducers and switches, thermal switches, and vac-ion pumps. No cryogenic testing was conducted. Visual inspection revealed no problem. These tests would have disclosed external leakage or serious internal malfunctions of most types, but would not disclose fill line leakage within oxygen tank no. 2. Further calculations and tests conducted during this investigation, however, have indicated that the forces experienced by the shelf were probably close to those originally

calculated assuming a 2-inch drop only. The probability of tank damage from this incident, therefore, is now considered to be rather low, although it is possible that a loosely fitting fill tube could have been displaced by the event.

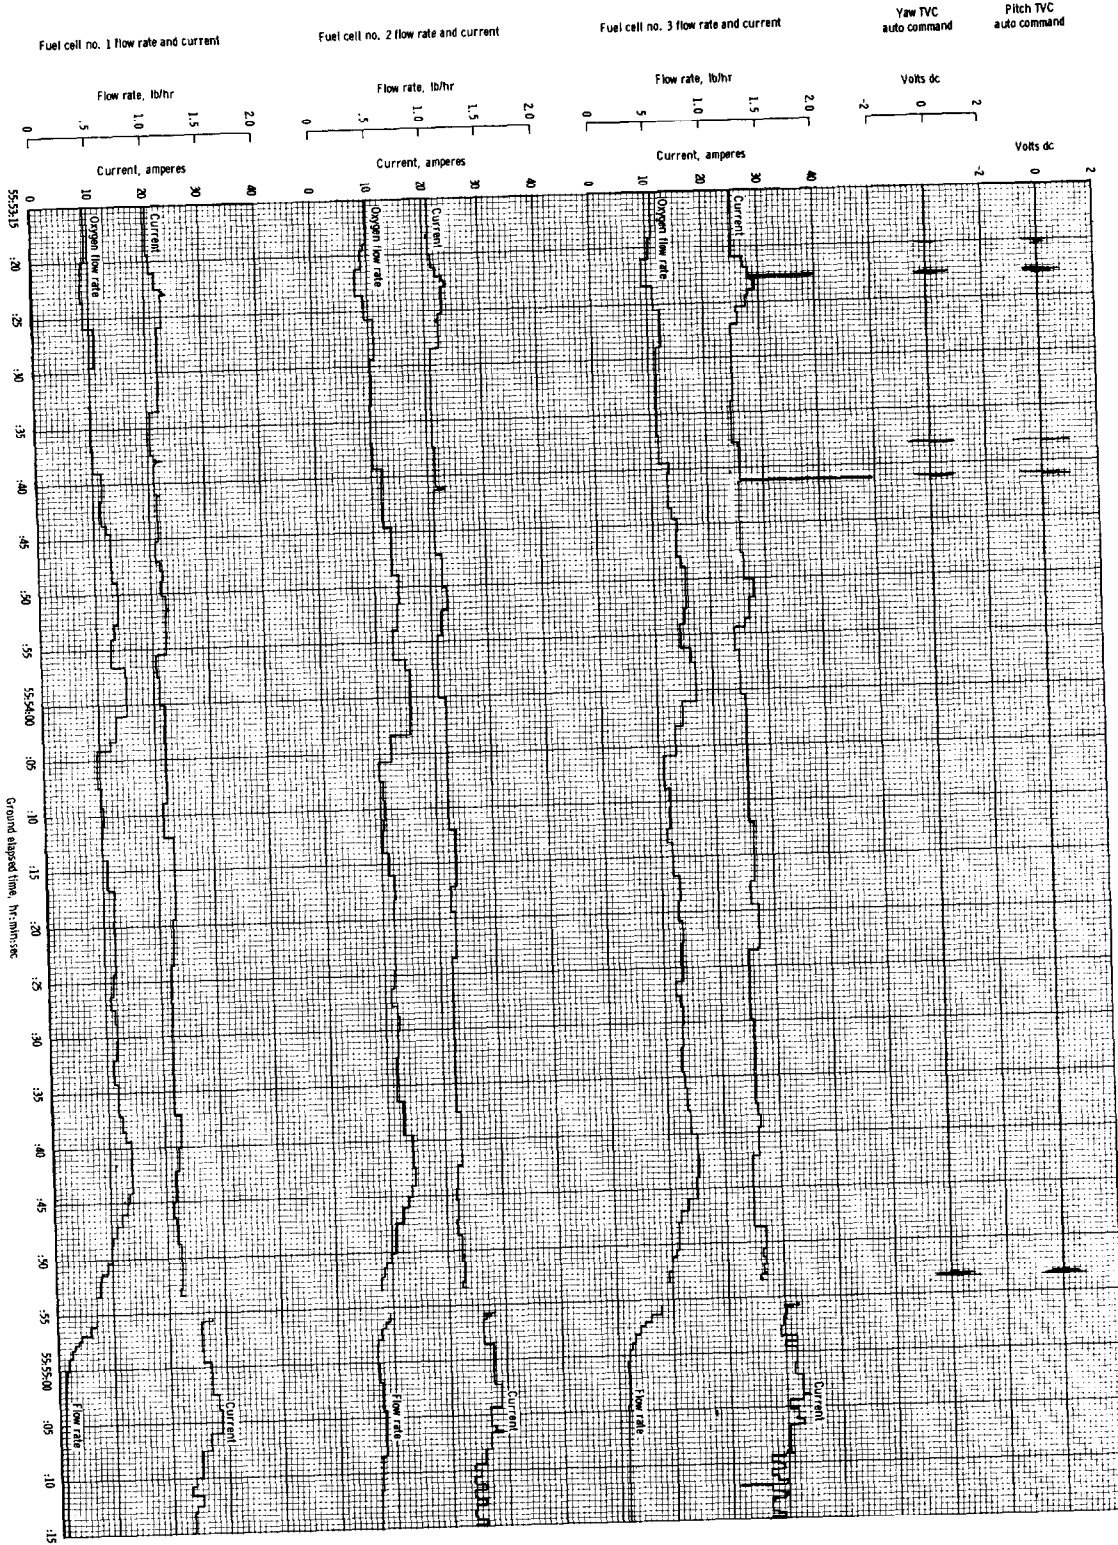
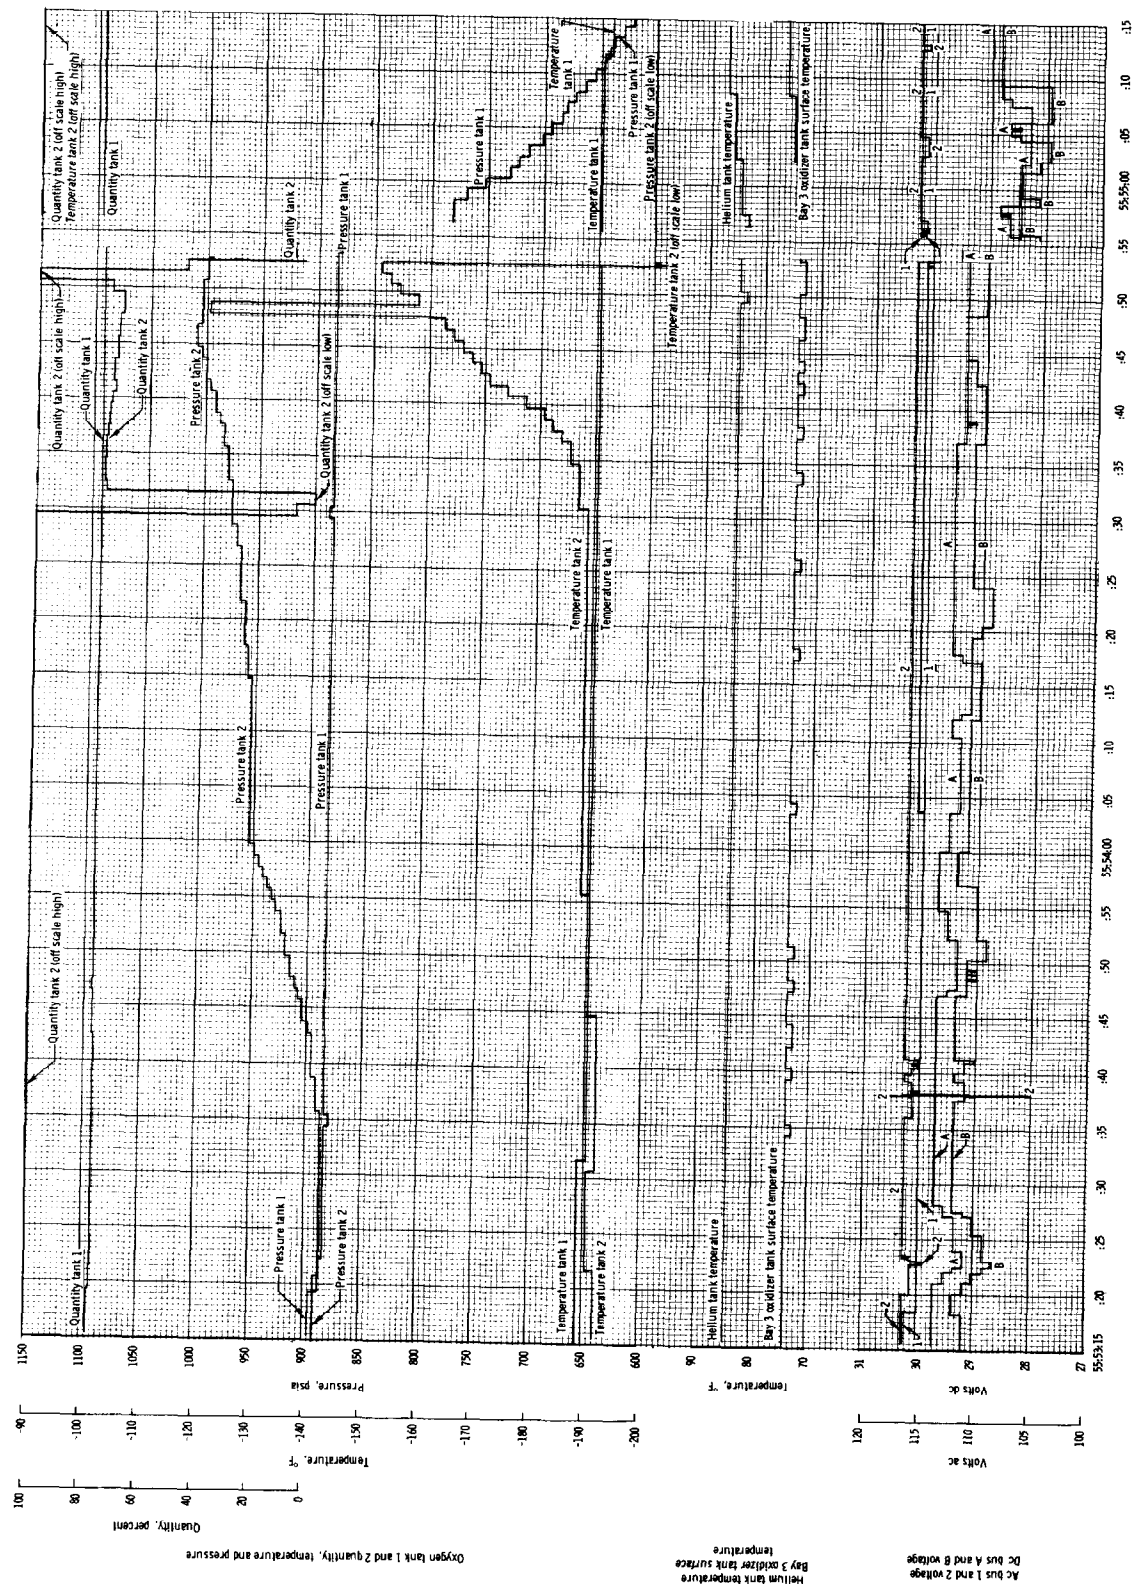
Figure 4-10.- Telemetry record.

The various telemetered parameters of primary interest are shown in figure 4-10 and listed in table 4-11.

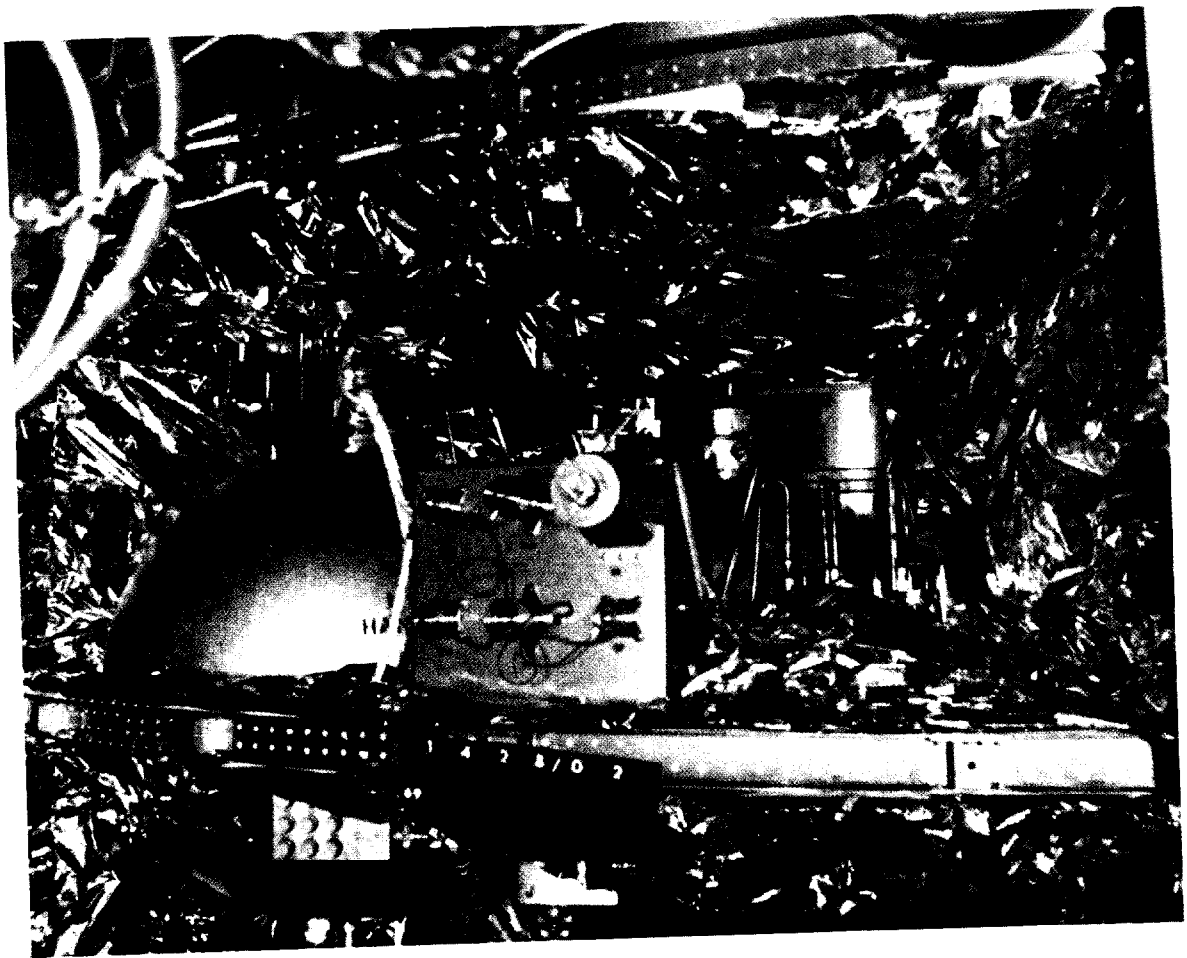
4-11.-  
Figure ~~XX-XX~~ Closeup view of oxygen tank shelf.

Release of the oxygen then began to pressurize the oxygen shelf space of bay 4. If the hole formed in the pressure vessel were large enough and formed rapidly enough, the escaping oxygen alone would be adequate to blow off the bay 4 panel. However, it is also quite possible that the escape of oxygen was accompanied by combustion of Mylar and Kapton (used extensively as thermal insulation in the oxygen shelf compartment, figure 4-11, and in the tank dome) which would augment the

pressure caused by the oxygen itself. The slight temperature increases recorded at various SM locations indicate that combustion external to the tank probably took place. Further testing may shed additional light on the exact mechanism of panel ejection. The ejected panel then struck the high-gain antenna, disrupting communications from the spacecraft for the 1.8 seconds.
