Structural Aspects of the Chernobyl Accident

**Robert C. Murray
Garth E. Cummings**

Structural Aspects of the Chernobyl Accident¹

*Robert C. Murray
Garth E. Cummings
Nuclear Systems Safety Program
Lawrence Livermore National Laboratory
Livermore, California*

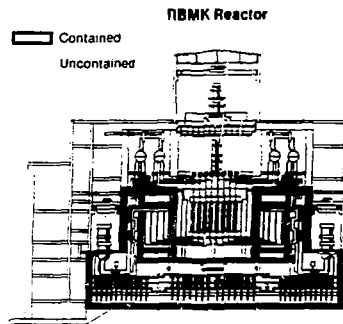
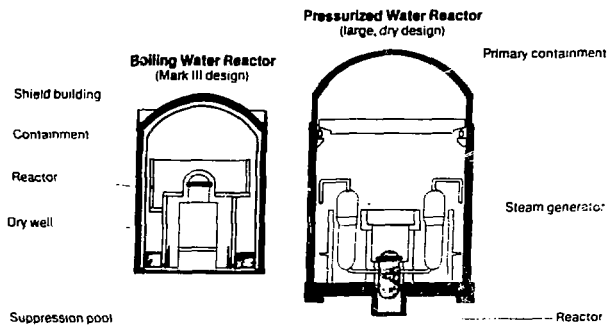
Fig. 3 RBMK reactor and typical U.S. reactor containment structures (EPRI, 1987).

Chernobyl did not have a containment building which completely enclosed the reactor and coolant pressure boundary as do all U.S. commercial light water reactors. Containment walls were provided around and underneath the lower half of the reactor, but the top half is essentially uncontained (except for the core pressure boundary) and surrounded by an ordinary industrial building. Fig. 3 shows the RBMK reactor and contrasts it to typical U.S. reactor containment buildings which are constructed of thick steel-lined concrete structures. The layout of the Unit 4 reactor and adjacent turbine hall is shown in Fig. 4. A cross-sectional view is shown in Fig. 5. The RBMK design evolved from the military plutonium production reactors and were first constructed when soviet technology did not permit construction of large steel reactor pressure vessels and concrete containment structures. Currently there are about 15 RBMK type reactors in this size range operating in the Soviet Union.

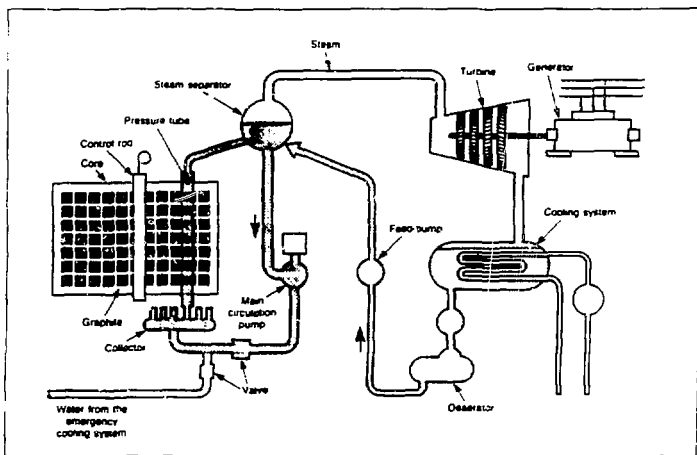
Fig. 5 Schematic diagram of the RBMK-1000 (Snell and Howeson, 1986).

The reactor core is composed of stacked graphite blocks (2000 ton) which contains the uranium fuel in 1661 pressure tubes each about 3 1/2 inches in diameter. Water flows vertically through these tubes to cool the fuel and generate steam to drive two turbine-generators. The pressure tubes are made of a zirconium alloy. The pressure tubes are connected by a series of pipes to four steam separators, which are large horizontal tanks used to separate steam and water. Steam is taken off the top of the separator to drive the two turbines. Water from the steam separators and turbines is returned to the reactors by pumps. The reactivity was controlled by 211 control rods which were hung from cables wrapped around electric motor driven drums. This control rod system is slow and can scram the reactor in about 20 seconds. An emergency cooling system was also available as a back-up safety system if the primary cooling system was not working. A schematic diagram of the reactor design is shown in Fig. 6. Partial containment was provided by reinforced concrete compartments surrounding various components. The core and pressure tubes were in a room with a capability to withstand about 26 psi. Suppression pools were located below the reactor to capture and condense steam from small pipe breaks but could not handle multiple pressure tube ruptures. The pressure capability of the industrial building over the reactor core has been estimated at 1/4 psi.

The reactor is unstable at low power and difficult to control, but achieves more stability at operating power levels. A rule existed that did not permit extended operation below 700 MW thermal.

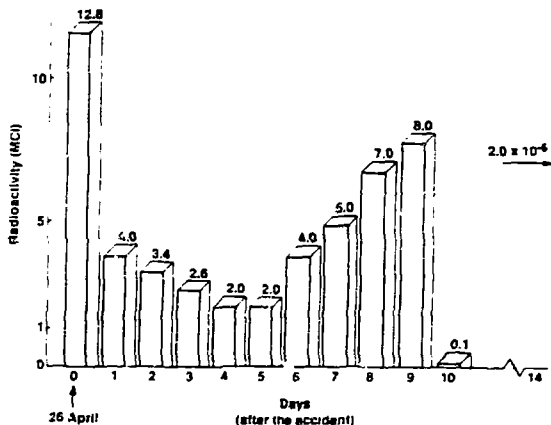
Fig. 9 Calculated daily release of radioactivity from the day of the accident until the quenching was successfully completed (Ahcame, 1987).

Emergency medical and radiation safety teams were sent from Moscow after notification that a problem existed. Inhabitants of Pripjat were told to remain inside their houses. They were evacuated the next day due to high radiation levels. About 135,000 people were evacuated from a 30 km radius around the accident site, (see Fig. 2). Emissions from the plant continued for the next nine days as the graphite core continued to burn. Estimates of daily releases are shown in Fig. 9. Emergency teams were dropping tons of lead, sand and clay, dolomite and boron carbide on the plant in an attempt to quench the burning graphite. After the fifth day the radioactive release started to increase. This was thought due to the insulating effect of all the material dropped on the core. Liquid nitrogen was pumped into the space under the reactor for additional cooling. Releases essentially stopped on the tenth day.

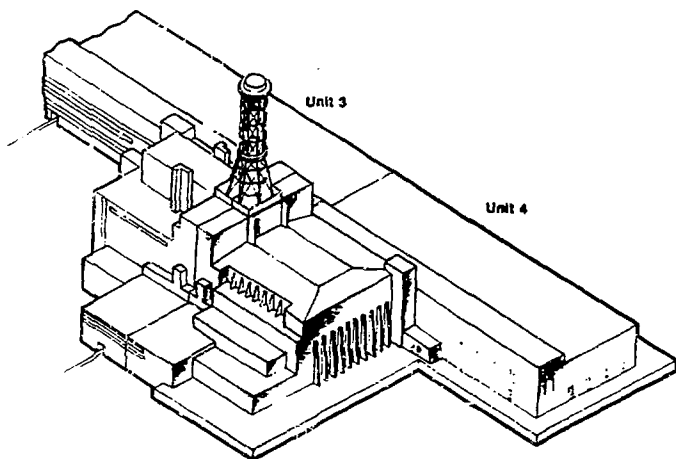
Fig. 10 Unit 4 burial (Snell and Howieson, 1986).

A permanent vault, called a sarcophagus, was built around the Unit 4 reactor and the turbine building as shown in Fig. 10. This huge containment structure was completed by November 1986. Design and construction of the sarcophagus represented a major structural engineering accomplishment that was completed in a short time. Essentially all of Unit 4 was entombed by this structure which included internal monitoring instrumentation. Up to a meter of top soil was replaced around the site.
