ORNL/NSIC-176

**Descriptions of Selected Accidents
that Have Occurred at Nuclear
Reactor Facilities**

Date Published: April 1980

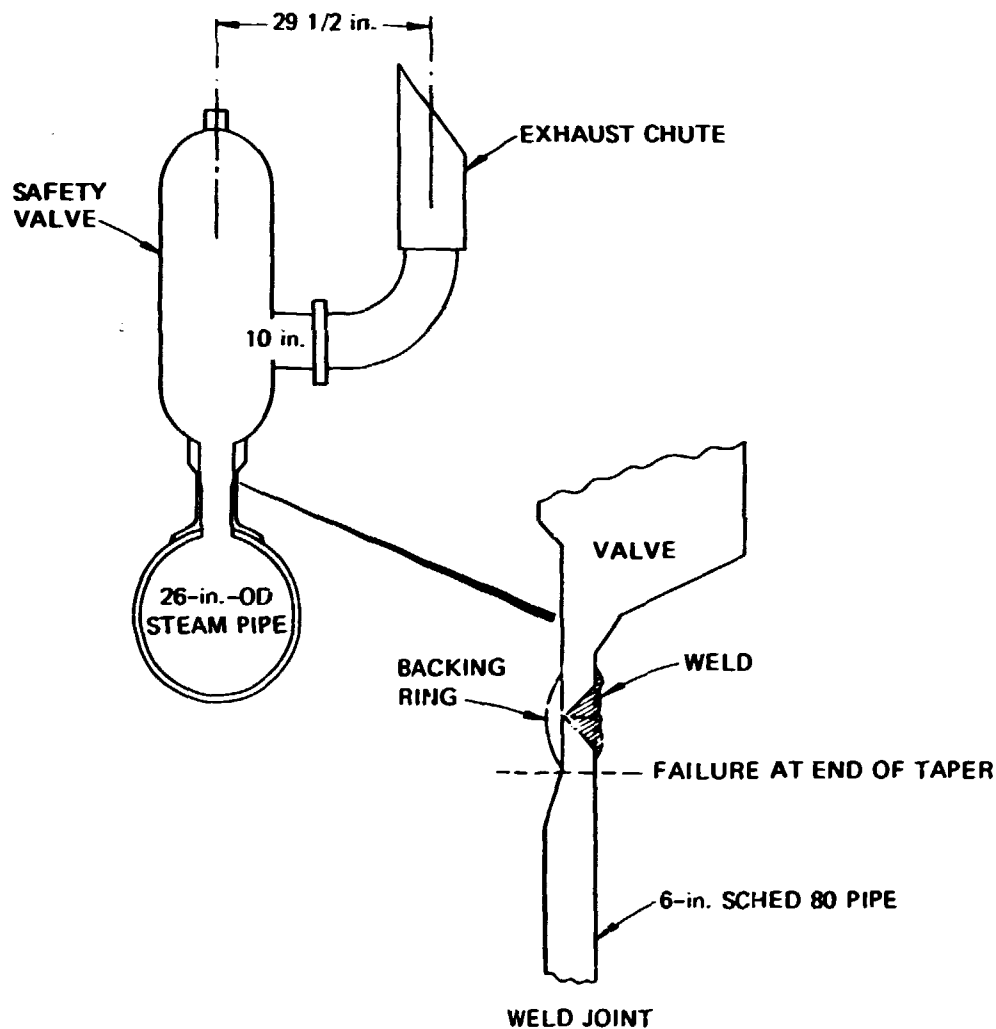
Fig. 3.4. Area of break in steam nozzle at Robinson 2.

All the connections (nozzles) between the 26-in. steam pipes and the safety and relief valves were replaced by nozzles of larger diameter and thicker steel.

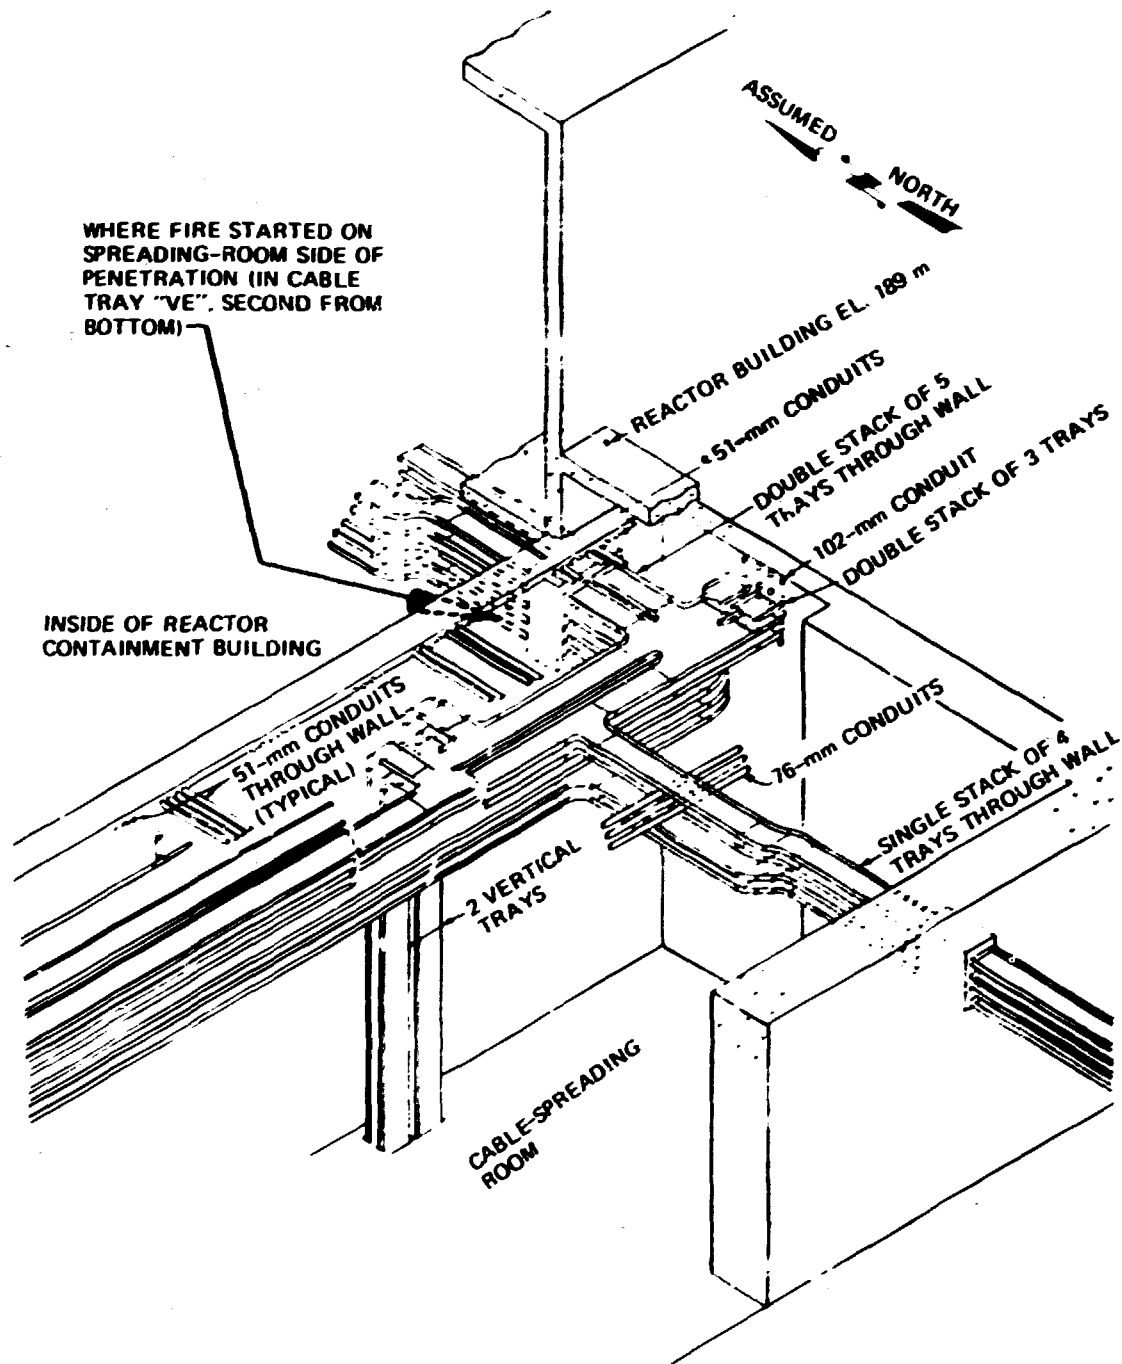
Such a leak was found in a corner of the room by a workman who was lying on his side using a candle and a flashlight, since lighting was

Fig. 3.10. Area of fire at Browns Ferry Nuclear Power Station
 (51 mm = 2.04 in.; 76 mm = 3.04 in.; 102 mm = 4.08 in.; 189 m = 620 ft).

poor. The time was 12:15 PM on Mar. 22, 1975. The workman had stuffed some sheet polyurethane (which is more flammable than the foam) into the hole and again tested for leaks with the candle. The leak persisted, but this time the horizontal flame of the candle ignited the sheet polyurethane, and the burning sheet polyurethane, in turn, ignited the foam. The air rushing into the hole spread the fire into the hole away from the workmen so that they could not extinguish it with hand-held dry-chemical extinguishers. An alarm was sounded and the cable-spreading room was evacuated. The fire was smoldering and beginning to spread slowly by burning the insulation on the cables on both sides of the wall. Workmen went into the reactor containment building to try to extinguish the fire and found that the penetration on the inside of the wall was about 20 ft above the floor level. Using a ladder to reach the fire, a workman discharged a dry-chemical fire extinguisher on the smoldering tray, but he was forced to withdraw because of smoke. Smoke made visibility difficult, and it curtailed fire-fighting efforts even after airspace breathing apparatus was obtained.
