# TECHNICAL REPORT

## VERIFICATIONS UNDER THE TERMS OF ARTICLE 35 OF THE EURATOM TREATY

### URANIUM SITES

#### Environmental Radioactivity and Discharge Monitoring and part of National Monitoring System for Environmental Radioactivity Portugal

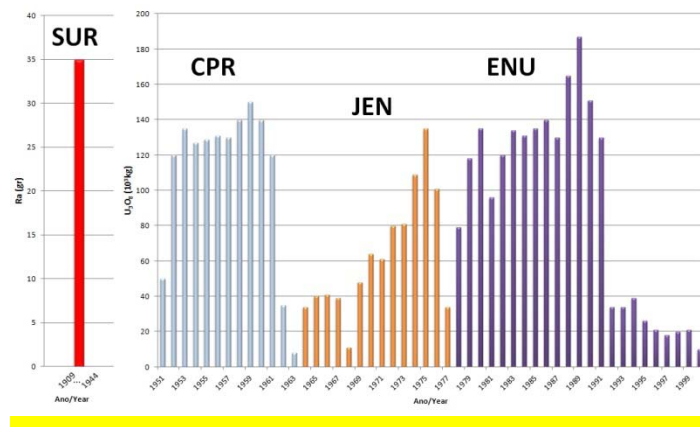
Figure 1: Production of radium and  $U_3O_8$  in Portugal (©EDM)

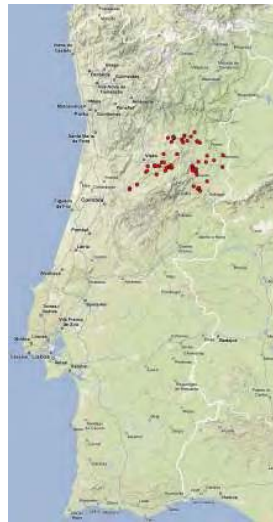
Figure 2: Location of uranium and radium mines in Portugal (overview)

Sixty mines were exploited for uranium and radium ore, most of them located in the counties of Guarda, Viseu and Coimbra (Figs. 2 and 3). The exploited ore bodies had different characteristics, particularly in terms of typology and structure (depth and regularity of the mineralization distribution), or host rock characteristics. These characteristics determined the different mining methods: underground, open pit, combined underground/open pit, sometimes using heap or in situ acid leaching (ISL). A great number of mines were of small size and exploited as open pits, although some of the larger ones were exploited as underground galleries or in a combination of both methods (see Appendix 3).
