APPENDIX D
REPORT OF DESIGN PANEL

The Design Panel was assigned the task of reviewing the design of the systems involved in the Apollo 13 accident, including their qualification history. The service history of the specific components flown on Apollo 13 was also to be examined from a design point of view to ascertain whether any abnormal usage experienced might have had a detrimental effect on the functional integrity of the components. The Panel was also charged with review of other spacecraft systems of similar design or function to ascertain whether they contained potential hazards. Finally, the Panel was to analyze, as required by the Board, proposed failure mechanisms to the extent necessary to support the theory of failure.

Early in the proceedings of the Board, it became evident that the failure was centered in the cryogenic oxygen subsystem of the electrical power system of the spacecraft, and, more specifically, in the no. 2 cryogenic oxygen tank. For this reason, detailed examinations of the Panel were limited to this subsystem. Interfacing systems were examined only to the extent required to understand the function of the oxygen system and/or to relate data from flight

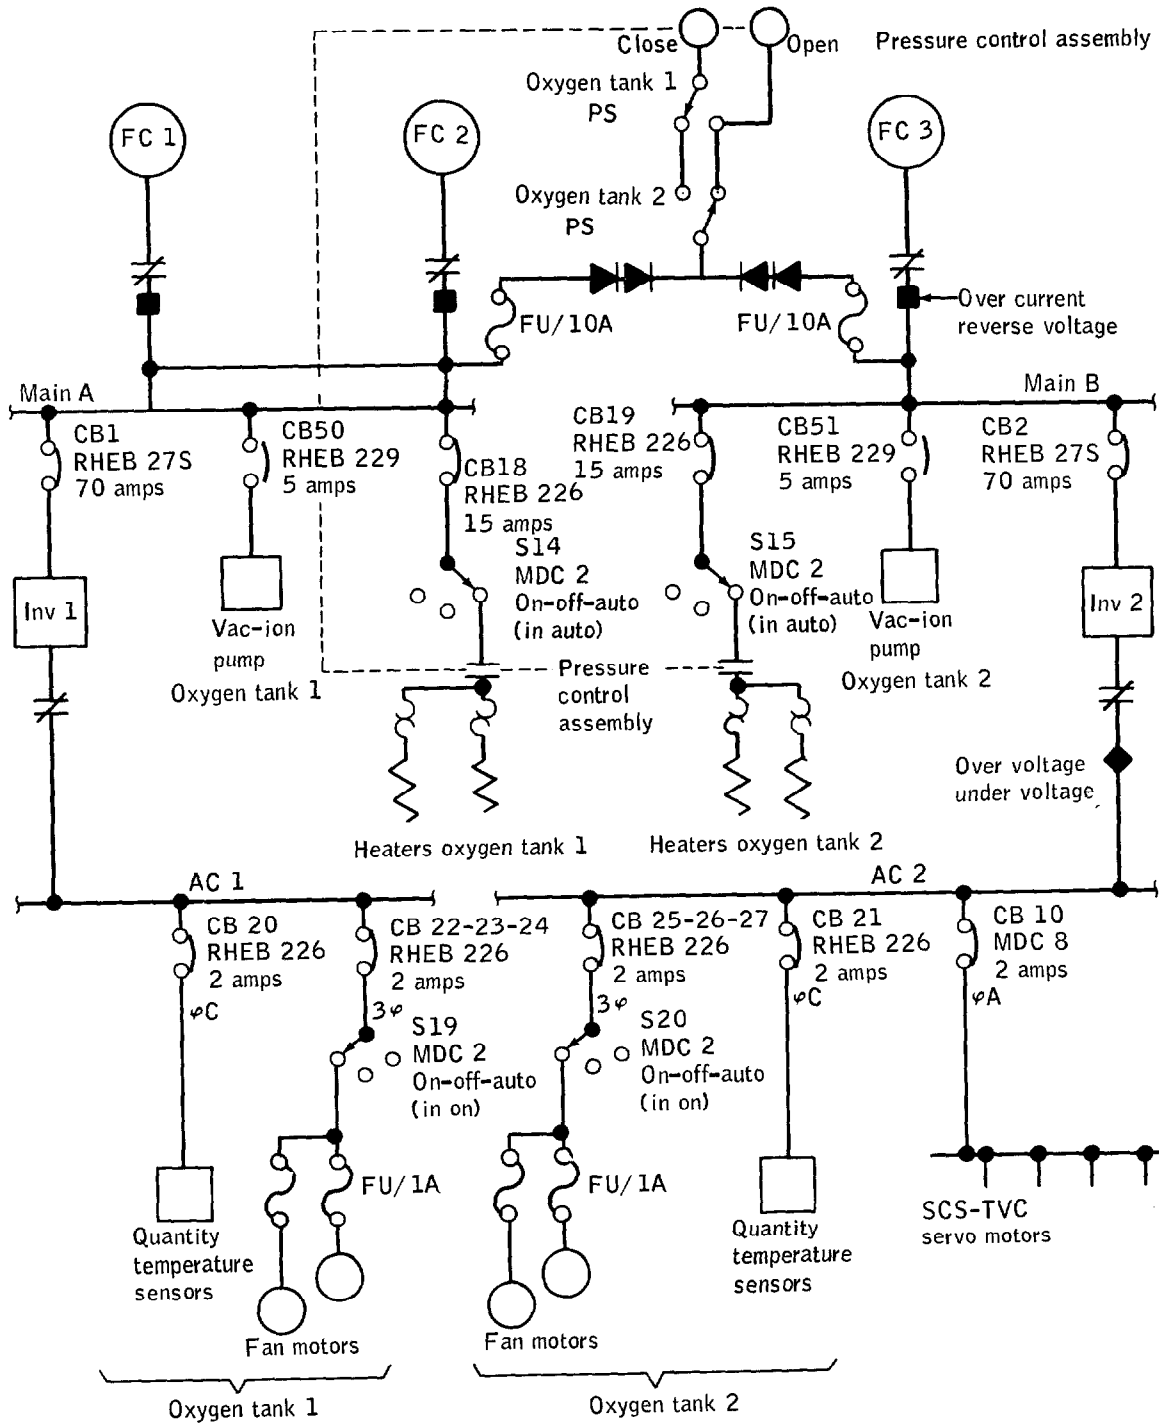
Figure D3-5.- Electrical schematic of relevant portions of electrical power system at 55:53:21.

The electrical power system, in general, provides multiple power busses with switching options for selecting an operating configuration. At 55:53:21, the electrical system was configured in accordance with reference 1, as shown in figure D3-5, with fuel cells 1 and 2 connected to main bus A and fuel cell 3 connected to main bus B. Inverter 1 was connected to main bus A and powering ac bus 1. Inverter 2 was connected to main bus B and powering ac bus 2. Inverter 3 was not connected. Battery busses A and B were not connected to main bus A or B. The switches controlling heater operation for both oxygen tanks were in the "automatic" position, controlling heater operation through the pressure control assembly. Pressures in the oxygen tanks were at levels which did not demand operation of the heaters. Temperature and quantity sensors on oxygen tank no. 2 were energized from ac bus 2. The quantity gage

had remained off-scale high from 46:40:06, indicating a probable short circuit either on the leads or the probe assembly. Operation of the fan motors in the oxygen tanks was accomplished throughout the mission using manual control in lieu of the automatic operation afforded by the logic of the pressure control assembly. A routine operation of the fans was requested by the ground at 55:52:58 and acknowledged by the crew at 55:53:06. Energizing of the fans in oxygen tank no. 1 is confirmed by a drop in voltage of ac bus 1 and an increase in total fuel cell current at 55:53:18. Energizing of the fans in oxygen tank no. 2 is confirmed by a drop in voltage of ac bus 2 and an increase in total fuel cell current at 55:53:20. Data substantiating operation and operation times are presented in Appendix B.

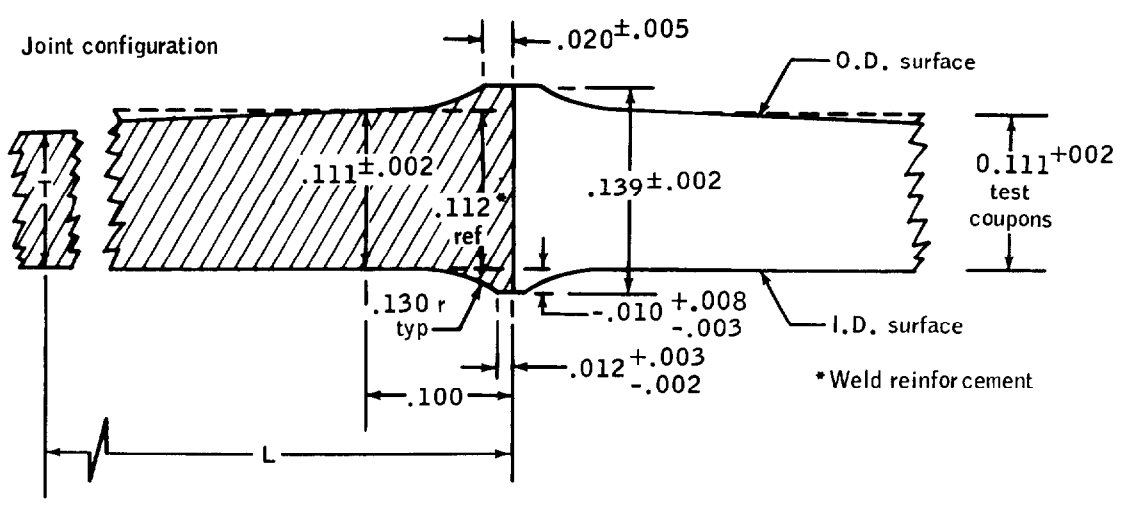
Figure D3-7.- Girth weld joint configuration and schedule.

A total of 39 data packages on oxygen pressure vessels were reviewed and it was ascertained that only 12 vessels had had weld discrepancies. Table D3-1 describes the weld discrepancies and their disposition. Neither of the two Apollo 13 oxygen tanks flown (S/N 10024XTA0008 and S/N 10024XTA0009) appear on this list. There were no recorded weld discrepancies during the manufacture of these tanks.

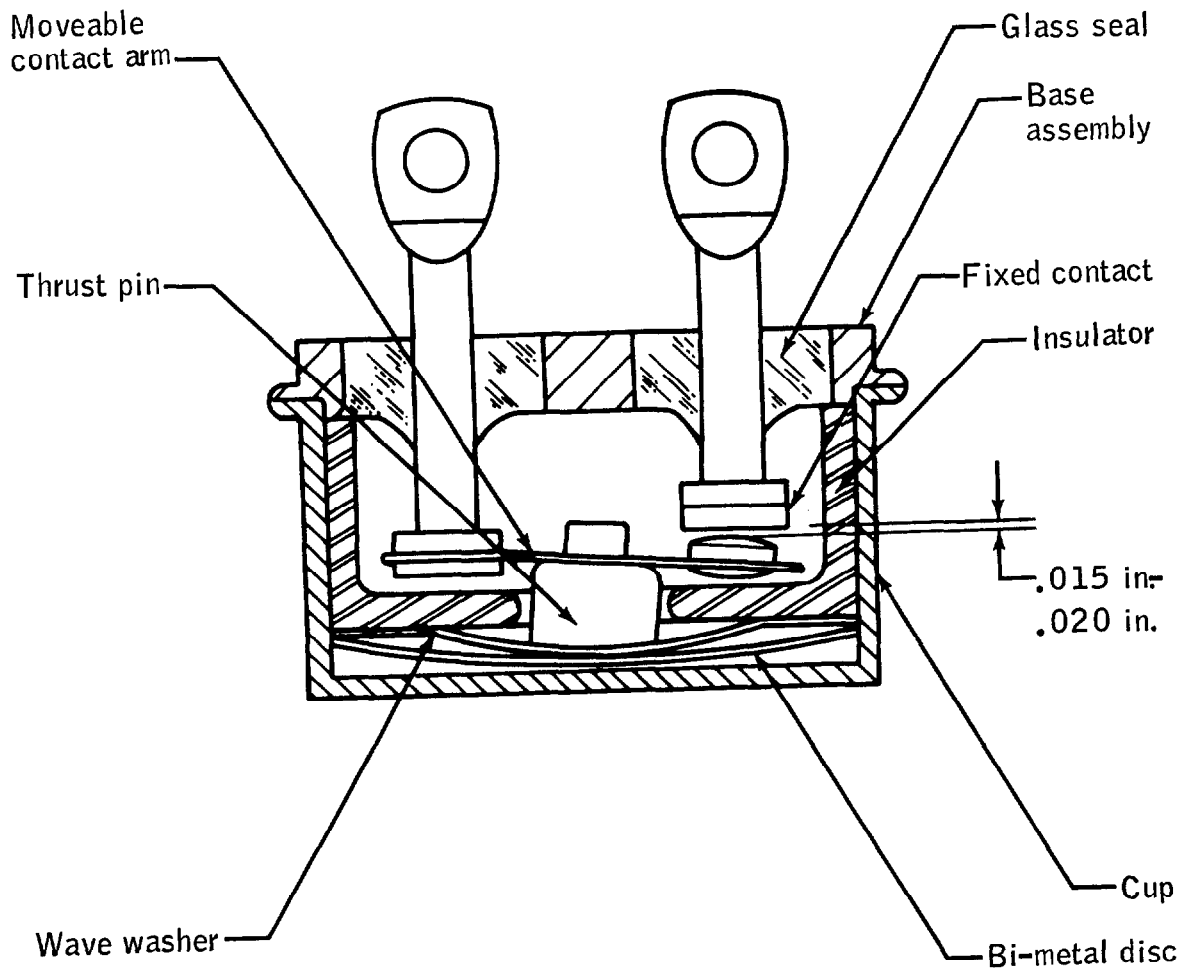
Figure D3-14.- Cross section of thermostat.

All qualification and acceptance tests identified were primarily concerned with the repeatability of the thermostat actuation at the specified temperatures. No qualification or acceptance tests have been identified which would verify the ability of the thermostats to open the heater circuit when energized at 65 V dc.
