# **REPORT OF APOLLO 13 REVIEW BOARD**

**APPENDIX F - SPECIAL TESTS AND ANALYSES**

**APPENDIX F**  
**SPECIAL TESTS AND ANALYSES**

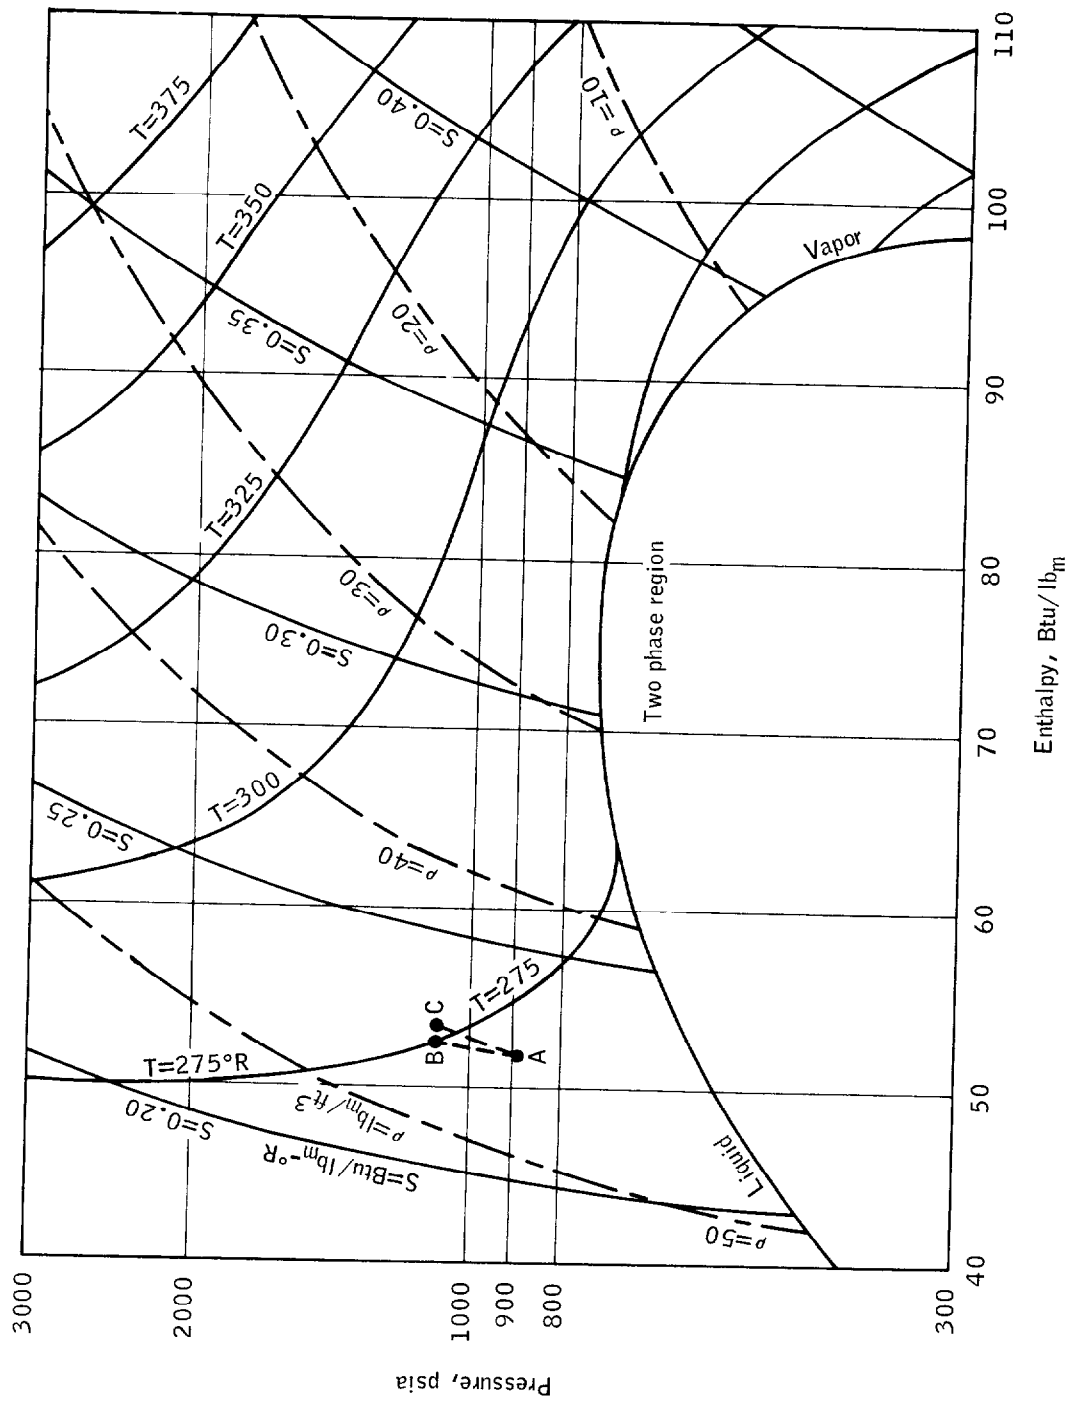
Figure F3.3-1.- Thermodynamic processes on pressure-enthalpy diagram.

Figure F3.3-1 also shows the constant density path along line AC from 887 psia to 1008 psia. This process could be achieved by complete mixing of the tank contents. The internal energy increase for this case (maximum energy) is about 130 Btu. The temperature increase for this process is  $2.6^{\circ}$  F. It should be noted that this energy addition is to the oxygen in the tank. It does not include energy that might be added to other tank components such as metal parts.

The measured temperature rise of  $38^{\circ}$  F (indicated by figure B5-3 in Appendix B) during the pressure rise to 1008 psia cannot be explained by

either of the above-mentioned thermodynamic processes because they give a rise of only 1.8° and 2.6° F. As figure B5-3 shows, the measured temperature rise lagged the pressure rise. Both this lag and the magnitude of the temperature rise can be explained by the passage of a combustion front near the temperature sensor.

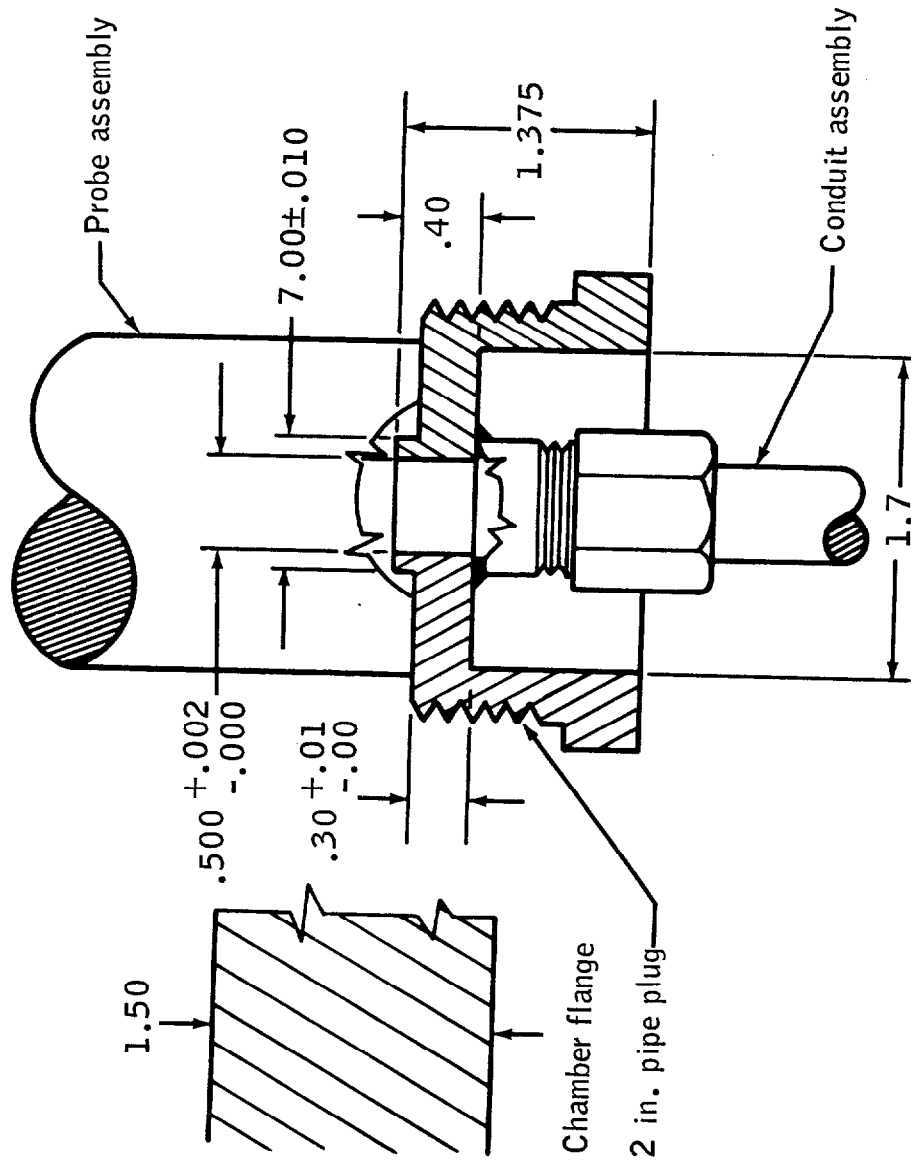
Figure F3.5-2.- Upper quantity probe - conduit interface.

The test item consisted of an upper portion of the quantity probe interfaced with a conduit assembly shown in figure F3.5-2. The quantity probe used was Block I hardware which had been sectioned for demonstration purposes. An additional hole was drilled in the probe insulator to modify it to Block II and wire was routed through it and the conduit assembly to represent the Apollo 13 configuration. Stainless steel sections were welded onto the probe to close the demonstration ports. Wiring with insulation was allowed to extend beyond the Teflon insulator approximately 4 inches. This wiring was also routed through the conduit and connected to the feedthrough pins through which power, 115 volts at 400 cycles, was supplied to both fan motor bundles by a system which had been

The probe conduit interface consisted of a stainless steel 2-inch pipe plug machined to the dimensions shown in figure F3.5-2. The interface was mounted on the bottom flange of the chamber so that flame propagation would be downward.

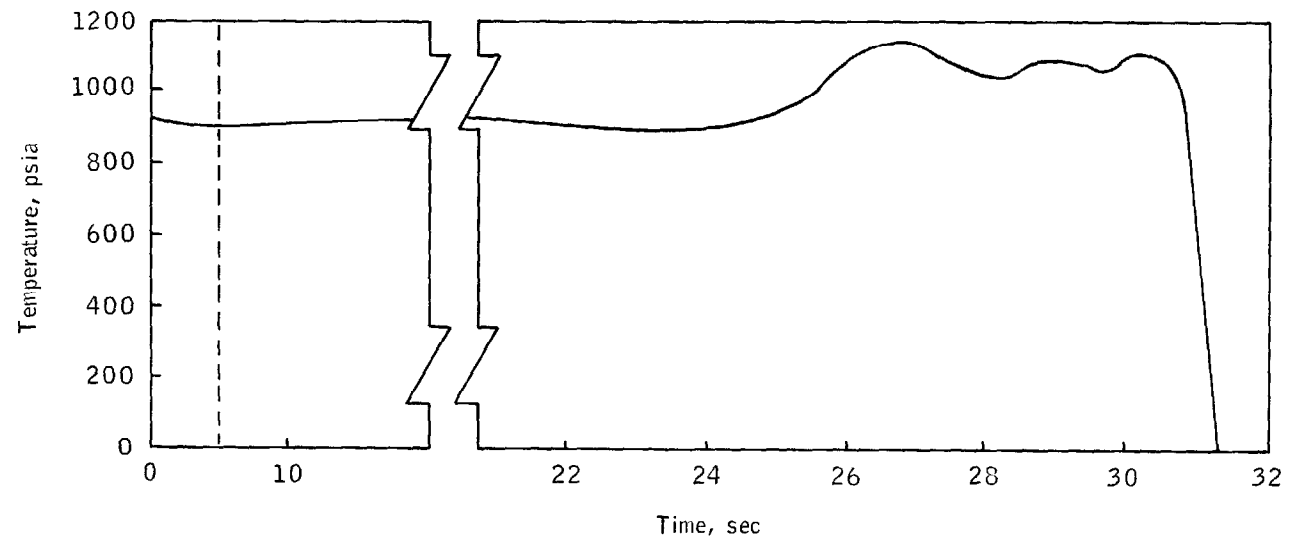
Figure F3.5-3.- Quantity probe and conduit assembly test pressure history.

Pressure history of the chamber is shown in figure F3.5-3. The first relief valve opening occurred at approximately 28 seconds. It subsequently reopened 15 times before failure occurred. Fusion of the ignitor is shown on the graph to indicate ignition of the insulation.

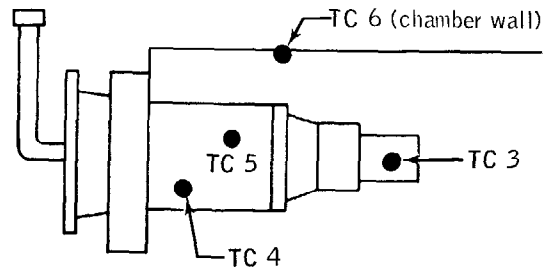
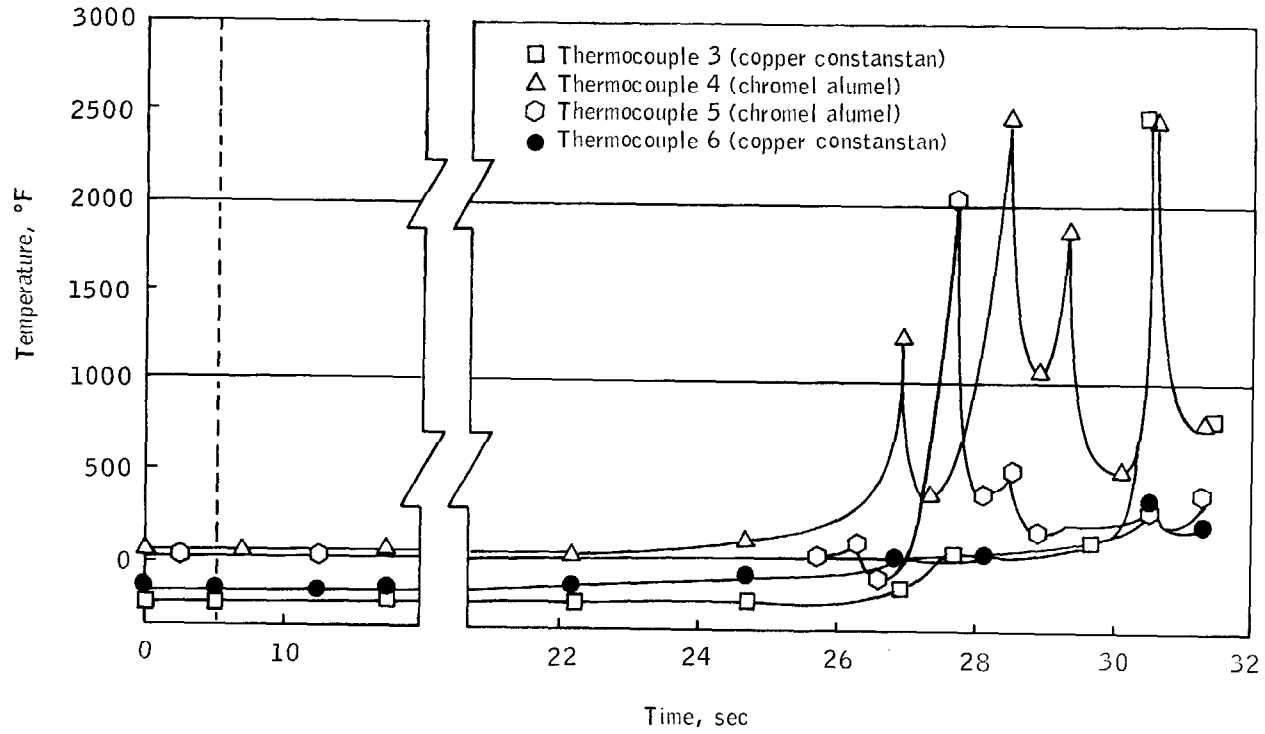
Figure F3.5-4.- Temperature history of quantity probe and chamber wall.

Temperature histories of both internal and external portions of the test apparatus are shown in figures F3.5-4 and F3.5-5. Thermocouple placements in each of these areas are included in the legend figures of each of these graphs. It should be noted that two types of thermocouples were used, one with good sensitivity at low temperatures, copper-constantan, and one with good sensitivity at high temperatures, chromel-alumel. These two types are also indicated in figures F3.5-4 and F3.5-5.

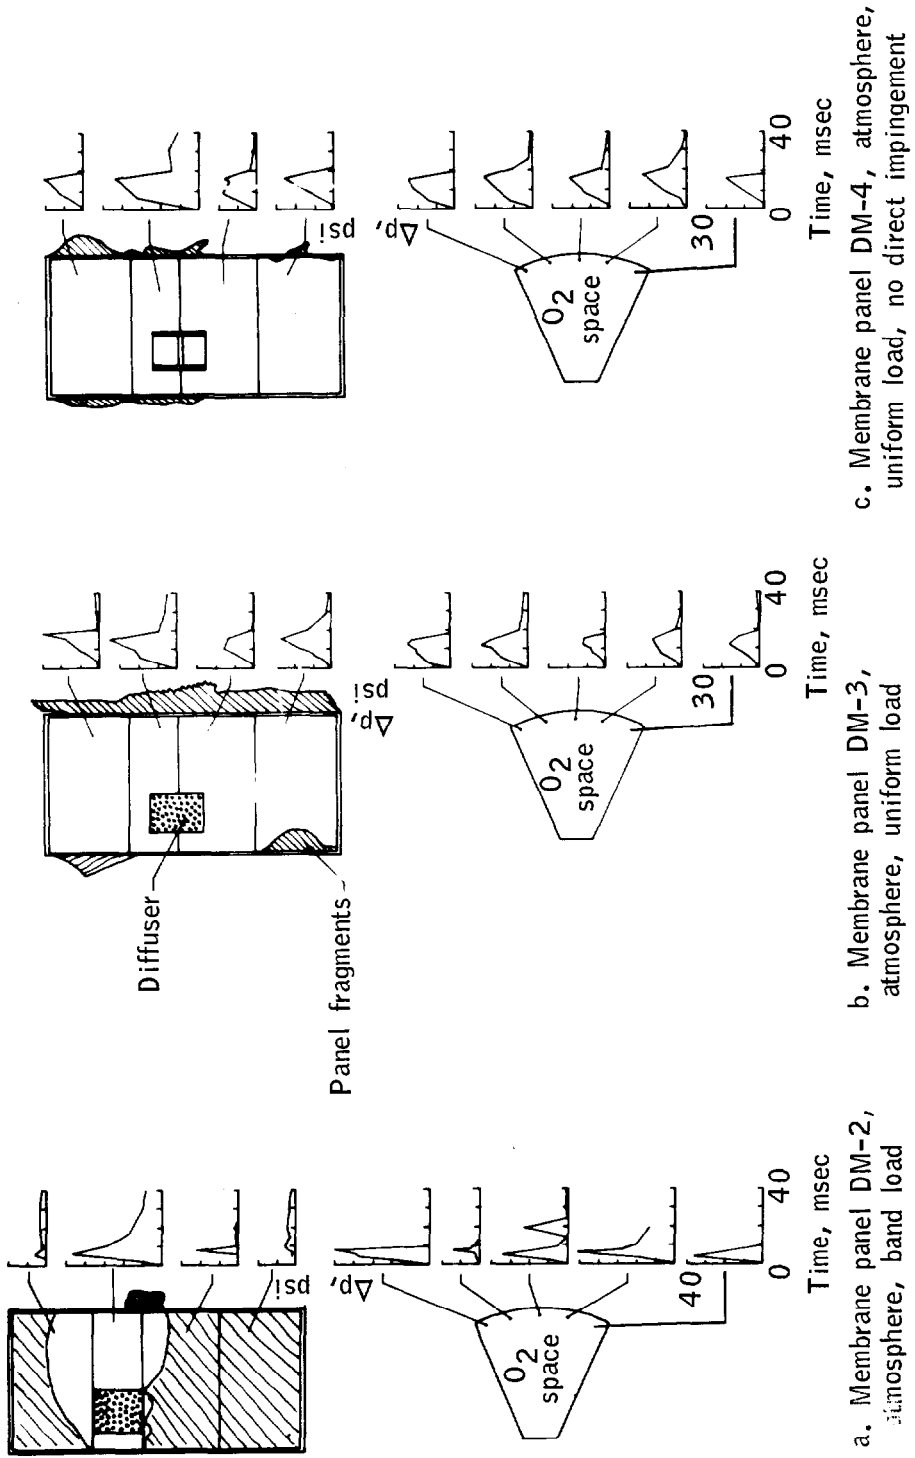
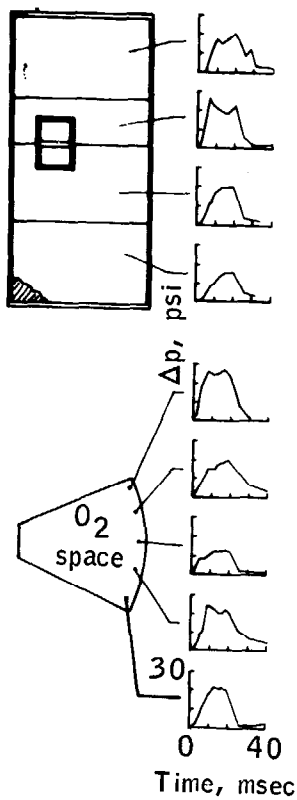
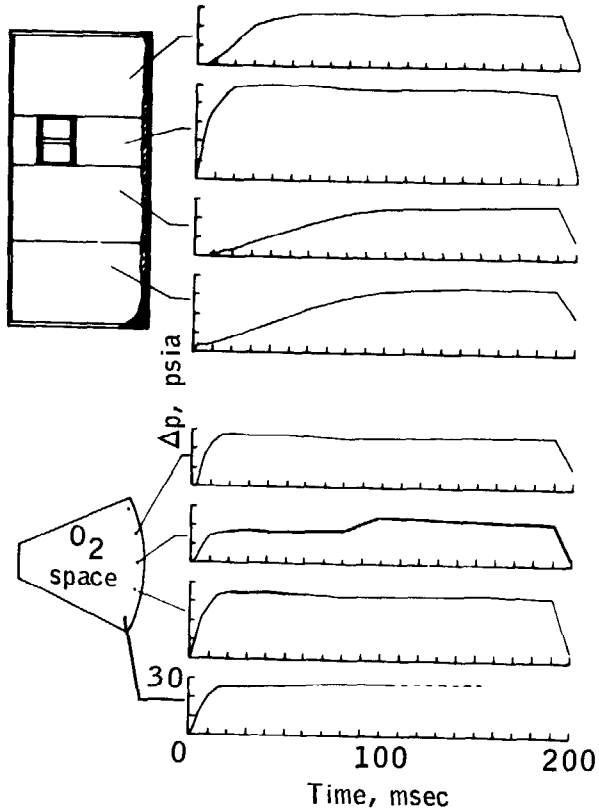
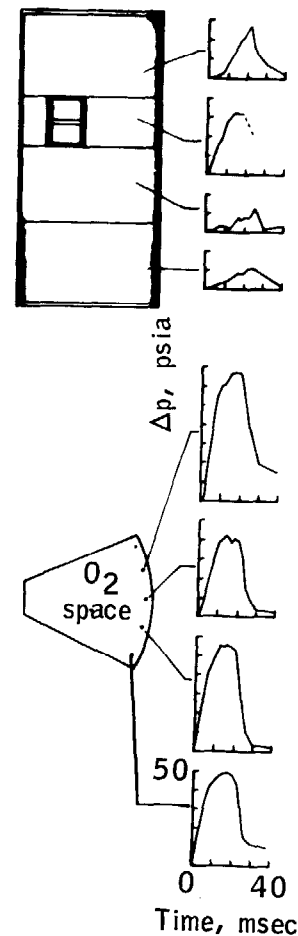
Figure F3.10-4.- Failure modes and pressure-time histories.

Demonstration of panel separation.- Panel separation has been demonstrated with both membrane and sandwich panels. Two sandwich panels separated completely from the test fixture during vacuum tests. Two membrane panels, although less representative of flight conditions, also separated completely in vacuum tests. However, similar tests with membrane panels in atmosphere left portions of panels attached to the test fixture as illustrated in figures F3.10-4(b) and (c). Complete separation in atmosphere could not be achieved due to mass and drag of the air.

Pressure distributions.- Complete membrane panel separation was achieved only with nearly uniform pressure distribution over the entire bay 4 panel cover, shown in figure F3.10-4(d). When just the oxygen shelf space experienced high pressures, membrane panel separation was localized to the area of the panel over the oxygen shelf space as shown in figure F3.10-2(a). This type of local failure occurred in both atmosphere and vacuum. When scaled internal venting was introduced, model DM-10 lost a slightly larger portion of panel due to high pressure experienced by both the oxygen shelf and fuel cell shelf spaces while the rest of bay 4 was at low pressure.

of the Apollo 13 SM shown in figure F3.10-2 and have been verified in these experiments. Peak pressure levels were varied from test to test but the curve shape was always similar. One sandwich panel separated after about 0.02 second during the initial pressure rise in the oxygen shelf space, while overall panel loading was highly nonuniform as shown in figure F3.10-4(b). The other sandwich panel did not separate until about 0.19 second after all bay 4 compartments had time to fill with gas and arrive at a much more uniform loading, as shown in figure F3.10-4(e).

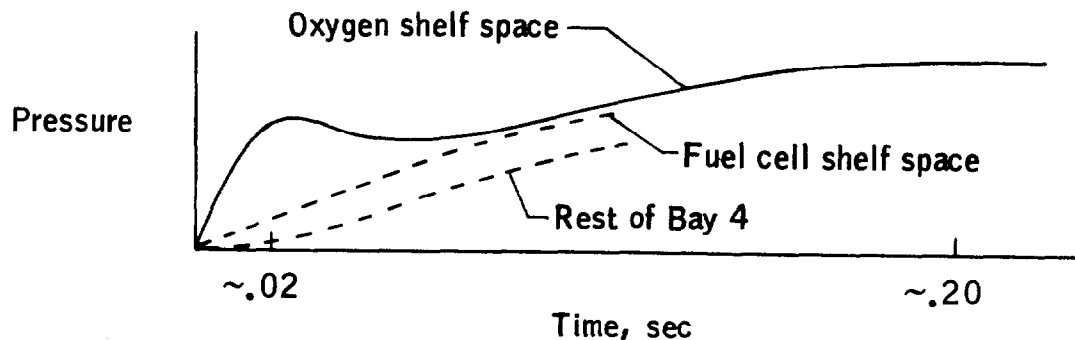
Figure F3.10-8.- Pressure build-up in bay 4.

Complete separation of sandwich panels has been obtained with both uniform and nonuniform pressure distributions. Figure F3.10-8 shows the type of pressure time histories experienced by various sections of the panels. The pressure predictions are based on the internal flow model
