CHAPTER 4  
REVIEW AND ANALYSIS OF APOLLO 13 ACCIDENT

## PART 1. INTRODUCTION

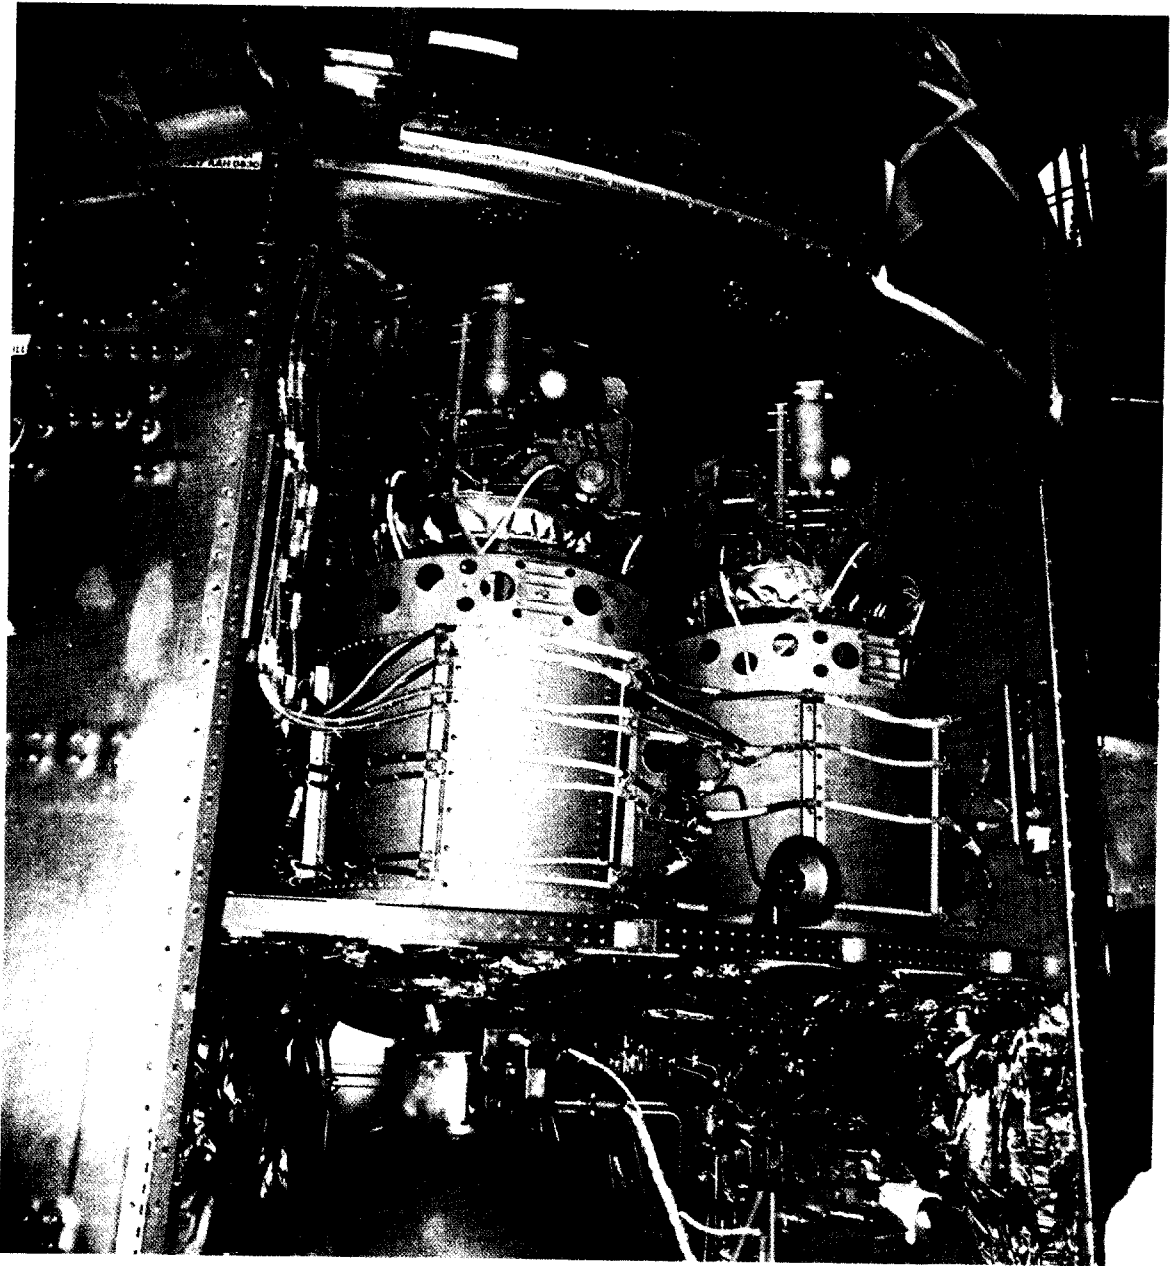
Figure 4-5.- Fuel cells shelf.

of the Apollo 13 service module (SM 109) at the North American Rockwell plant prior to shipment to KSC. Figure 4-5 shows the fuel cell shelf, with fuel cell 1 on the right, fuel cell 3 on the left, and fuel cell 2 behind cells 1 and 3. The top of oxygen tank no. 2 can be seen at the lower left. Figure 4-6 shows the oxygen tank shelf, with oxygen tank no. 2 at left center. Figure 4-7 shows the hydrogen tank shelf with hydrogen tank no. 1 on top and hydrogen tank no. 2 below. The bottom of the oxygen shelf shows some of the oxygen system instrumentation and wiring, largely covered by insulation. Figure 4-8 is a photograph of the bay 4 panel, which was missing from the service module after the accident.
