ORNL/NSIC-176

**Descriptions of Selected Accidents
that Have Occurred at Nuclear
Reactor Facilities**

Date Published: April 1980

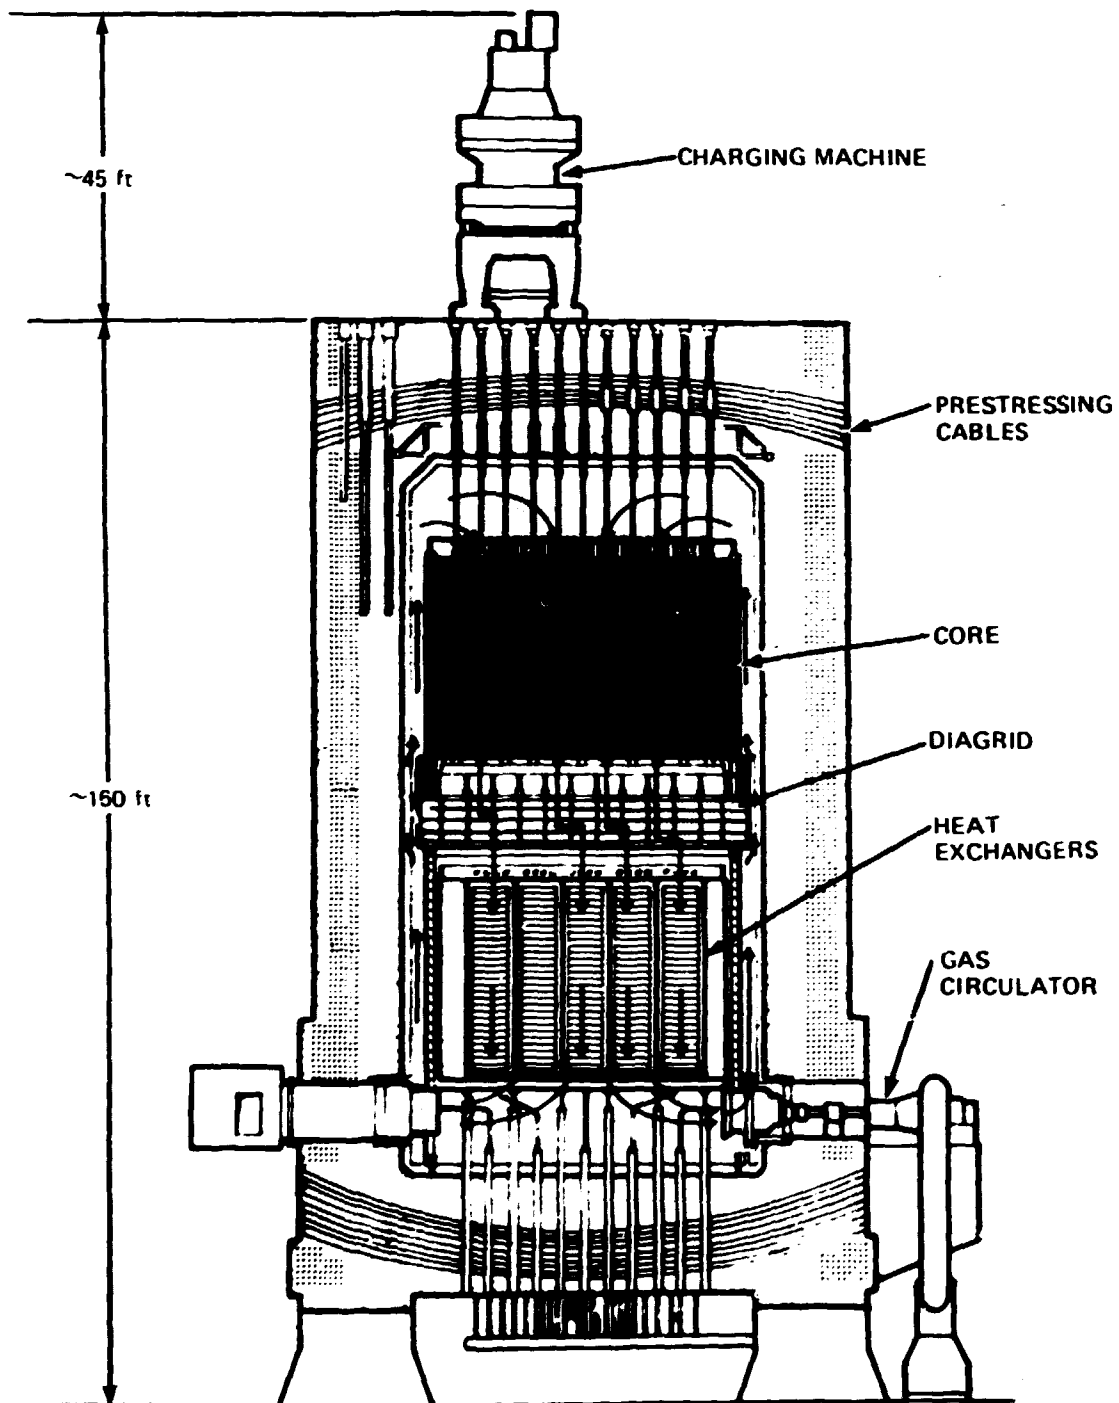
Fig. 3.1. Reactor at Saint Laurent.

Subsequent investigation revealed that the charging machine had stopped the last time because a coolant flow restrictor rather than a fuel element was in position to be loaded. When the operator overrode the stop and loaded this restrictor into the top of the channel, the coolant flow to this channel was reduced to one-fourth the normal flow. Without proper cooling, some of the fuel elements and cladding heated up beyond their melting point and flowed out of the core onto the diagrid below (see Fig. 3.1), releasing radioactive fission products that set off the alarms and the scram. The melted fuel (about 110 lb)⁵ was still well contained within the massive concrete structure (see Fig. 3.1); hence, little, if any, radioactivity was released outside of the structure, and there were no injuries. However, a year was needed to complete the cleanup operations and restart the reactor. Modifications to the machine have been made, and it is no longer so simple to override a charging machine stop.

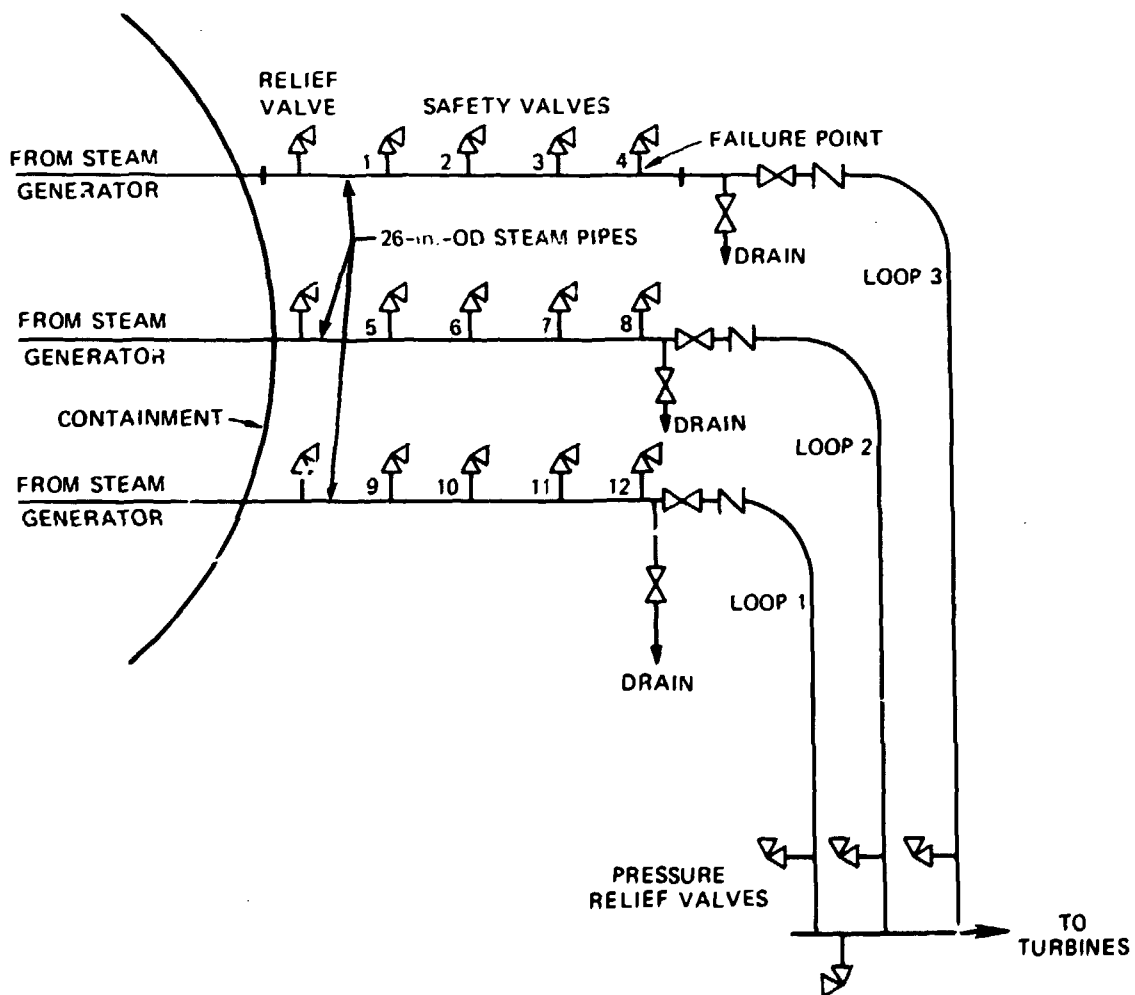
Fig. 3.3. Schematic diagram of the general area of the accident at Robinson 2.

(see Figs. 3.3 and 3.4). As one of the men attached the testing equipment to valve 4, a jet of steam sliced out horizontally in a fan-like fashion, followed almost immediately by a blast as the entire valve tore loose and was propelled upward, followed by a vertical jet of steam that reached a height of 150 ft. The blast caused a shower of scaffolding, insulation, metal parts, and construction debris, and the men were either knocked to the floor or fell there intentionally to escape the steam.

All the connections (nozzles) between the 26-in. steam pipes and the safety and relief valves were replaced by nozzles of larger diameter and thicker steel.

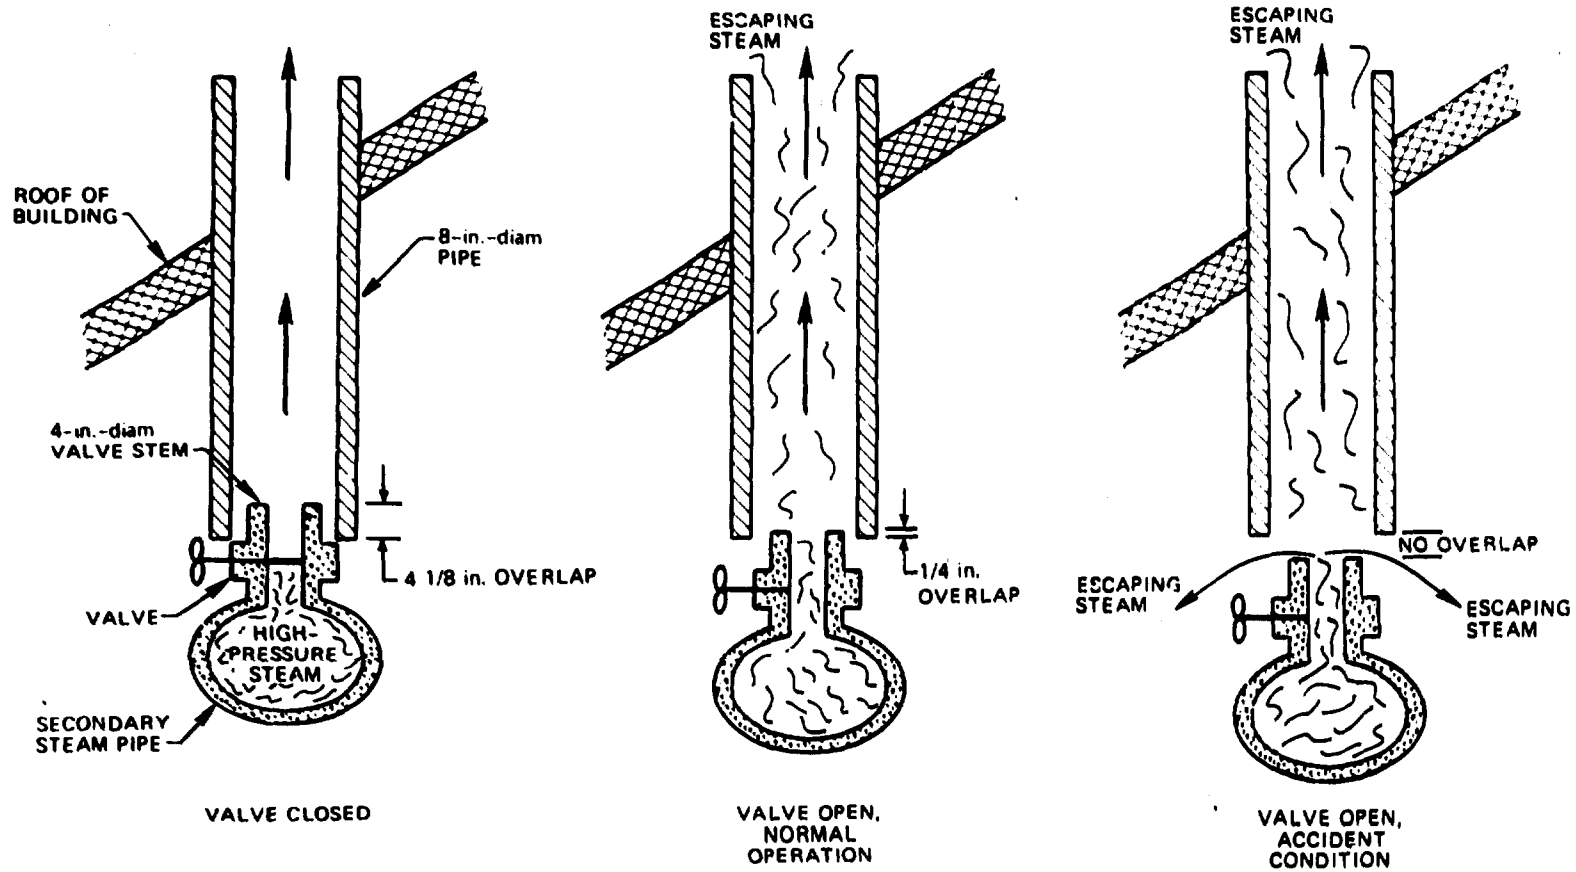
Fig. 3.8. Decay-heat release valve under various conditions.

The valve that caused the accident had been operated successfully about 20 times previously. It was not the valve itself that was at fault, but the manner in which it vented the steam (see Fig. 3.8). When steam passed through the valve, it came out vertically through a 4-in.-diam extension. Inserted over this extension (but not attached) was the 8-in.-diam vent pipe that passed through the roof. There was a 4-1/8-in. overlap between the pipe and the extension; that is, the valve extension extended into the vent pipe a distance of 4-1/8 in. Escaping steam, under normal conditions, forced the valve back down so that the overlap was only 1/4 in. At the time of the accident, it was believed that the valve "hung up" and then suddenly opened, which caused it to move down further than usual for a few seconds. Thus, the valve extension was completely out of the vent pipe momentarily, which allowed steam to escape into the room.

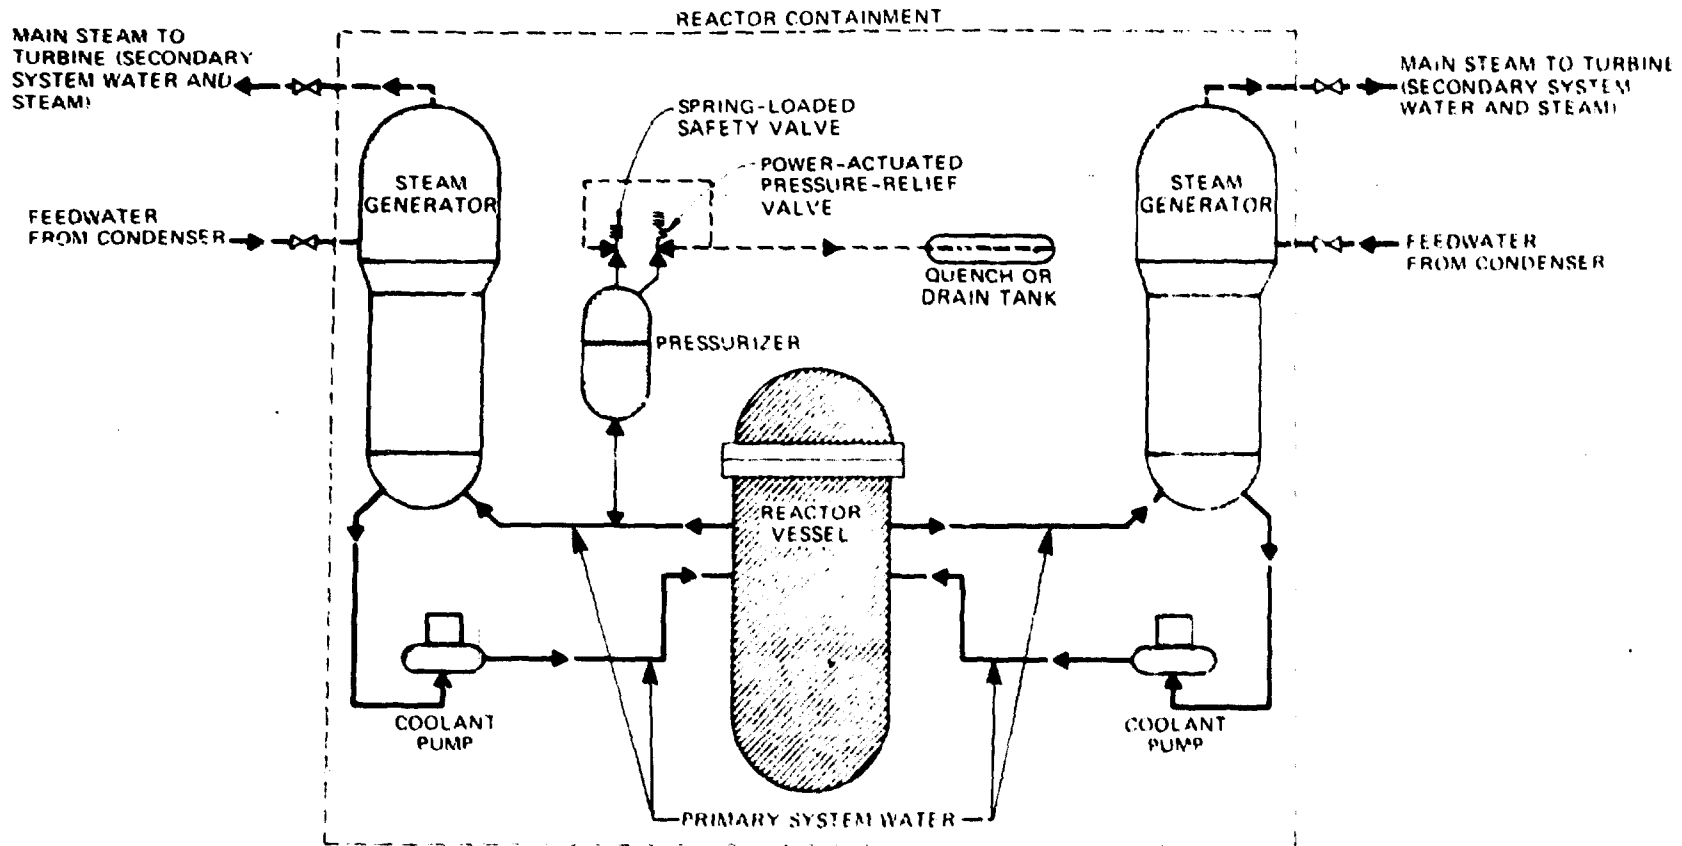
Fig. 3.12. Schematic diagram of a typical nuclear steam supply system in a pressurized-water reactor.

On Sept. 24, 1977, with the reactor in Davis-Besse 1 about 10% of its full power (but not generating electricity), a system associated with the feedwater to the steam generator partially shut down. The cause of the initiating event is unknown. This "half trip" caused a valve to close the water supply from the condenser to one of the steam generators. Figure 3.12 is a schematic of the system.

which sent the water level in the pressurizer to its maximum value.* The primary system continued to lose pressure, and about 20 min after the onset of the event the operators determined that the pressurizer relief valve was stuck open. They isolated it by closing a block valve, which collapsed the steam bubbles in the primary system, and then the pressure stabilized. Subsequently, they were able to achieve cold shutdown.

During the investigation that followed, it was determined that a relay which is used to hold the pressurizer relief valve open until there is a 50-psi drop in pressure was missing. The use of this relay prevents oscillations of the kind that had damaged the valve.

The relief valve in the pressurizer was repaired, the missing relay was installed, other equipment that had not operated properly was modified, and the reactor was returned to service. There were no injuries, and no radioactivity was released.

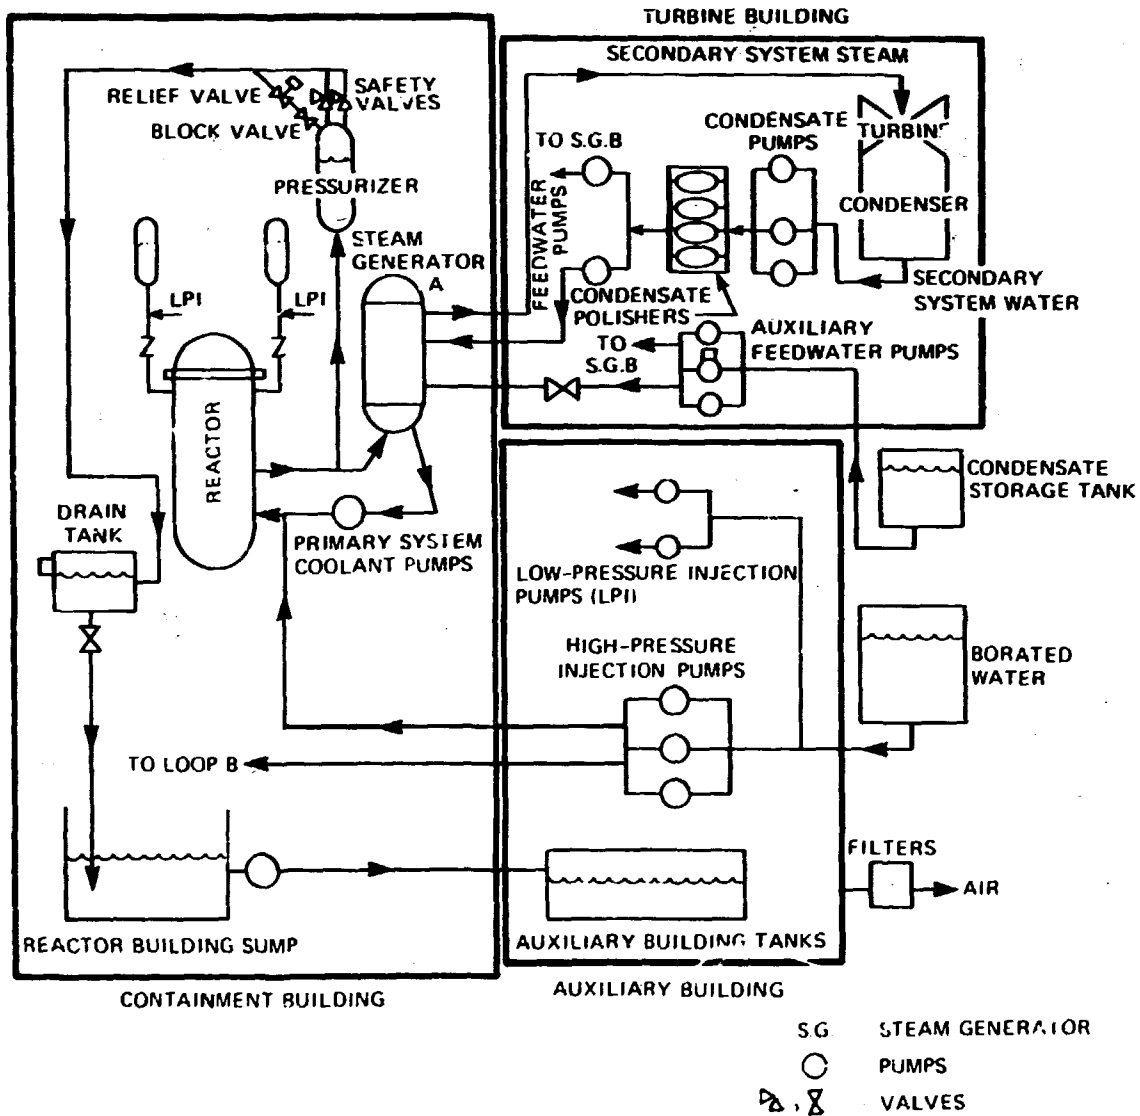
Fig. 3.13. Typical flow system for pressurized-water reactor. (Courtesy of American Institute of Physics.)

At about 4:00 AM on Mar. 28, 1979, a condensate pump in the turbine building (Fig. 3.13) stopped. This led to the shutdown of other pumps downstream (steam generator feedwater pumps in the turbine building), which in turn shut down the turbines. The reactor was scrammed automatically. When the pumps stopped, there was no supply of secondary system water to the steam generators. Secondary system water must circulate through the steam generators in order to pick up and carry away

pumps in the turbine building) which would have added the needed water to the steam generators started up. However, valves that blocked the flow of this water had been incorrectly left closed following maintenance. Without secondary system water flowing through the steam generators, they soon dried out. Without heat removal provided by the secondary system water, the primary system water began to heat up, and the pressure in the primary system began to rise. The pressure-relief valve in the pressurizer opened and later failed to close. The pressure began to plummet as water and steam poured out of the stuck-open valve into the drain tank. At about midway in this drop in pressure, two pumps (high-pressure injection system pumps in the auxiliary building) turned on to feed water into the primary system and stabilize the pressure. At this point, a meter on the pressurizer indicated that the pressurizer was completely full of water,* so the operator turned one of the pumps off and then about 10 min later he turned off the other one. Actually, primary system water continued to escape through the stuck-open valve. The pressure in the primary system continued to drop until it reached the saturation point, at which time some of the water began to change to steam.

In spite of the blowing of the rupture disk, the systems continued to stabilize and remained relatively stable for about 3/4 hr. The primary cooling pumps then began to vibrate due to steam that had been generated when some of the primary system coolant water turned to steam during the initial drop in pressure. The operator turned them off. Since the water in the primary system was thus no longer circulating, it began to heat up from the decay heat generated in the reactor, and the pressure began to rise. In the meantime, the operator had ascertained that the relief valve on the pressurizer was stuck open, and he activated the "block" valve, thus sealing the pressurizer. (The block valve serves as a backup for the pressure-relief valve; see Fig. 3.13).

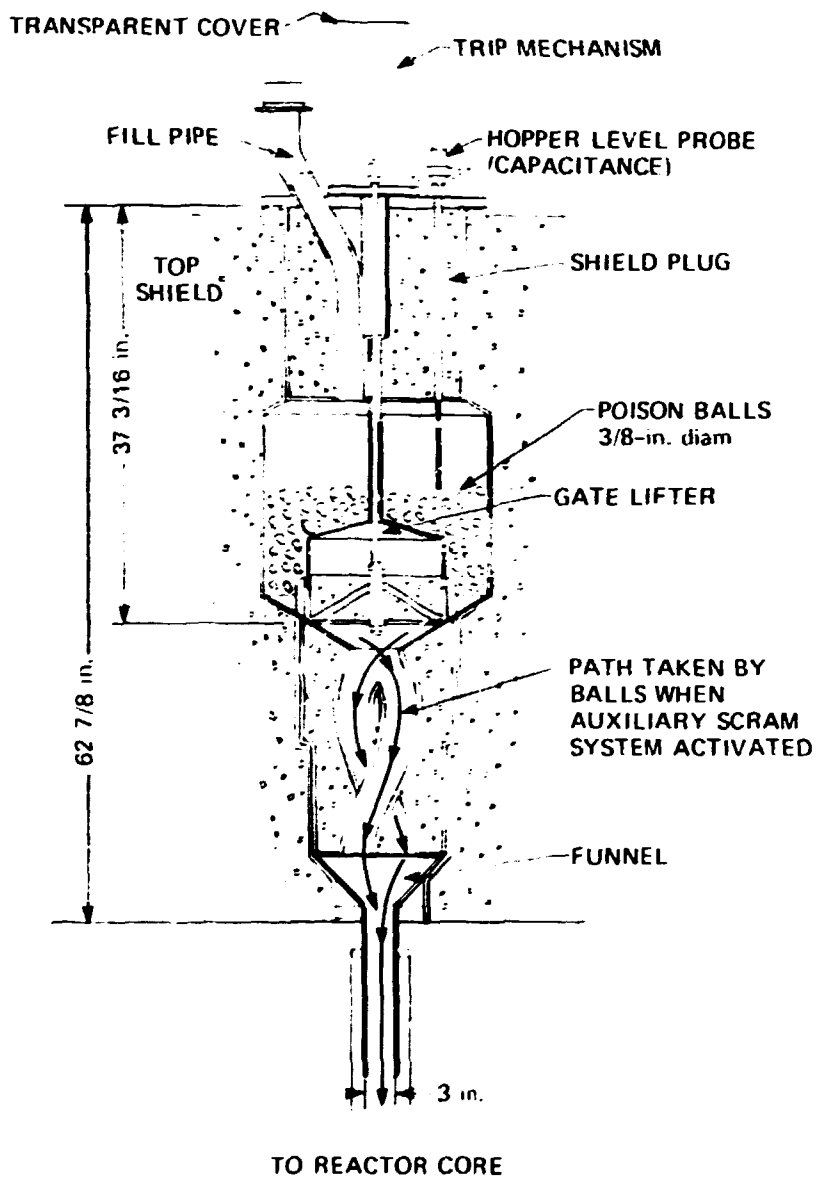
Fig. 4.1. Auxiliary scram system.

In addition to the primary system, there is an independent auxiliary scram system, which is situated on top of the reactor. In the event that the primary system control rods do not enter the reactor within 1.5 sec after a scram signal, the auxiliary system is activated. This system simply drops small balls of "poison" material (samarium oxide), that is, a material that readily absorbs neutrons, into the reactor and shuts it down. Figure 4.1 is an illustration of the mechanism.

Returning to the primary control system, each control rod drive mechanism has a five-position switch, and each position serves a different function. In addition, there are two independent sources of electrical energy to the system. Unfortunately, they were wired in such a way that if the five-position switch on a single control rod mechanism was in a particular position (an uncommonly used position) and if also that same control mechanism had a serious short circuit, then a scram signal would not release any of the rods. The scram signal ordinarily cuts off the supply of electrical energy to the rods, but under the conditions noted above, the auxiliary electrical system continued to supply electrical energy, thus holding the rods out. This exact condition prevailed at the time of the incident.

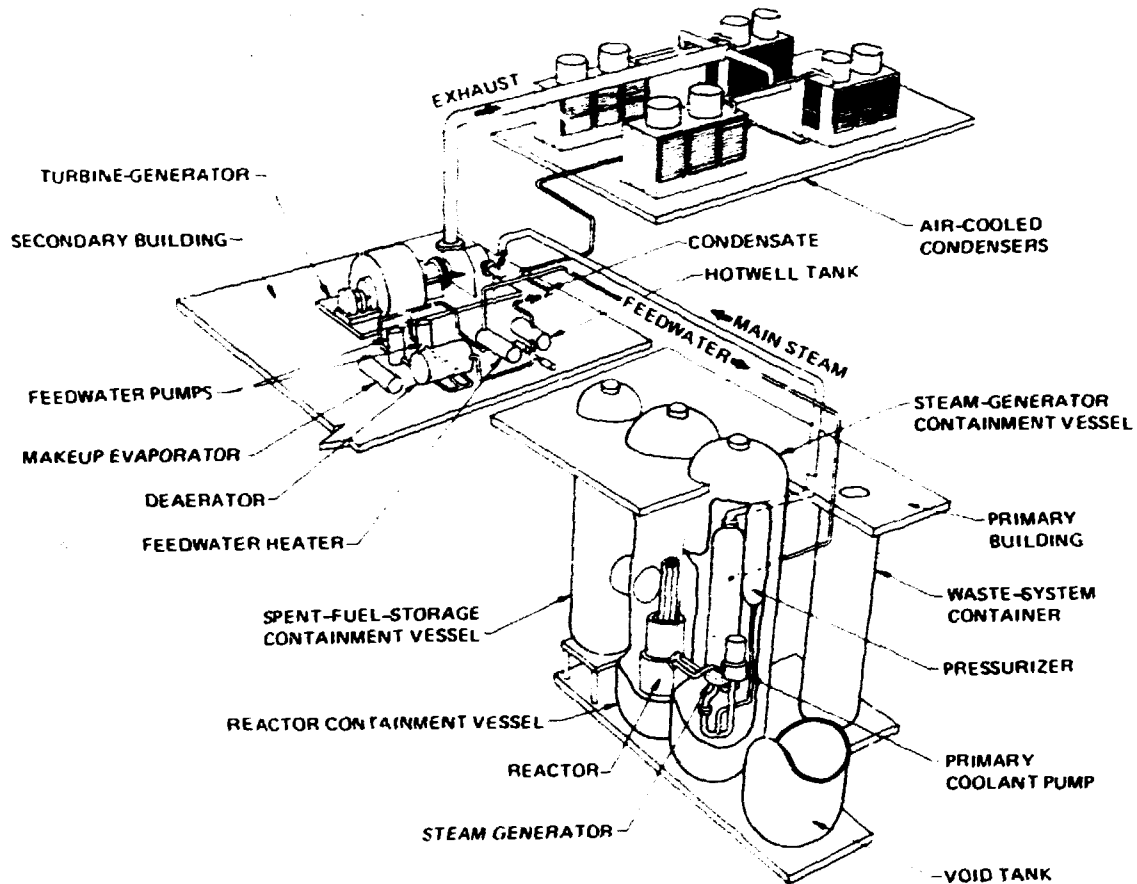
Fig. 5.2. basic flow and orientation diagram of PM-3A Nuclear Power Plant.

The reactor had operated successfully for the 3 months prior to the incident. On the morning of Oct. 7, 1962, an automatic scram shut the reactor down. The reason for the scram could not be determined, but instrument problems caused by excess humidity had been experienced previously. Spurious signals resulting from humidity twice prevented the reactor from being restarted after the scram. On the third attempt, a scram initiated by a different signal occurred. Investigation revealed

that the signal had been generated by a short circuit in the electrical wires that passed through the containment vessel for the steam generator.

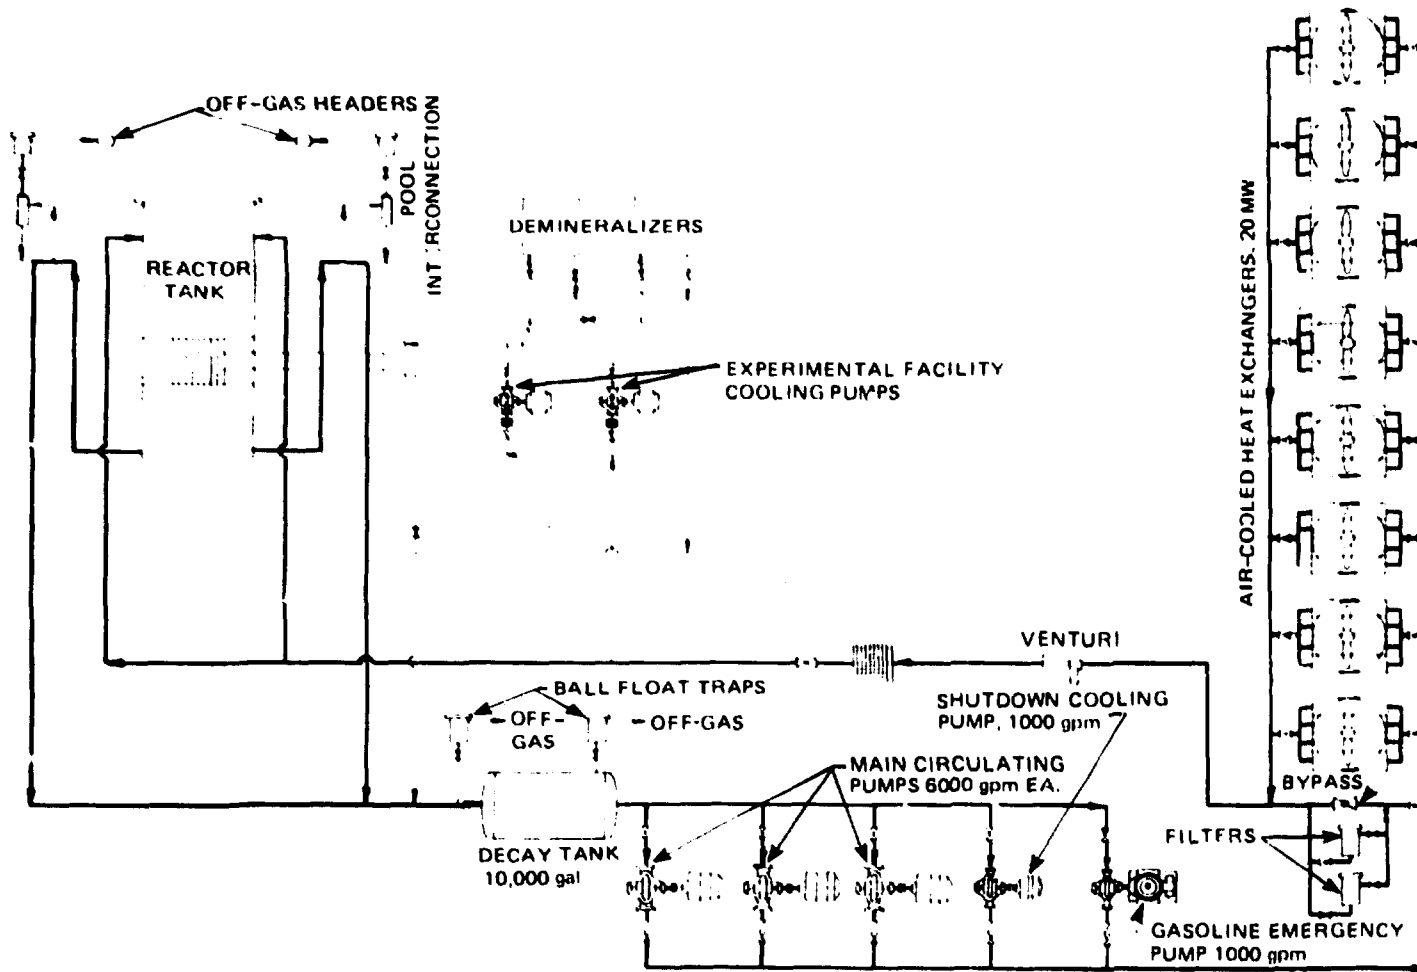
Fig. 5.4. Schematic diagram of the coolant system in the Oak Ridge Research Reactor.

In the early morning of July 1, 1963, the reactor was being brought to full power after being shut down for maintenance and installation of a new experiment. The reactor power was increased in small increments, and the systems were allowed to stabilize before the next increase. At 6 MW, a visual inspection was made of the top of the core through a viewing port to search for obstructions (at 6 MW, the Čerenkov radiation*

was sufficiently bright that an obstruction would cast a shadow). Nothing was observed in the field of view, so the power increases were continued. Small fluctuations were observed in some of the instruments when the power reached 12 MW, but these were attributed to malfunctions of the servomechanism for the control rods. Actually, this was probably an indication of boiling in one of the fuel plates. When the power level reached 24 MW, radiation alarms associated with the primary cooling system sounded, and the reactor was shut down.

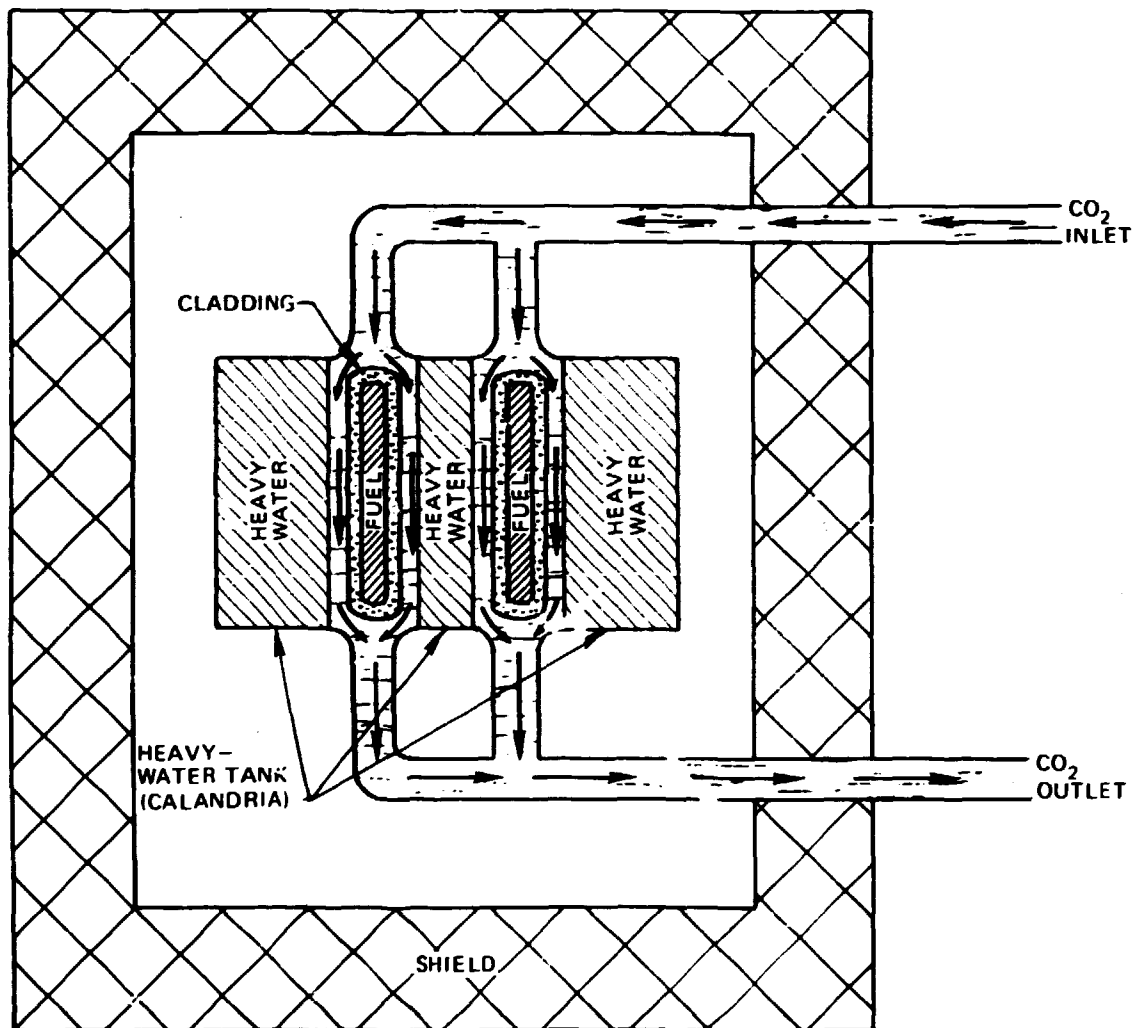
Fig. 5.7. Schematic diagram of the main features of the core of the Lucens reactor.

The accident at the Lucens Experimental Nuclear Power Station occurred on Jan. 21, 1969, during startup procedures. It had operated at nearly full power during the previous 6 months and had been shut down for routine maintenance. Figure 5.7 is a schematic diagram of the essential features of the core of the Lucens reactor. It is located in an underground rock cavern.

When the power level reached 12 MW(t), several things happened within 10 min. The CO₂ coolant pressure dropped to atmospheric pressure (it normally is about 60 times atmospheric pressure), and the reactor was scrammed. Then radioactivity levels increased in the cavern, whereupon the cavern was sealed. Finally, there were indications of the leakage of large amounts of heavy water. The moderator tank had ruptured.
