## **MISSION REPORT**

# **IAEA INTERNATIONAL FACT FINDING EXPERT MISSION OF THE FUKUSHIMA DAI-ICHI NPP ACCIDENT FOLLOWING THE GREAT EAST JAPAN EARTHQUAKE AND TSUNAMI**

**Tokyo, Fukushima Dai-ichi NPP, Fukushima Dai-ni NPP and  
Tokai Dai-ni NPP, Japan**

*24 May – 2 June 2011*

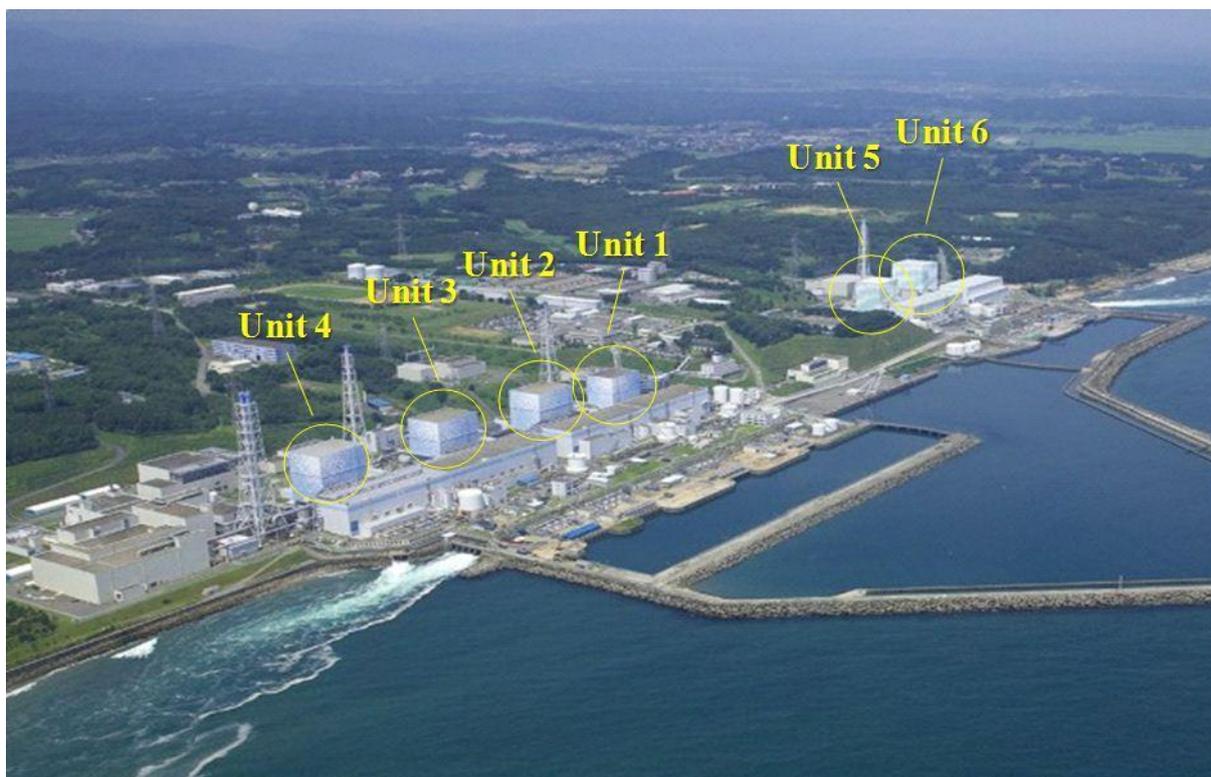
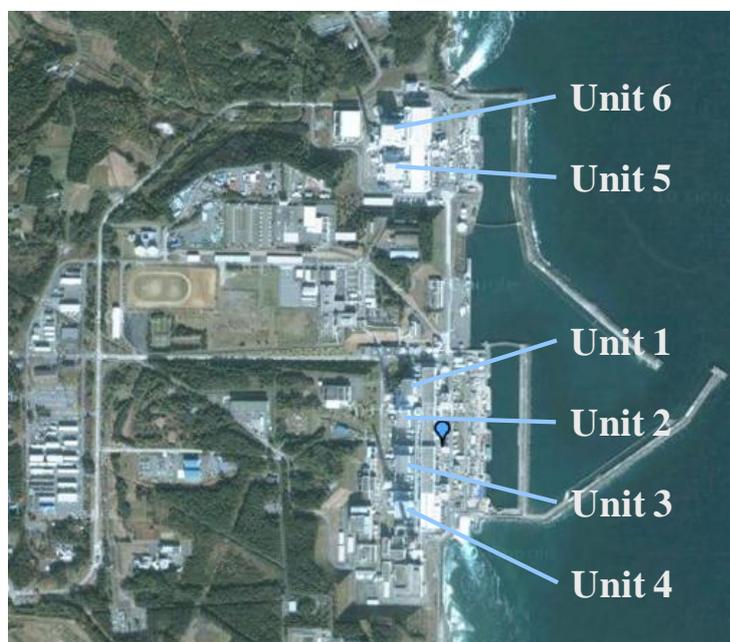
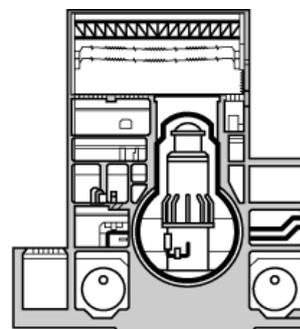
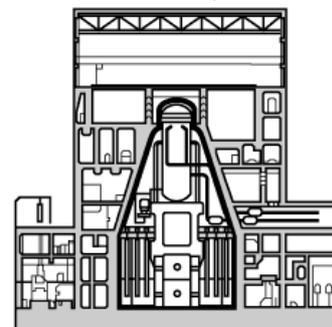
FIG. 1.2. Fukushima Dai-ichi NPP.

a) Pictorial view

**BWR Mark I (Unit 1~5)**

**BWR Mark II (Unit 6)**

b) Layout

Dai-ni site. Tokai Dai-ni has one operating BWR-5 unit of 1100 MW(e) capacity. Pictorial views of Fukushima Dai-ichi NPP, Fukushima Dai-ni NPP and Tokai Dai-ni NPP are given in Figs 1.2, 1.3 and 1.4 respectively.

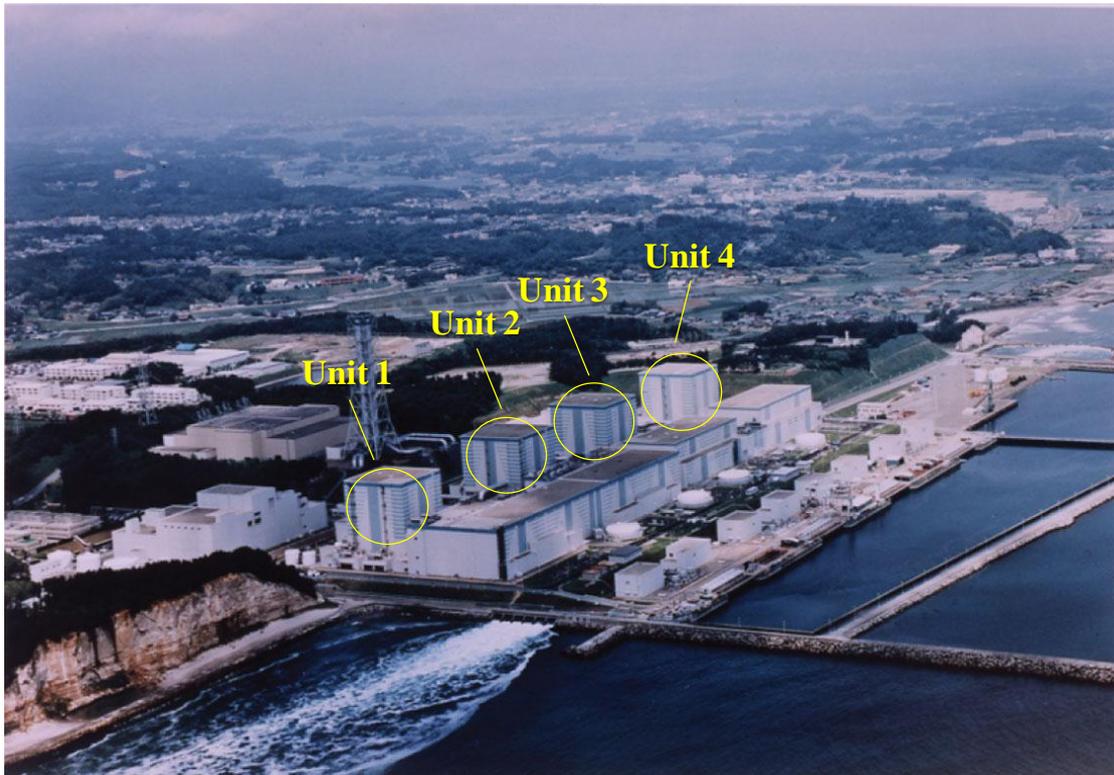
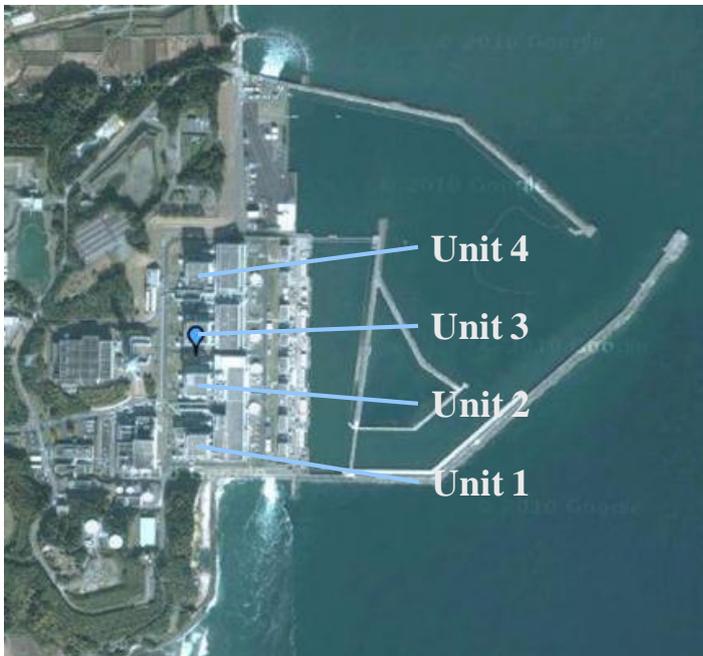
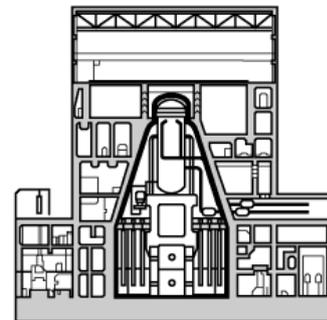
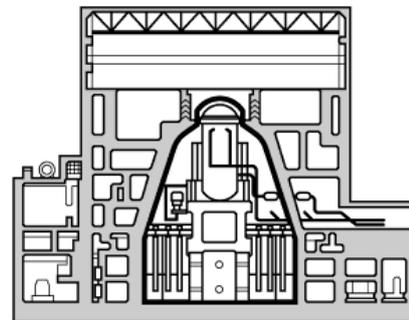
*FIG. 1.3. Fukushima Dai-ichi NPP.*

a) Pictorial view

**BWR Mark II (Unit 1)**

**BWR Mark II R (Unit 2~4)**

b) Layout

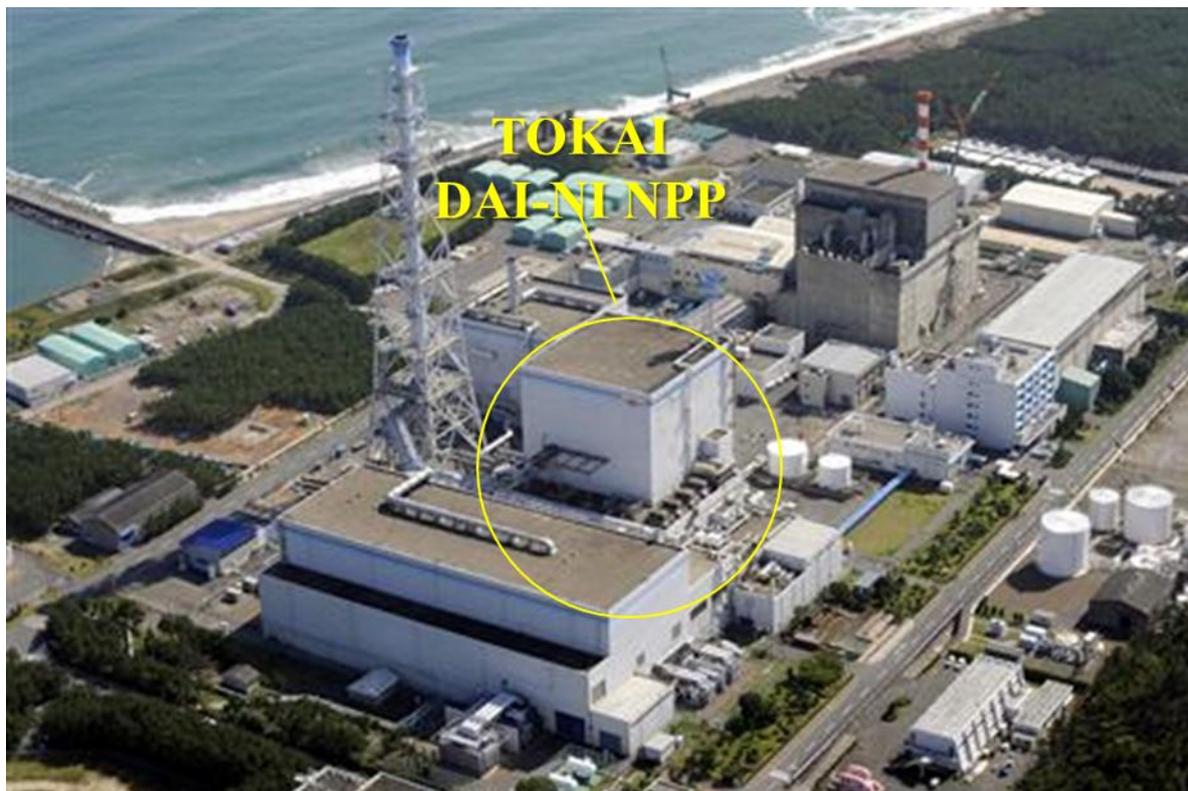
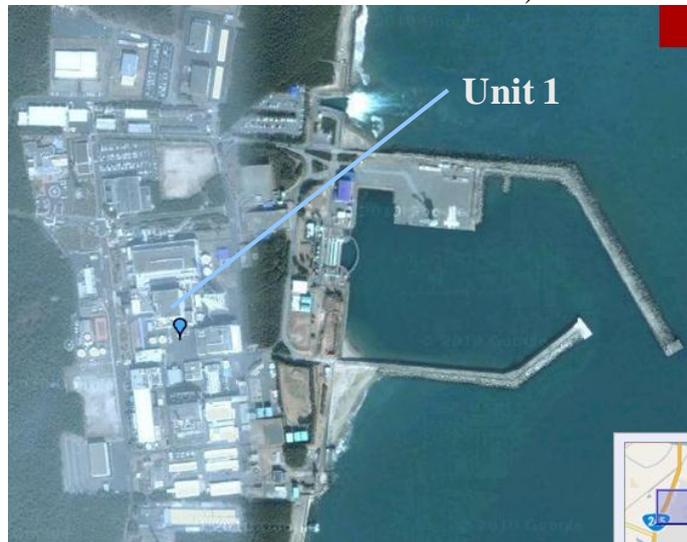
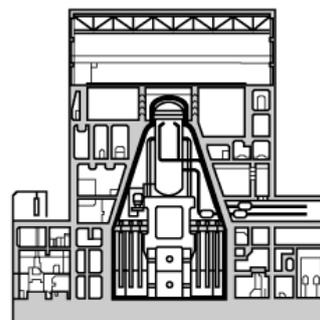
**BWR Mark II (Unit 1)***FIG. 1.4. Tokai Dai-ni NPP.*

a) Pictorial view

b) Layout

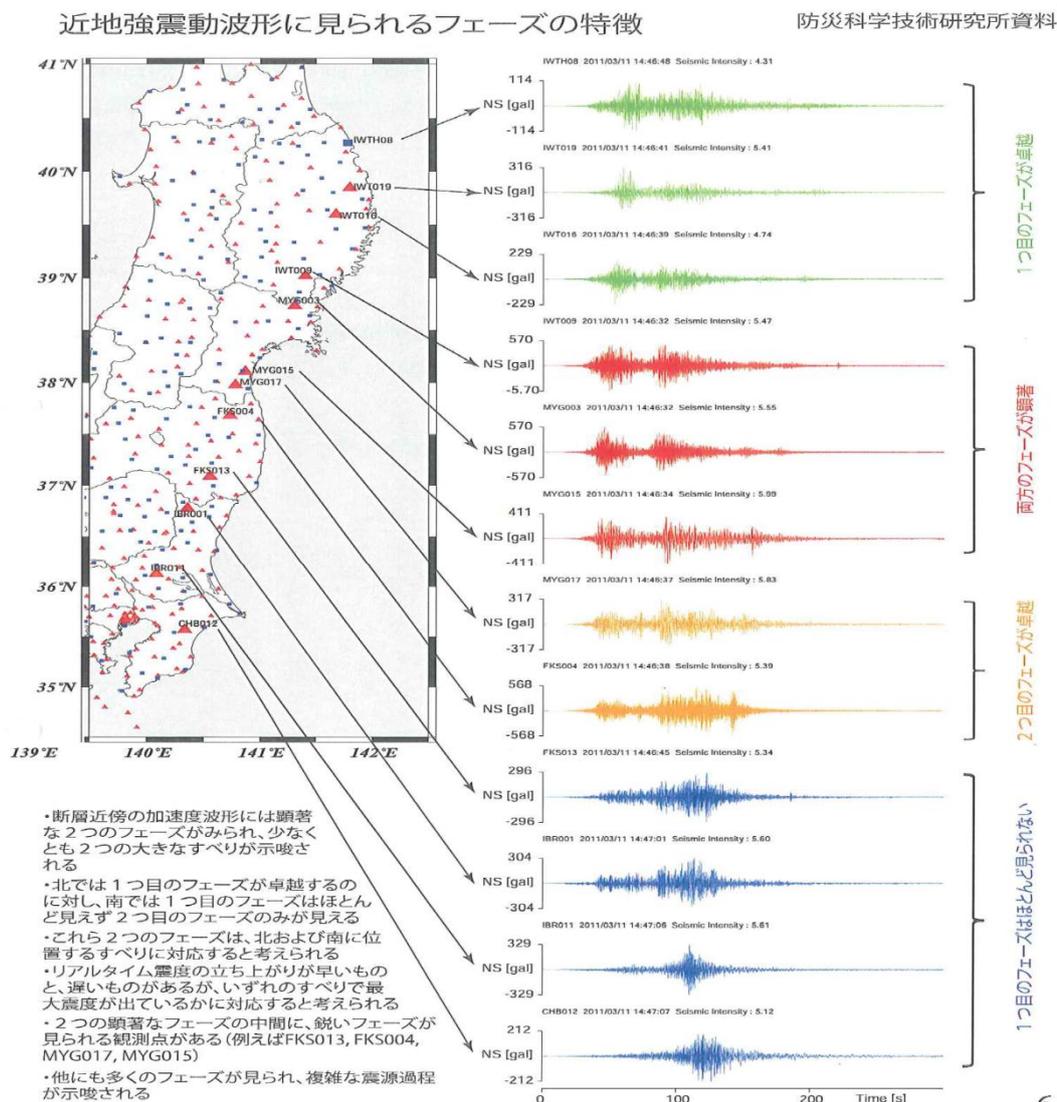
- The Magnitude Mw 9.0 earthquake occurred at 14:46 on 11 March 2011, off the Pacific coast of the Tohoku region in the subduction zone. The hypocentre was located at 24 km depth and the epicentre at a distance of about 180 km from Fukushima Dai-ichi NPP site and 130 km from Onagawa NPP site. Its duration was very long, about 140-160 sec, and 2-3 significant pulses are present in the observed records. The following graph shows the observed records in a number of locations in the coastal zone of east Japan.

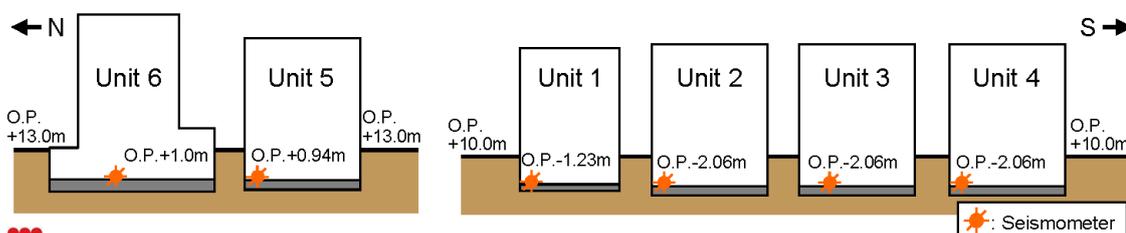
#### Records of Observations at Base-mat Slab of Reactor Building at Fukushima Daiichi NPS

The estimated values at base mat levels for the six units are indicated in columns 4-6 following table.

Maximum acceleration value from observation records (Gal)			Maximum response acceleration value (Gal)					Static horizontal acceleration (Gal)
				New design-basis seismic ground motion Ss			Original design-basis seismic ground motion		
	NS	EW	UD	NS	EW	UD	NS	EW	
Unit 1	460	447	258	487	489	412	245		470
Unit 2	348	550	302	441	438	420	250		
Unit 3	322	507	231	449	441	429	291	275	
Unit 4	281	319	200	447	445	422	291	283	
Unit 5	311	548	256	452	452	427	294	255	
Unit 6	298	444	244	445	448	415	495	500

\*   indicates the observed value was beyond the response of Ss, the others were under the response of Ss.

During the Mission, no comparison was made between the observed spectra with the design ones since they were not made available to the Review Team. Regarding the peak accelerations at the foundation base mat level, the recorded maximum response accelerations exceeded the originally design value for S2 earthquake from 1.13 to 2.2 times, with exception of Unit 6 that shows no exceedance.

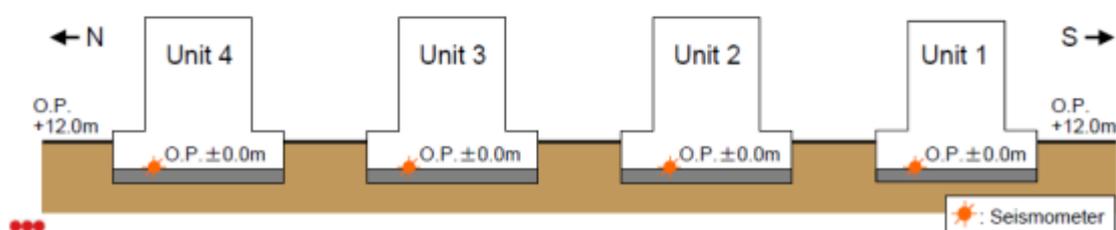
Maximum acceleration value from observation records (Gal)			Maximum response acceleration value (Gal)					Static horizontal acceleration (Gal)
				New design-basis seismic ground motion Ss			Original design-basis seismic ground motion		
	NS	EW	UD	NS	EW	UD	NS	EW	
Unit 1	254	230	305	434	434	512	372	372	470
Unit 2	243	196	232	428	429	504	317	309	
Unit 3	277	216	208	428	430	504	196	192	
Unit 4	210	205	288	415	415	504	199	196

\* All observed maximum acceleration values were under the response of Ss.

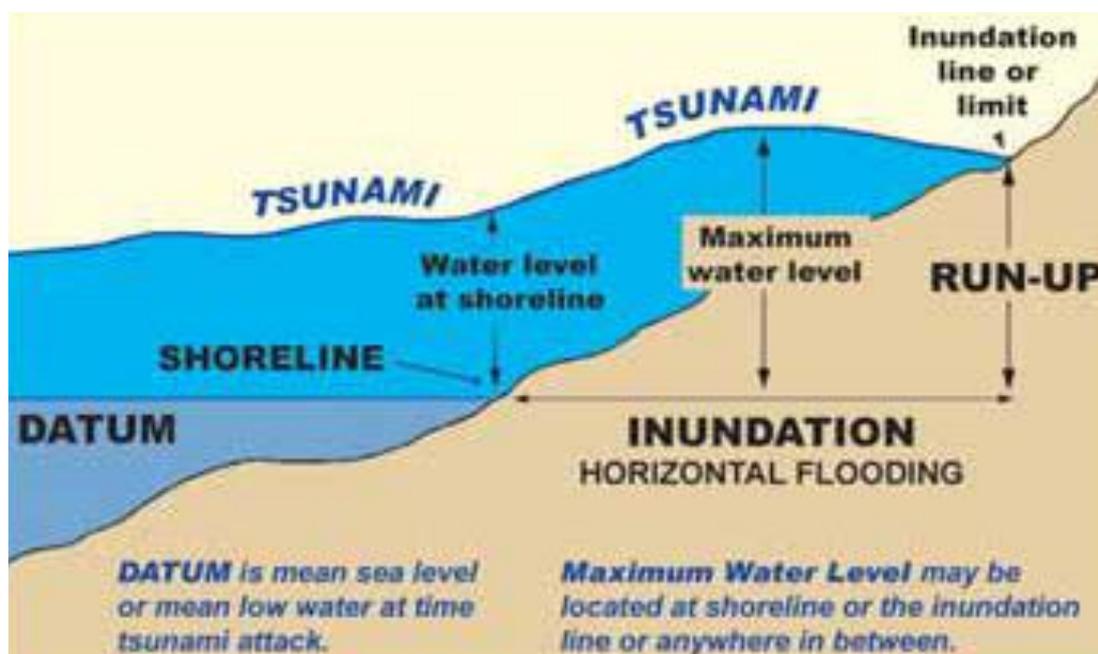
The following parameters should be defined, as illustrated in the diagram. They are included here for a common understanding of the terminology used in this report:

- **Run up:** elevation reached by the tsunami wave at the inundation limit or inundation line
- **Water level at shoreline**
- **Maximum water level**
- **Inundation area (or horizontal flooding area)**

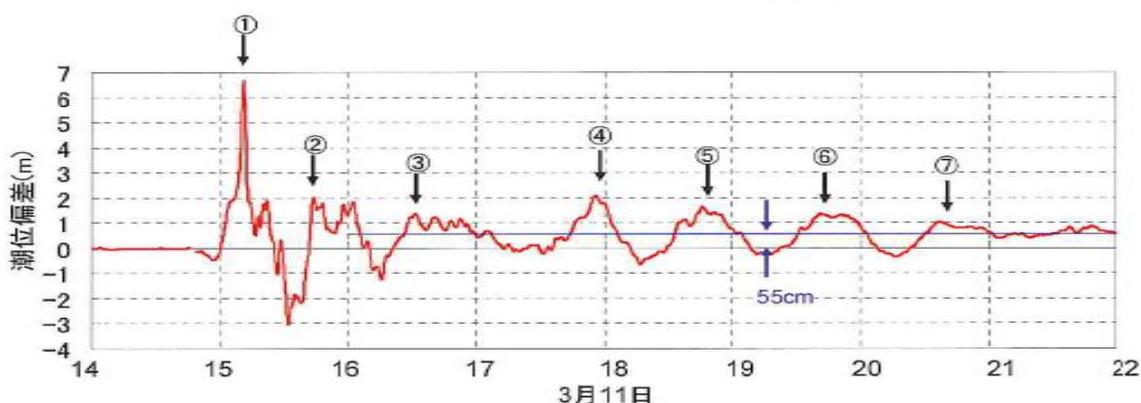
図一 2 岩手南部沖GPS波浪計で捉えた津波の初期の波形

- The Magnitude Mw 9.0 earthquake that occurred at 14:46 on 11 March 2011 triggered a tsunami that reached the site at about 15:30, i.e. ~44 minutes later with run-up heights of about 14-15 m, well above the plant main grade. This produced flooding, destruction and disruption of safety functions in the form of inundation, hydrodynamic forces, impact of dragged debris, deposition of sand and silt, debris, etc. The observed record at IWATE Nanbu Oki Tidal Gauge in open sea can be seen in the following graphs.
