Gasbuggy, New Mexico, Site

FACT SHEET

*This fact sheet provides information about the Gasbuggy, New Mexico, Site.
This site is managed by the U.S. Department of Energy Office of Legacy Management.*

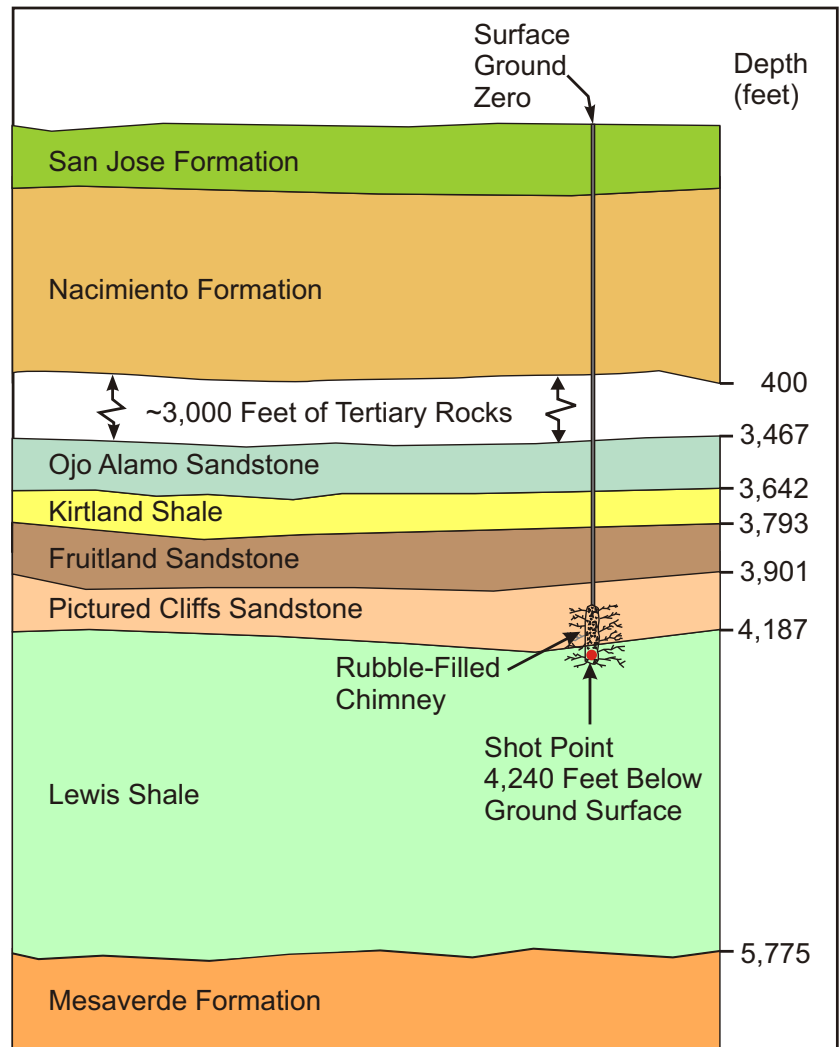
Cross Section of the Gasbuggy, New Mexico, Site

On December 10, 1967, the U.S. Atomic Energy Commission (AEC), a predecessor agency of the U.S. Department of Energy (DOE), detonated a 29-kiloton-yield nuclear device 4,240 feet below ground surface in an attempt to stimulate production of natural gas from deeply buried, low-permeability, gas-bearing formations. This was the first natural-gas-reservoir stimulation experiment in the Plowshare Program, which was designed to develop peaceful uses for nuclear energy. AEC, U.S. Department of the Interior, and El Paso Natural Gas Company jointly sponsored Project Gasbuggy.

The blast created a cavity and a chimney of rubble above and within it. The purpose of the detonation was to stimulate flow of natural gas through the fractures created by the blast and use the chimney as a collection chamber. No radiation was released at the surface at the time of the blast. The molten rock in the cavity encapsulated most of the radionuclides from the detonation.
